**December 22<sup>nd</sup>, 2021**

**Phoenix V Condominiums  
24400 Perdido Beach Blvd,  
Orange Beach, AL 36561**

**Subject: Handrail Securement Component Observations**

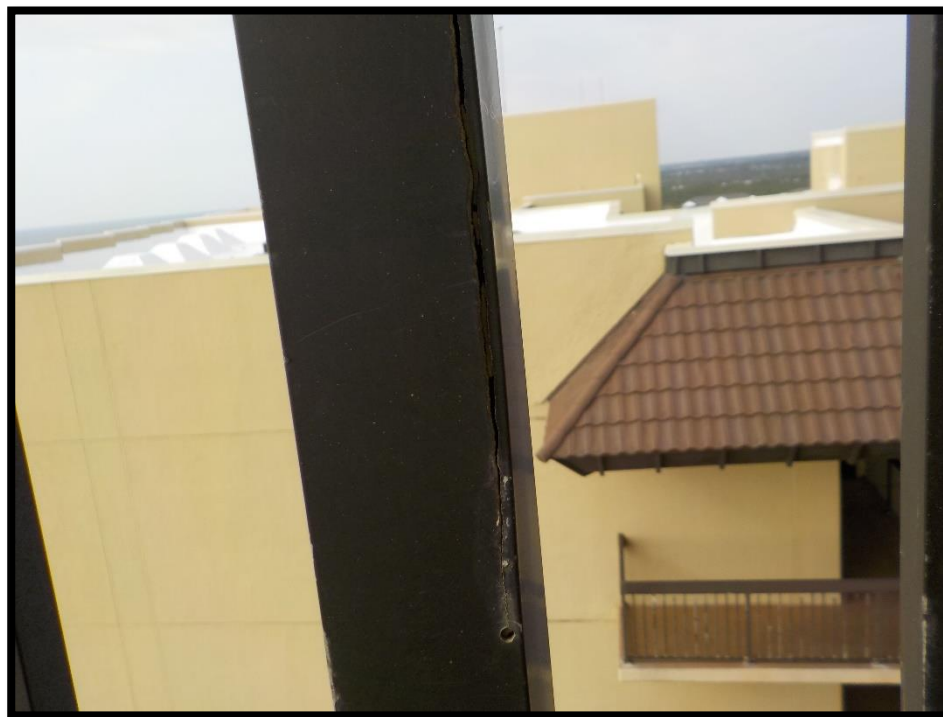
The South elevation balcony was noted to have cracked/split metal stanchions (likely from freeze/thaw cycles) on the West side of the balcony area. The Easternmost stanchion pocket was deconstructed in a small area and samples were gathered in an attempt to determine material make-up of the pockets' fill. When chiseling out the material, it was noted that there appeared to be a topically applied non-shrink

Cracked/split metal stanchions (likely from freeze/thaw cycles) on the West side of the balcony area.

The handrail stanchions that are split should receive a recommendation from a certified handrail manufacturer/applicator or Structural engineer who knows and understands both handrail codes and resistance algorithms.

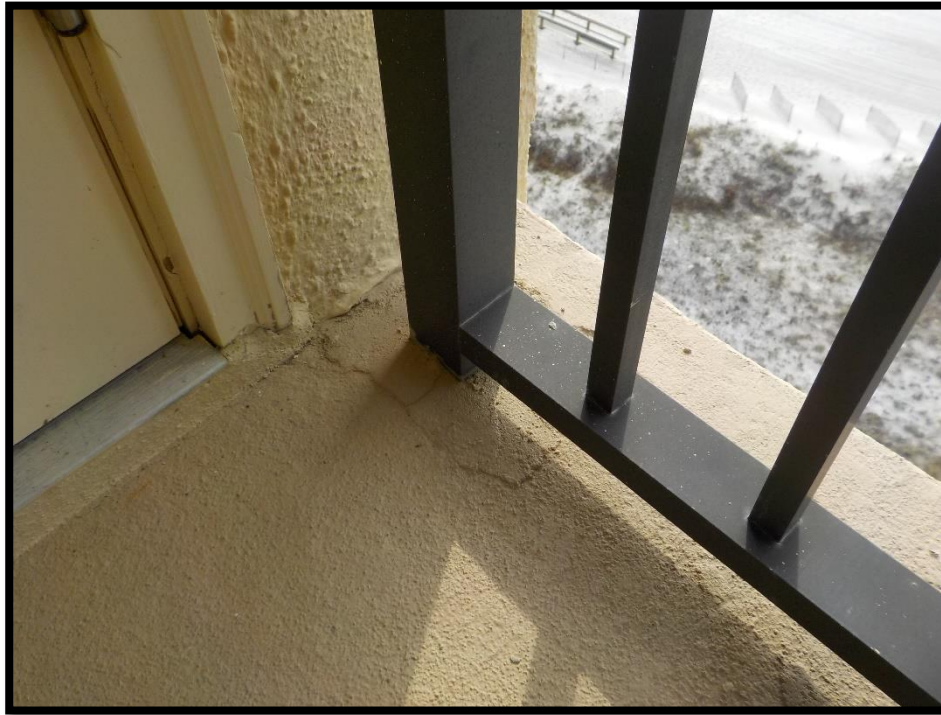
type grout applied over the original pocket fill material. The pocket was also noted to have some irregularity to its perimeter shape. This appeared to be a past repair to the original pocket. This topical repair effort was concluded to hinder any fast paced topical observations of the pockets for damage, as the visible material may not represent the material that is in the depth of the pocket(s). It was also noted that the rear perimeter of the pocket (most difficult area to reach while on the balcony with the handrails in place) where it abutted the south perimeter of the concrete balcony deck was soft and granulated. This resembled gypsum based grout that has gone through wet and dry cycles, which was unlike what was primarily observed atop and within the remainder of the pocket. This also eludes to the possibility of multiple past repairs/mitigation efforts at the handrail securement pockets.

Stanchion with stanchion pocket “cap” repair rather than a full in-depth repair.

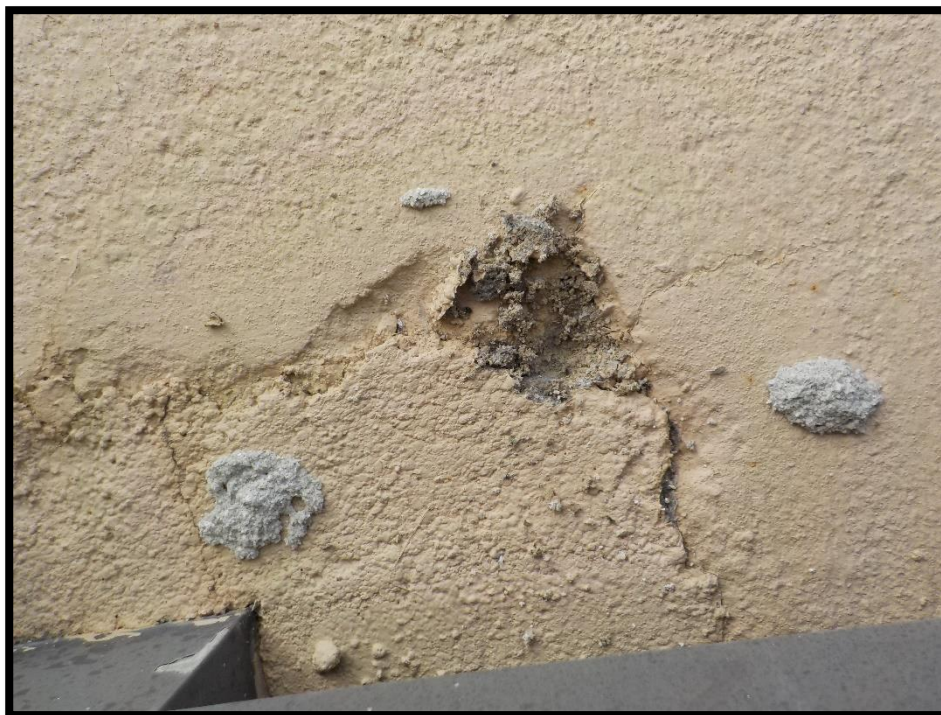
Example of difference in material between original pocket-fill and “cap” repair material.

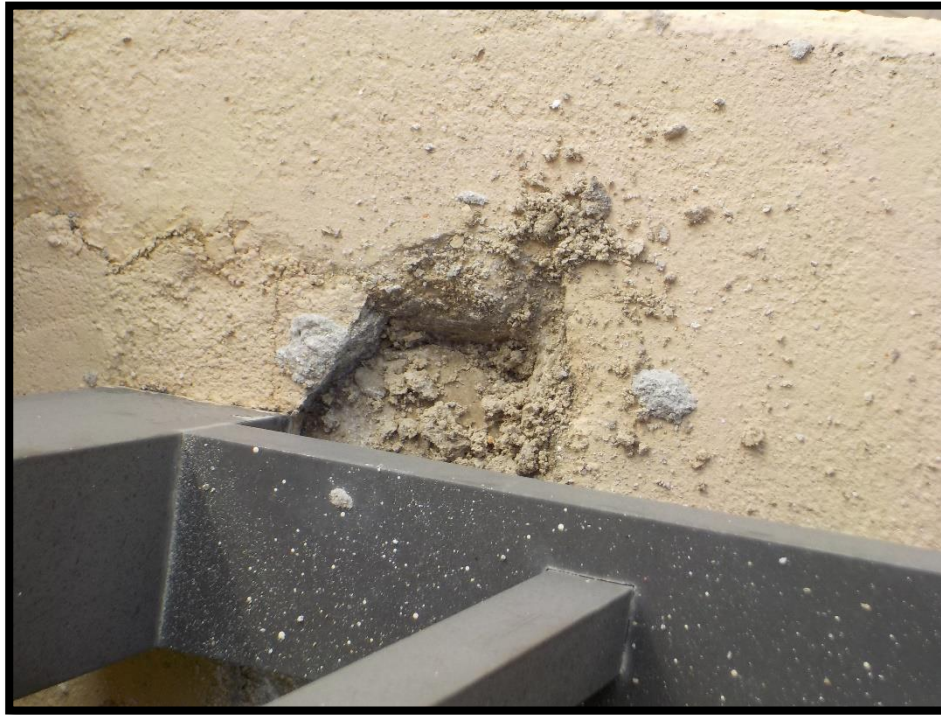
Example of original pocket-fill material.

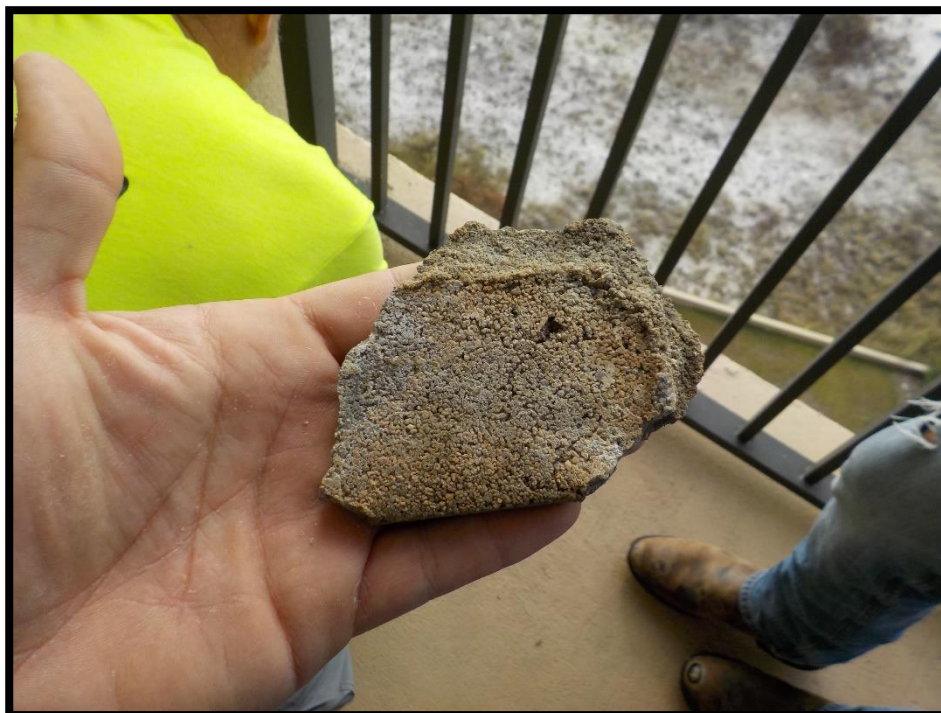
Example of material utilized during “cap” repairs.
