GEOTECHNICAL REPORT

Phoenix V Condominium
c/o Coastline Management LLC.
Front Lobby Foundation Evaluation Project
Orange Beach, Alabama

Thompson Engineering Project No.: 21-1102-0146

December 1, 2021

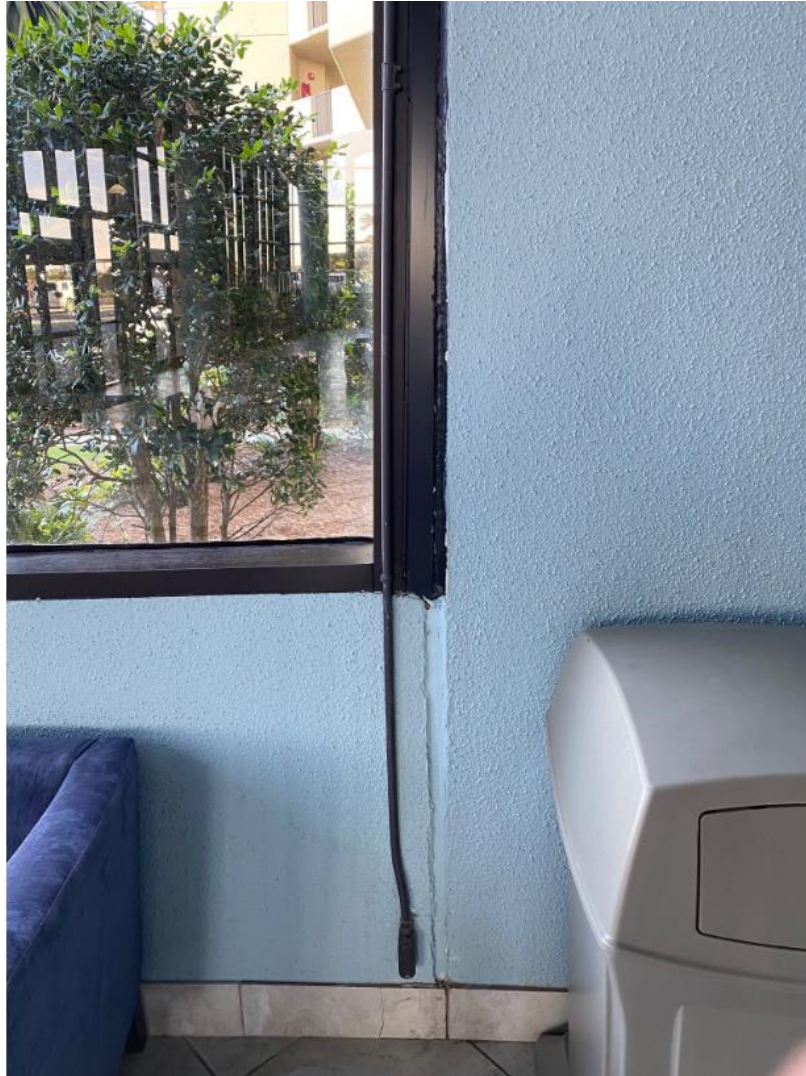
Figure 1: Front Lobby and Condominium Separation

Thompson visited the project site to observe and document the existing settlement concerns within the condominium front lobby. During our site visit, we observed the separation of the front lobby from the main condominium structure. As seen in **Figure 1** below, the existing front lobby structure has separated from the main condominium structure creating a gap that has been filled with grout and painted to match the existing frame color.

It is our engineering opinion that the settlement experienced at the project site is the result of settlement of the loose sands encountered below the slab which extend to depth of up to 12 feet below the ground surface. Likely the application of footing and slab loads and the repeated inundation of the loose sands has caused the settlement.

Remediation of the settlement should involve the design and construction of deep foundation elements that transfer the foundation loads to the dense soils beneath or ground improvement measures to prevent further settlement. While each of these systems are typically proprietary, in our experience, deep foundation elements such as helical piles or micropiles can be successfully installed to prevent further settlement of the shallow founded structure. These systems can be installed using low overhead equipment, thereby preserving most existing structure. The design of a helical or micropile support system should be performed by a Structural Engineer. Once foundation design loads have been determined, Thompson's

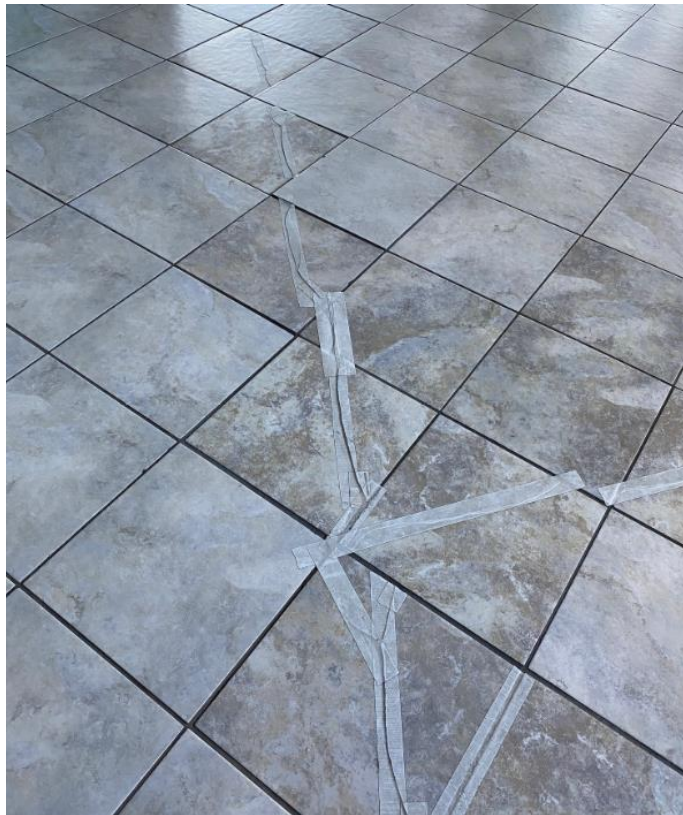
Figure 2: Front Lobby Tile Cracking

In addition, various cracking was visible within the ground floor tile installed in the front lobby. The extent of the tile cracking can be seen in **Figure 2**, presented below.

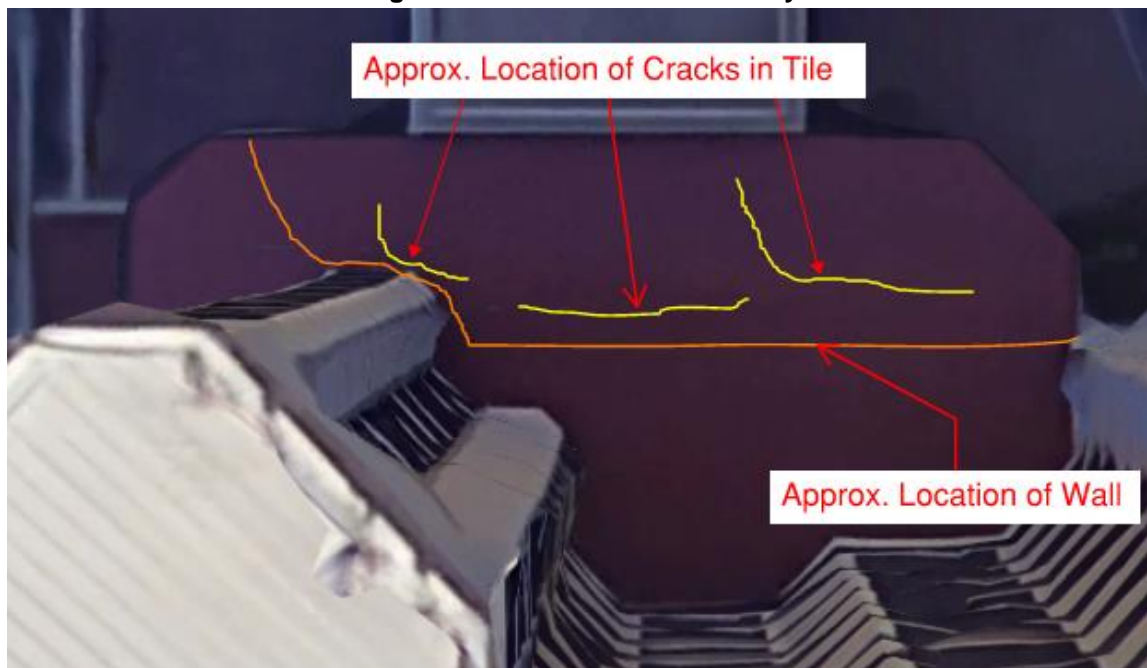
Figure 3: Overview of Front Lobby

An overview of the ground floor lobby showing the approximate locations of the tile cracks and condominium support wall are presented in **Figure 3** below.

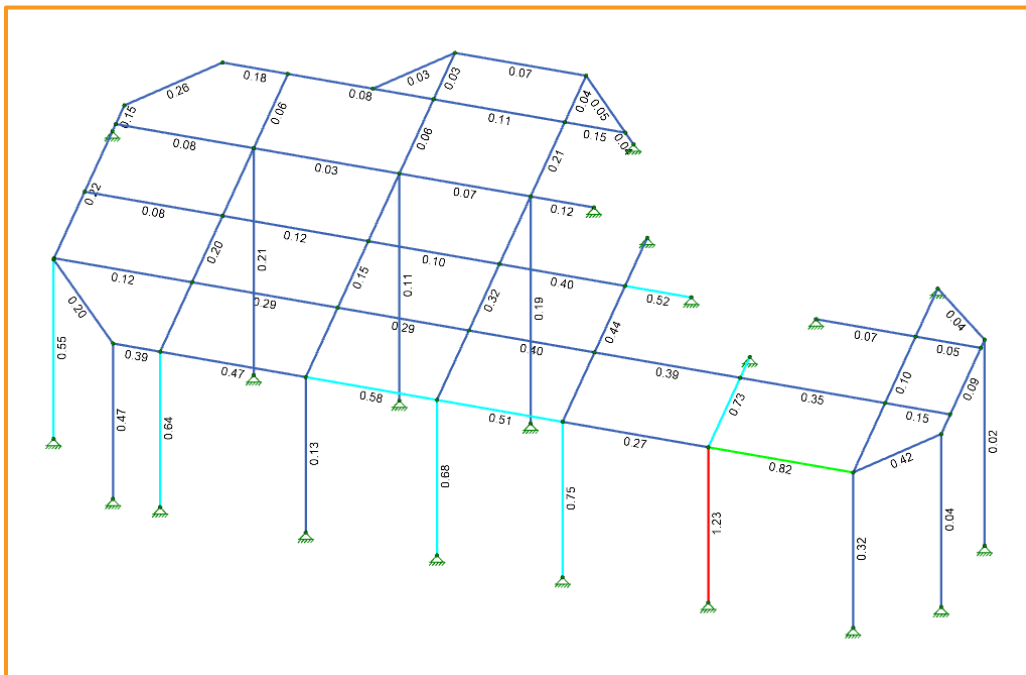
Figure 1 - 3D Analytical Model from RISA-3D

An analytical model was built to simulate the building's atrium existing conditions using RISA-3D structural analysis software. The purpose of the model was to determine the stresses in the atrium's supporting steel members as a result of the settlement and to determine the loads that the new pile support system will need to carry. The results of the analysis showed that one of the columns is currently 23% overstressed due to settlement as shown as the column in red in **Figure 1**.

Thompson Engineering is preparing a mitigation plan to arrest the settlement of the building's atrium structure. The plan includes adding helical piles underneath the existing concrete spread footings. The repair plan will also include a detail to jack the current overstressed column up to a point where the stresses in the column are within an allowable range. To repair the concrete slab on grade, Thompson recommends demolishing the existing concrete slab, placing and compacting new sand fill material to replace the material that was lost and either:

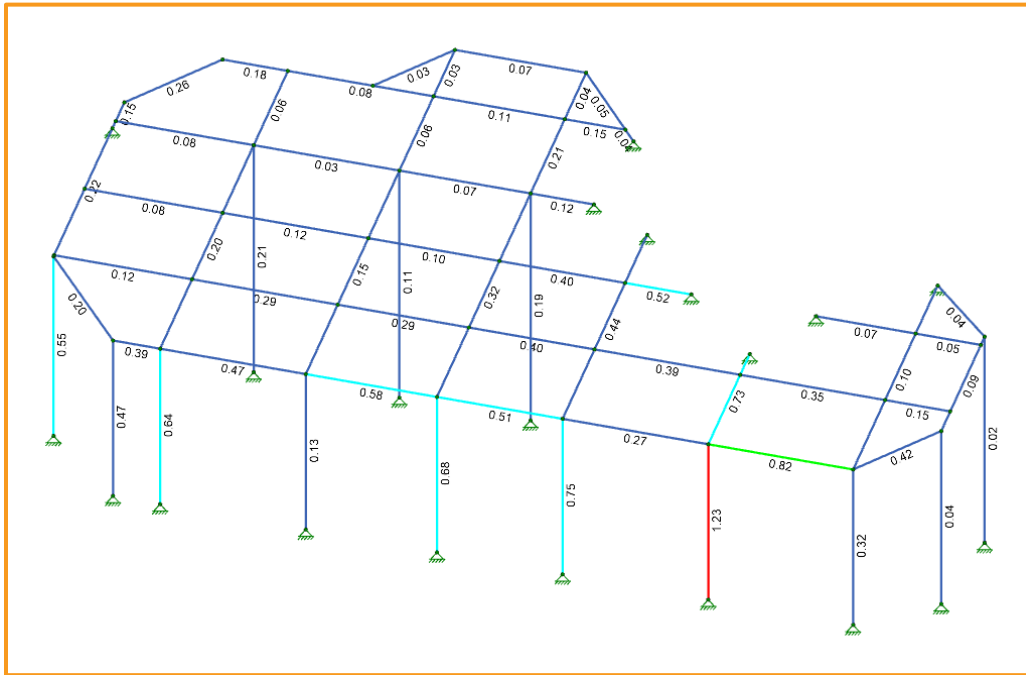
Figure 1 - 3D Analytical Model from RISA-3D

An analytical model was built for the building's atrium existing conditions using RISA-3D structural analysis software. The purpose of the model was to determine the stresses in the atrium's supporting steel members as a result of the settlement and to determine the loads that the new pile support system will need to carry. RISA-3D is a 3D finite element structural analysis software that is used to perform structural analyses. For this project, the as-built model was created representing the condition of the atrium structure as originally designed and built. The software then allows for input of an "enforced displacement" of the support locations. The field settlement at the column base locations provided the input for the "enforced displacement" values in the structural model.

The model was initially analyzed for the original conditions to validate the original design. The structure was determined to be adequate and well within allowable stress limits for the structural framing members of the atrium. Following the initial analysis, the "enforced displacement" at the bases of the columns were applied to the structural model. The results of the analysis showed that one of the columns is currently 23% overstressed due to settlement as shown as the column in red in **Figure 1**. It is apparent from the results of the model that the overstress is a result of the displacement or settlement of the column in combination with the fact that the overstressed column is also part of a very short frame that ties into the elevator shaft. The short length of the span does not allow as much displacement as the other longer spans resulting in overstressing at that location specifically. The model was finally run with a reduced displacement of 1" (representing jacking the column 1") which assured that all of the atrium members were within allowable stress limits following jacking of the single overstressed column.

Thompson Engineering has prepared a mitigation plan to arrest the settlement of the building's atrium structure. The plan includes adding helical piles underneath the existing concrete spread footings. The repair plan will also include a detail to jack the current overstressed column up to a point where the stresses within the column are within an allowable range. To repair the concrete slab on grade, Thompson recommends demolishing the existing concrete slab, bringing in and compacting fill material to replace the material that was lost and either:

- Reconstruct the concrete slab on grade with a defined control joint (in the tile as well) to help prevent widespread cracking of the concrete slab and tile should the slab settle if support soils are lost in the future
- OR
- Constructing a structural concrete slab that is supported by helical piles that would prevent slab settlement if support soils are lost in the future. Design of this system was not included in this scope of work.
 - Due to the cost of the work, mud-jacking or raising of the slab with urethane injection is not a preferred method for this project. This is primarily because the quality control is very easy to obtain with traditional demolition of a slab-on-grade and replacement vs. injection or pumping methods that when complete still have the same original slab and tile that need to be repaired.
