Phoenix V Building Observations

Notes from onsite building observations performed on September 29-30, 2020.

Phoenix V Building Observation Photographs

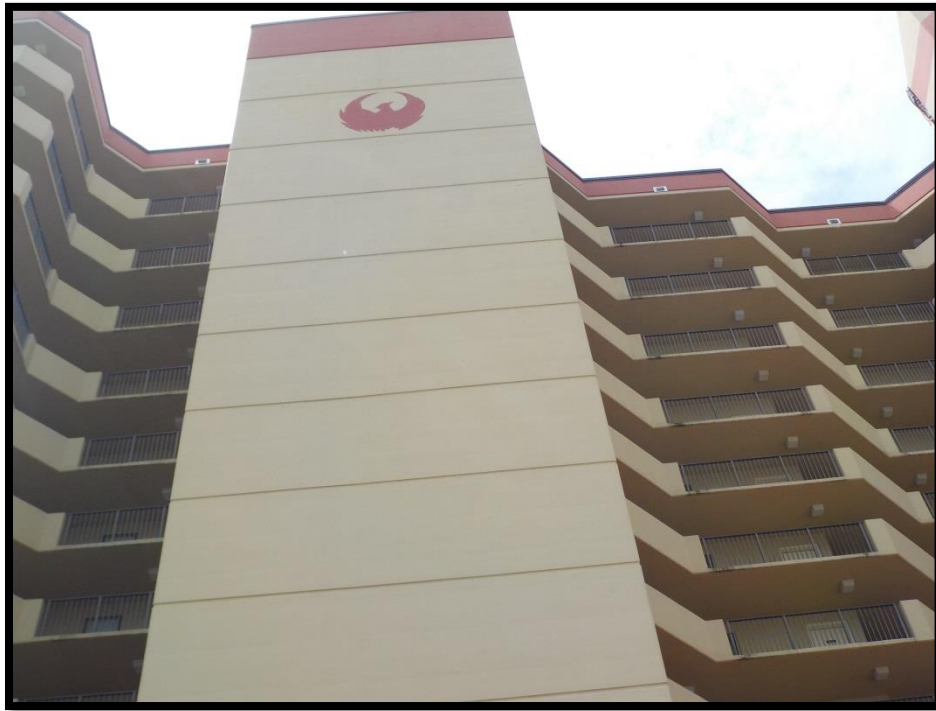
1. What exterior coating is currently on the Exterior? It appeared to be an elastomeric. The exterior coatings have lost their sheen which is typically the initial sign of losing their capability to shed dust/dirt and then moisture.
Note: The next stage/sign of a degrading elastomeric would be chalking which is a fine powder on the coatings surface caused by excessive weathering, fading and loss of elastomers. Splitting, tearing and delamination of the coating would be the final stage of deterioration and possibly could not be an acceptable substrate for recoating.
Recommendation: Learn type of coating. Assess on an annual basis to determine life span. We'd be comfortable with a 3-5yr life on areas that aren't peeling or moisture damaged from our observations. Repair areas of blistering and peeling after determining the root moisture intrusion cause. If time and funding don't allow this approach, spot patch these areas as they are allowing rain water behind the adhered coating near the failed areas.

1 – Overview of building face. Lack of sheen and faded coloring.

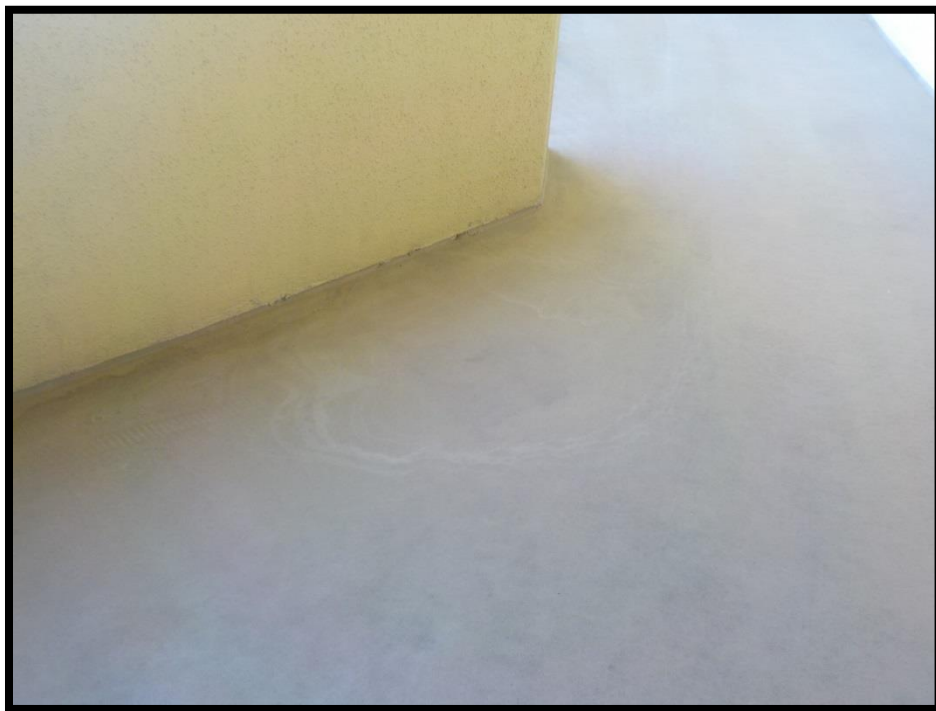
2. Common balcony deck coatings are thin and were noted as being stained. The lack of aggregate along with the color show staining very well. The floor cleaning machine and/or cleaner seems to leave its own tracks and stains on the coatings surface. Multiple low areas were noted that appear to stain where water ponds.
Recommendation: Track pond areas. Ponding should be prevented but doing so as soon as possible will create an aesthetic patch. An area that is filled and does not dry on its own within 24hrs is considered a pond. This can delaminate coatings and weep into the abutment of wall to deck coatings. From an observation standpoint, the decks have minimal slip resistance and wear level mils. With this being said, slip resistance can only be determined with testing, not by the naked eye, but it is our opinion that the deck could not be recoated without back rolling additional aggregate into the finish.

2 – Deck puddle evidence. Typical against common walkway knee walls.

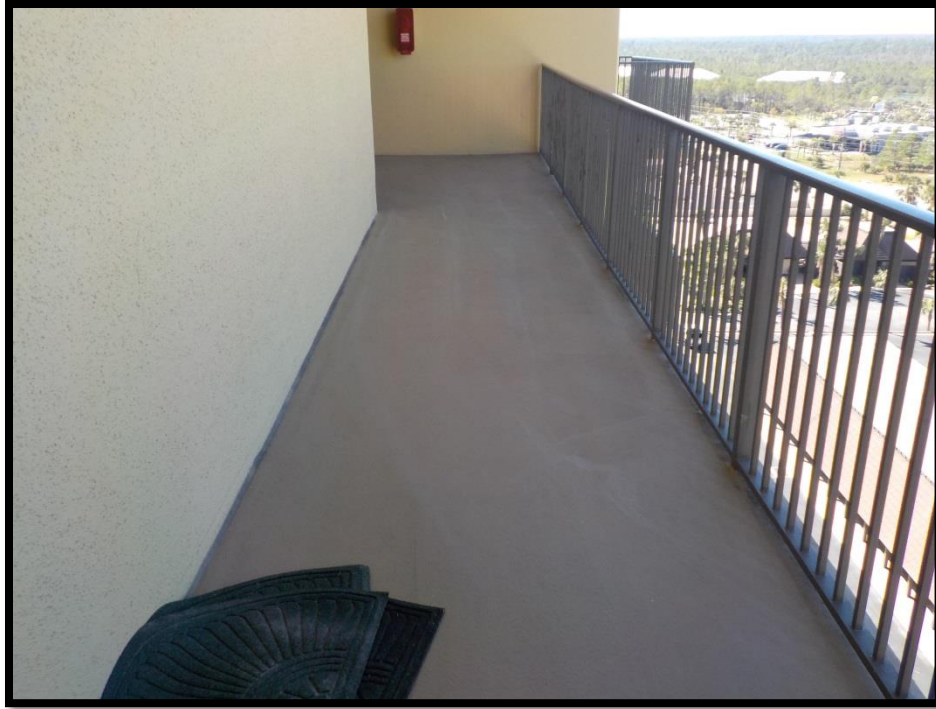
2 – Stain/tracks from floor cleaner.

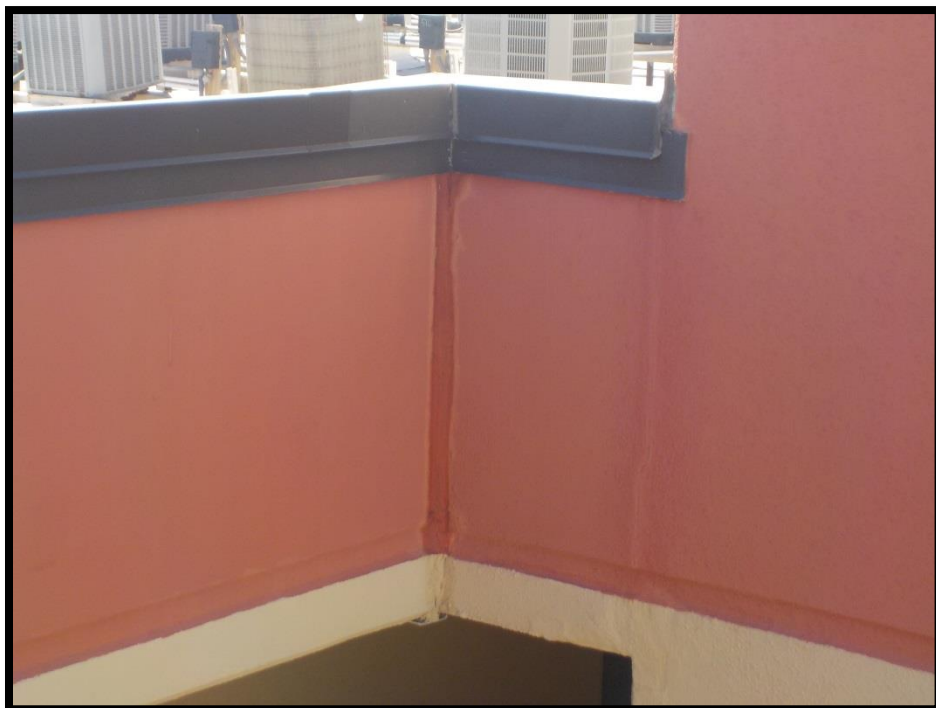
3. Noted repainting of the handrails in the West stairwell.
4. Expansion joints have some type of damage. Whether the parapet joints are splitting open with cohesive failures or the metal covers at the floor elevations show gaps and voids along with retired sealants, there are numerous joint failures.
Recommendation: Remove all expansion joint caps. Remove retired sealants. Prime concrete edges, install closed cell backer rod and reseal with a commercial grade low modulus sealant compatible to coating(s). Reinstall metal caps.

4 – Parapet expansion joint overview.

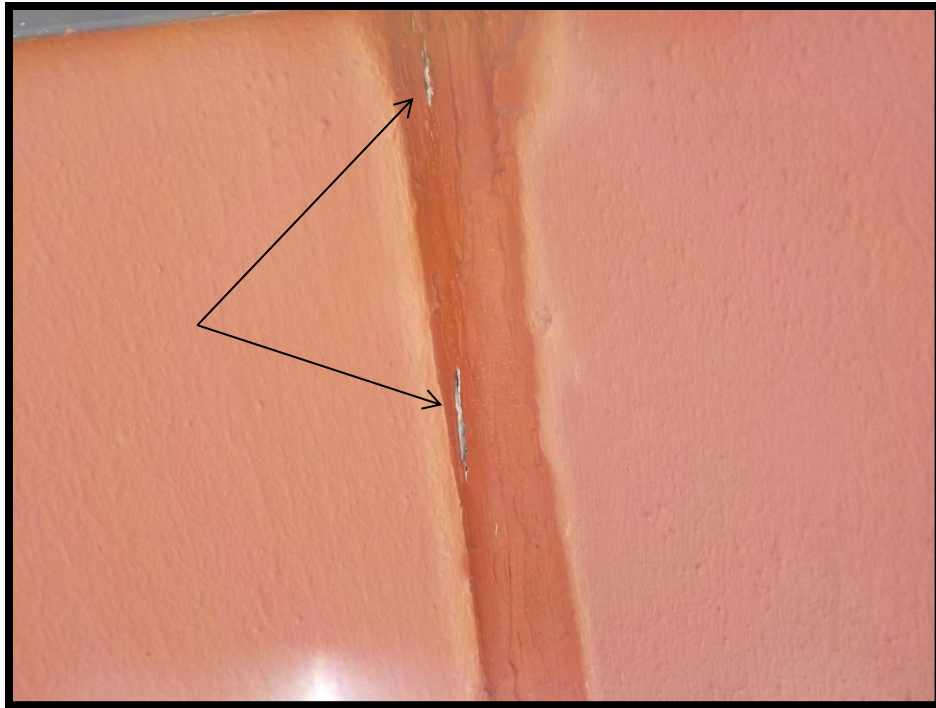
4 – Close up of parapet expansion joint. Cohesive sealant failure.

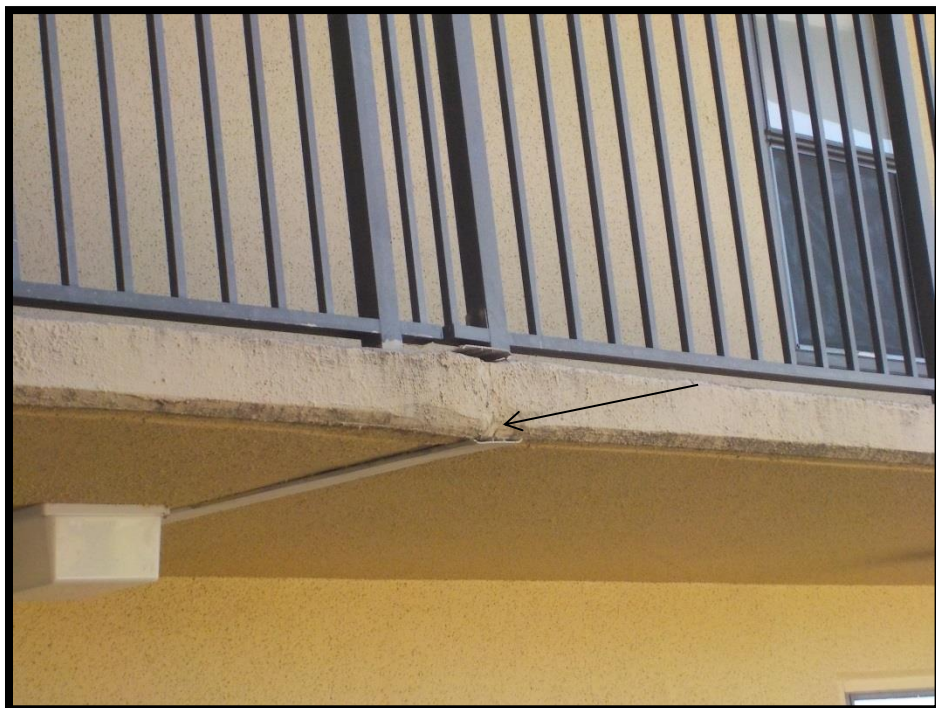
4 – Void at the expansion cap termination.

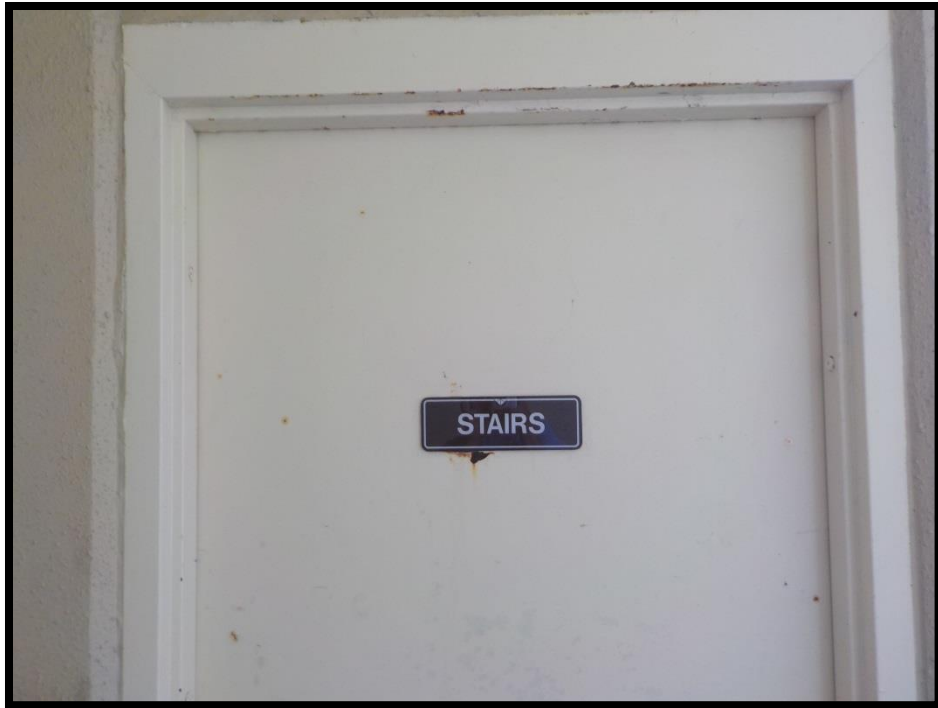
5. Unit and stairwell door and door frame corrosion. Ranged from tiny speckles to corroded holes.

5 – Door and frame in early stage of corrosion.

Recommendation: Remove and replace doors and door frames that are nearly or have corroded through the exterior door or frame skin. Perform quarterly scheduled assessments. Sand, primer and paint all assessment noted doors and door frames at early corrosion observation.

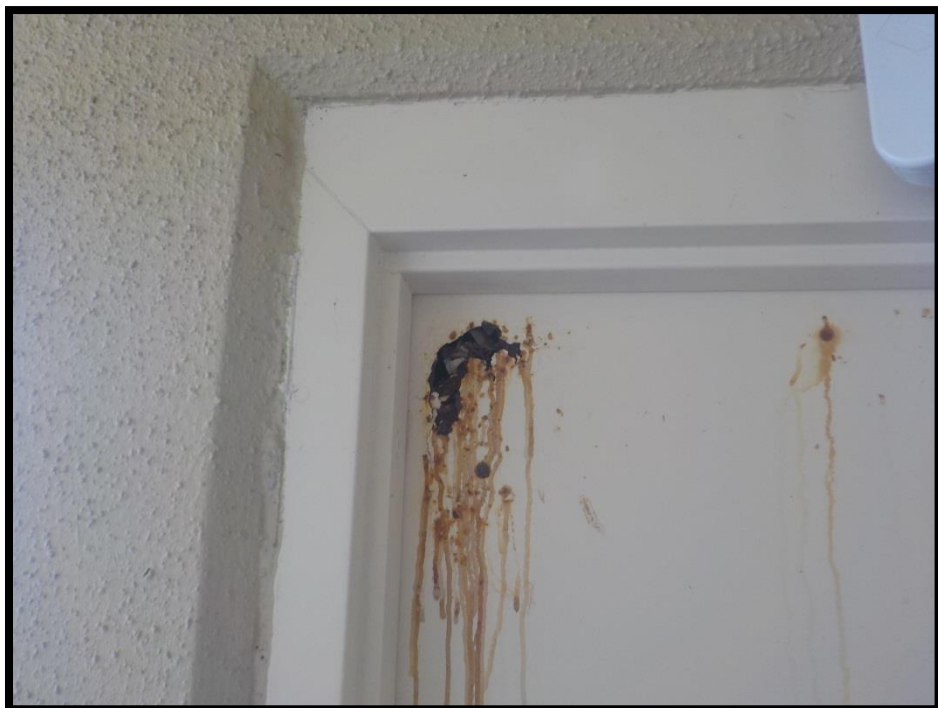
5 – Door skin corroded through.

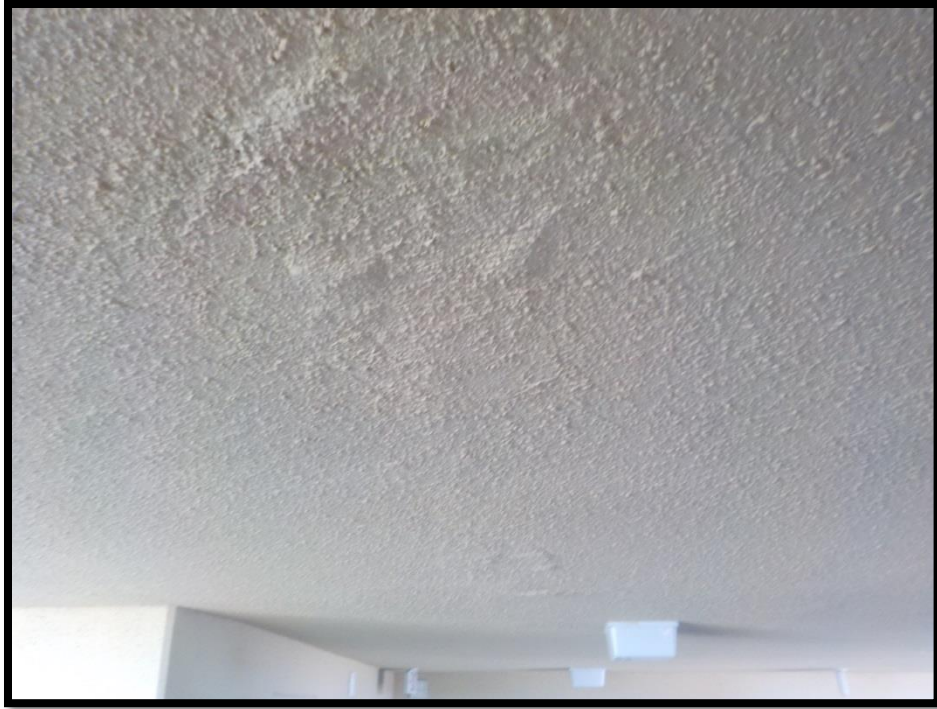
6

6. Ceiling blisters in coating. What is the ceiling coating product?

Recommendation: Learn type of coating. If the coating is not an acrylic paint or the paint was applied to a non-compatible substrate these could be problem areas in application. Acrylic is breathable which means that moisture is allowed to escape and will not typically cause loss of adhesion or blistering. Acrylic paints are also resistant to fading and will be able to resist damaging UV rays longer than some of the oil based paints available. If this is an acrylic coating, the substrate may have been deficient at application such as smoothed or finished gypsum based grout or leveler.

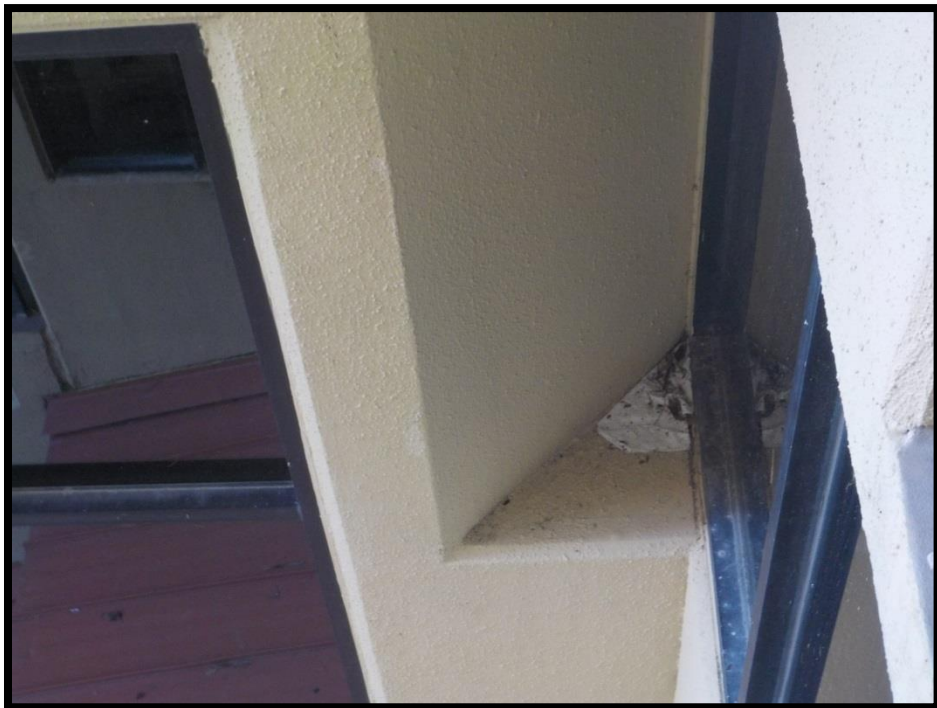
7. Coating blisters vertical to and in abutment with the elevator penthouse. Appeared to grow more common from the 6th floor elevation and up.

7 – Low slope edge that holds water at the elevator shaft.

Recommendation: Repair the moisture intrusion areas at these vertical points along with their common walkway knee wall abutments. The elevator penthouse is taking in water. This water runs down the wall within the concrete substrate in an attempt to get out. It is assumed that the initial entry points are the multitude of penetrations made by antenna fastening on the interior face of these shaft walls. There are flashing voids at the South elevator penthouse roof atop a piece of lumber that terminates the wall coating. This is more than likely a leak point as well. The common balcony knee walls terminate/about the elevator shafts with a low slope ledge that catches and holds moisture. It is also possible the curtain wall windows in the shafts allow moisture into the walls at the above described tie in points. Investigate/prove leak entry points. Properly repair. Remove damaged coatings, prepare substrate and reapply coating.

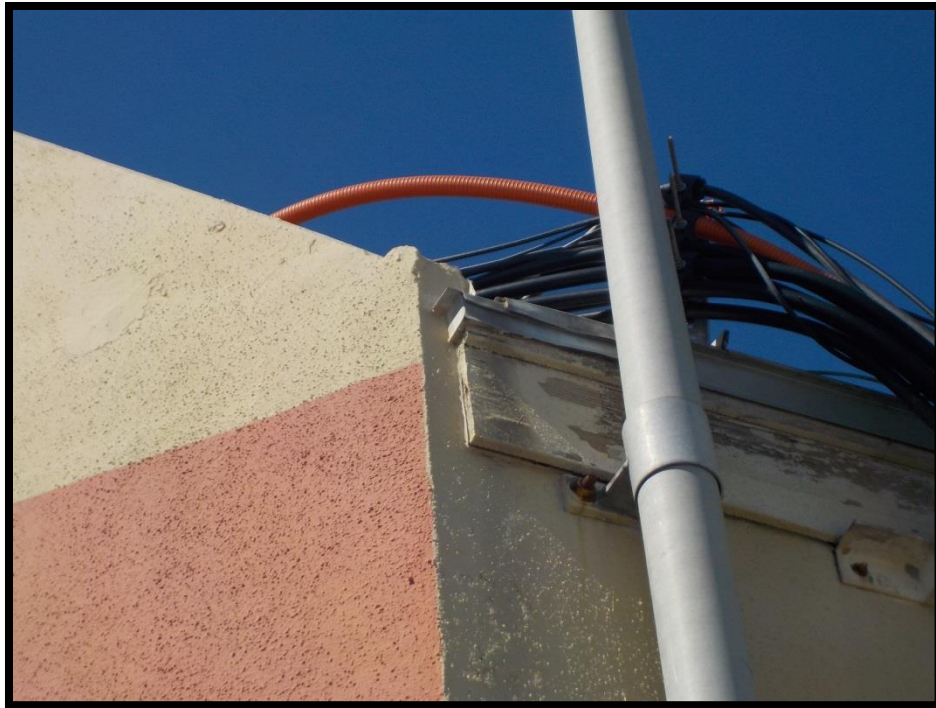
7 – Elevator penthouse roof to wall termination. Vertical coating blisters are just below this area.

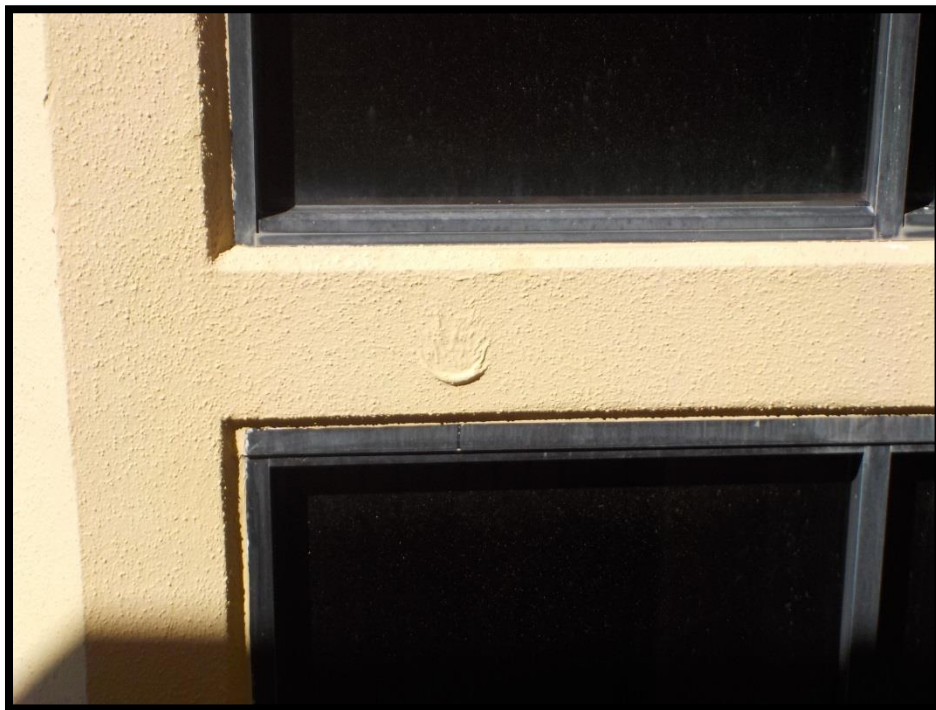
7 – Vertical wall blister beneath an elevator penthouse window.

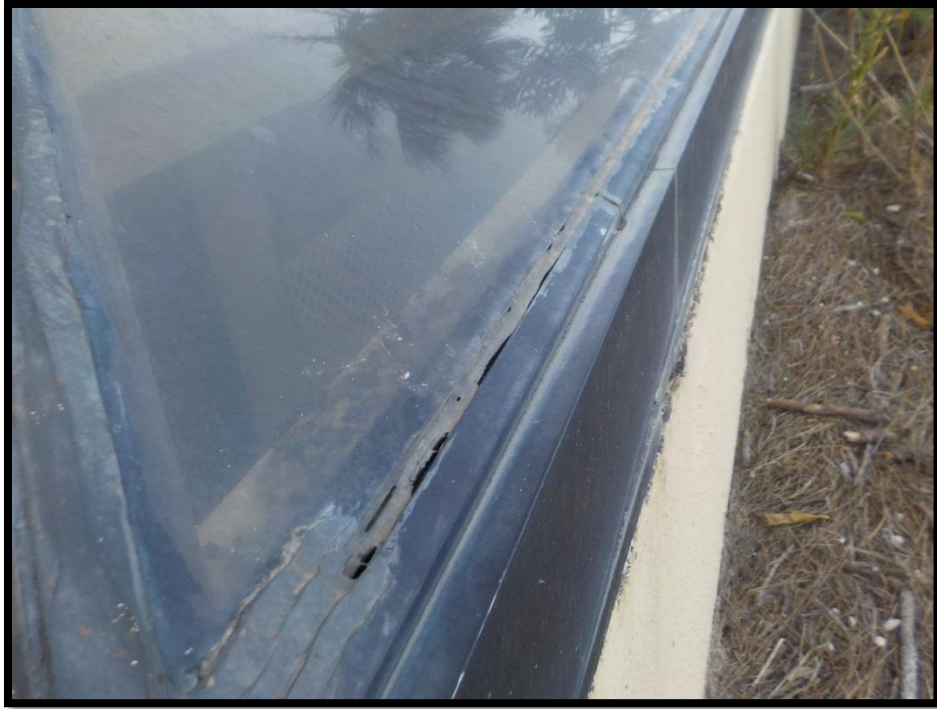
8. Sealant joints deteriorating throughout the ground floor skylights and at the lobby curtain walls/doors and lobby wall flashing to brick pavers. These items appeared to have had their original aluminum frame to glass pane gaskets replaced with field applied sealant. The sealants were adhesively failing in many areas. It appeared that the joints were not bond broken and are tearing themselves apart due to three sided adhesion.

8 – Sealant failure at skylight.

Recommendation: Perform sealant pull tests and destructive observation for bond breakers to confirm noted assumption. Remove and repair failing sealants if bond breakers appear to be present. Remove and replace all sealant if bond breaker evidence is not noted.

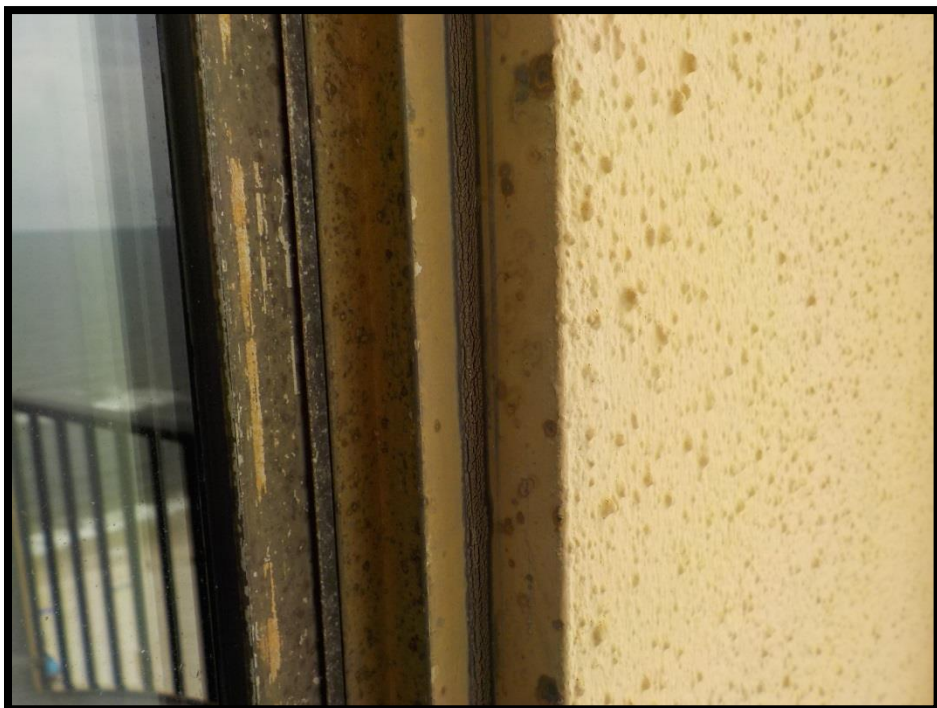
8 – Sealant failure at a South window.

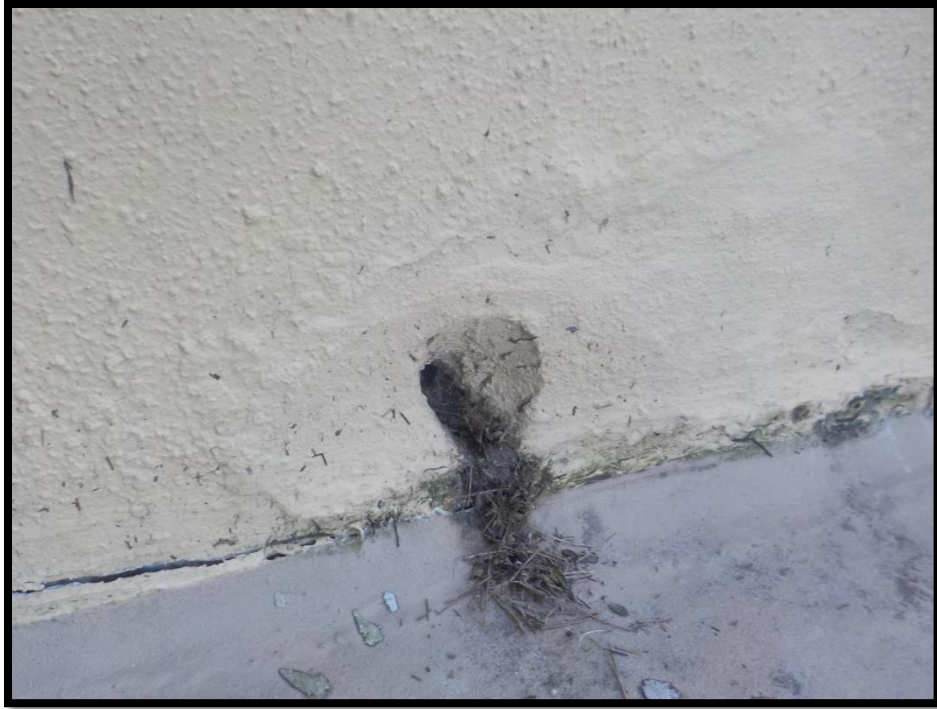
9. Clogged weep holes in the concrete knee walls throughout the first floor.

9 – Clogged weep.

Recommendation: Remove debris from all components. Investigate for any component damage and waterproofing voids.

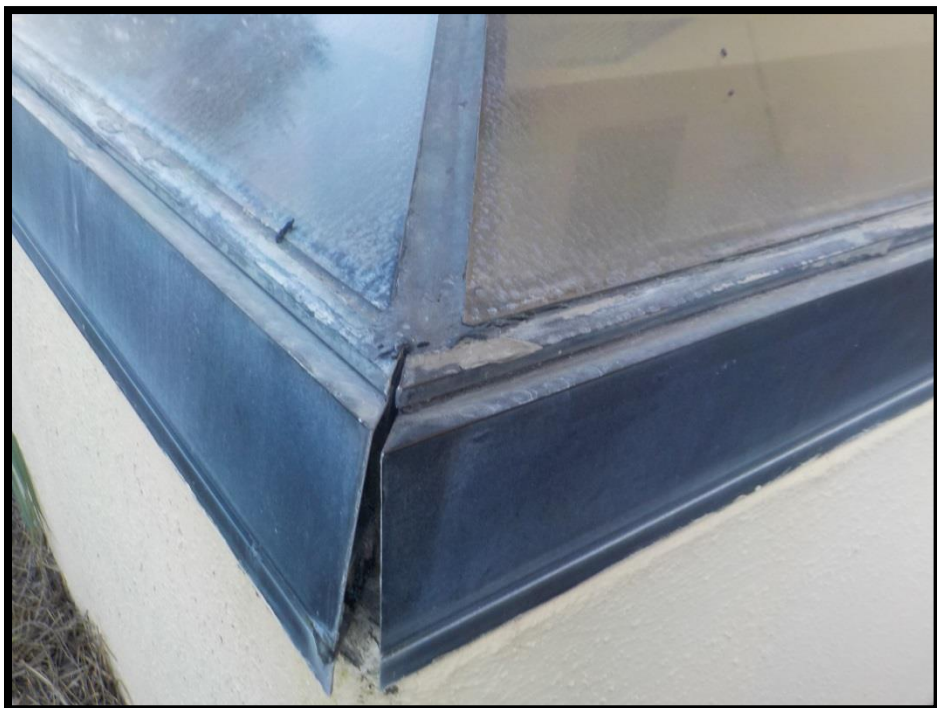
1. Skylight on the northeast corner ground floor had framing separation and a damaged glass pane – noted sealing joint failing as well (in typical notes)
Recommendation: Brett Robinson to compare current condition to past condition. Was this racked by the storm?

1 – Skylight framing separation.

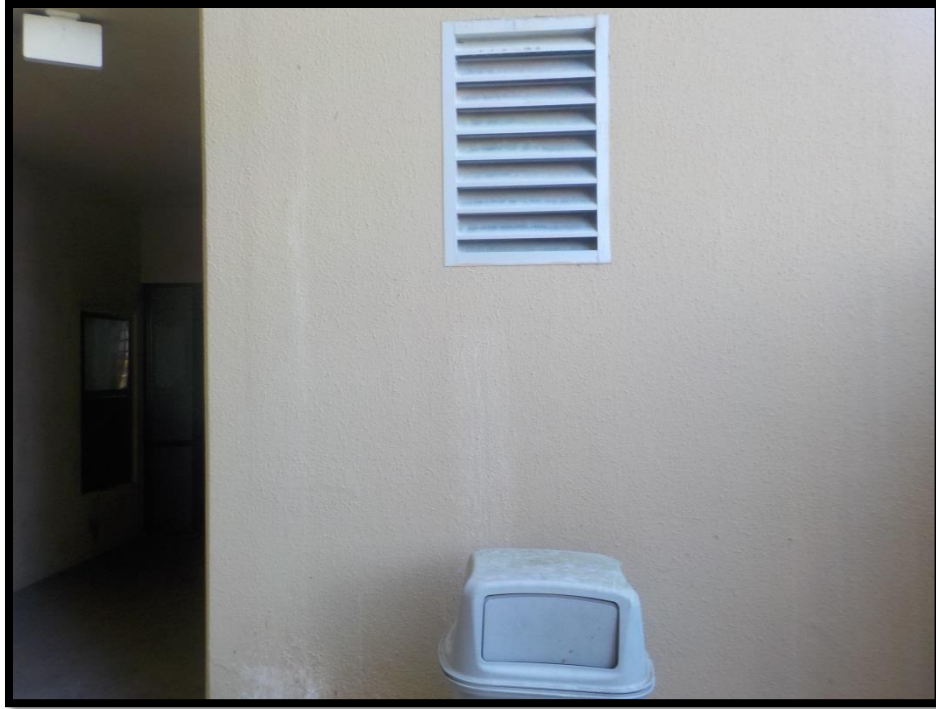
2. Documented efflorescence on the first floor stairwell vent on the north side stairwell.
Recommendation: Confirm moisture intrusion area causing the staining.

2 – Efflorescence on wall coating below vent.

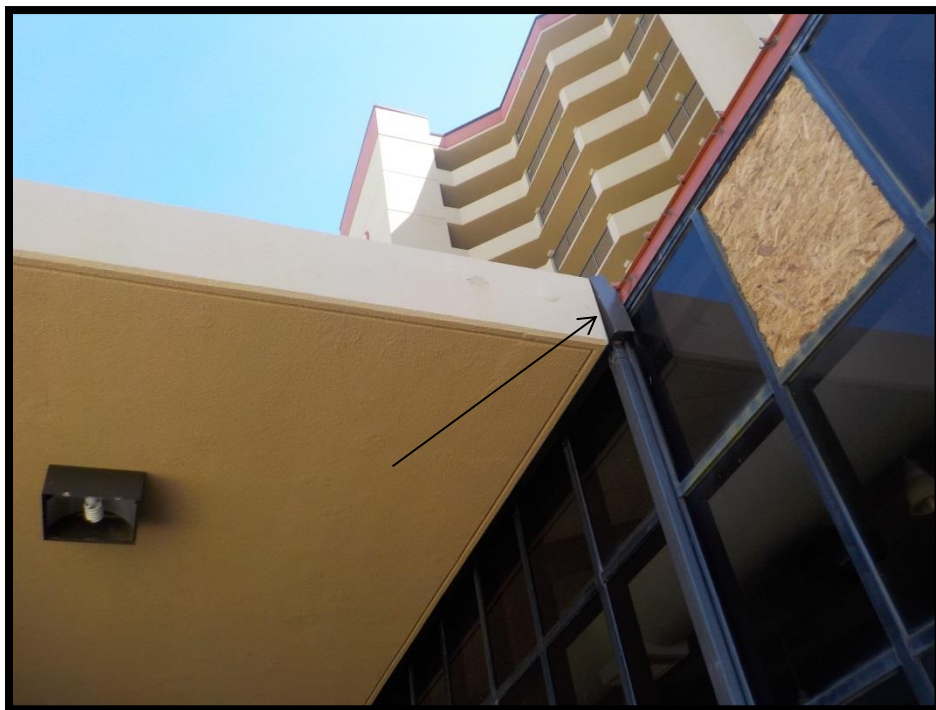
3. Counted 12 missing windows and damage to both sliding glass doors of the main lobby curtain wall ground floor – missing sealant on the curtain wall windows as well although some areas appeared to be recently patched – noted lack of seal between the curtain wall system and the concrete wall it abutted with evident daylighting on both sides.
Recommendation: Obvious storm damage that is more than likely being handled. Frame may need to be removed? Prime concrete edges and reseal with a commercial grade low modulus sealant compatible to coating(s) and frame material at the door perimeter.

3 – Hurricane damaged window. Also note loose metal at window frame to roof.

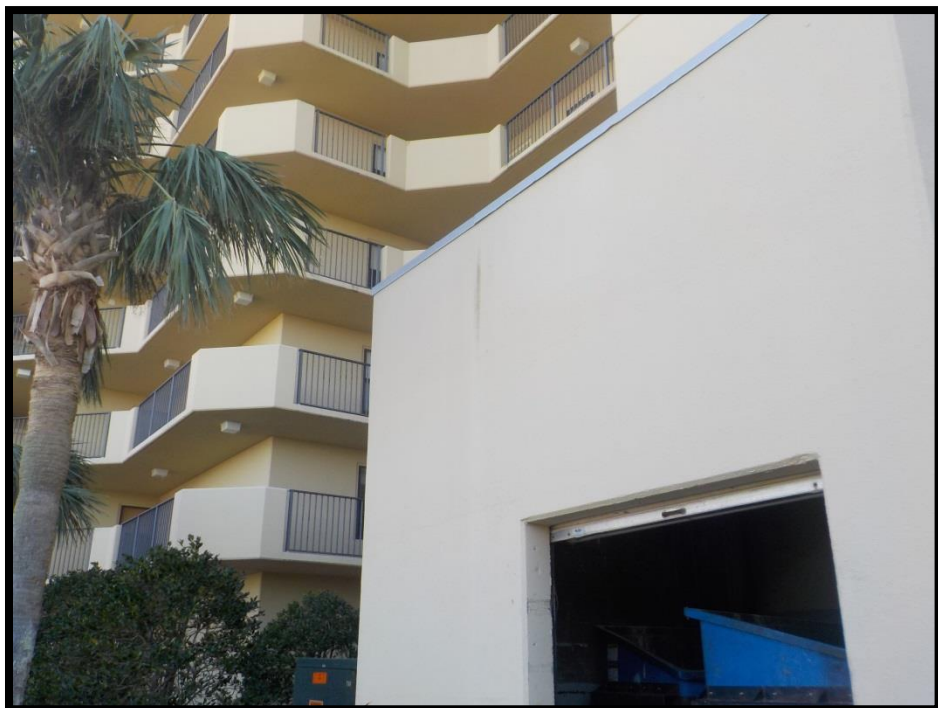
4. Noted moisture behind the coping metal above the North West dumpster housing area.
Recommendation: Seal metal parapet cap lap with compatible sealant.

4 – Moisture stain below coping cap joint.

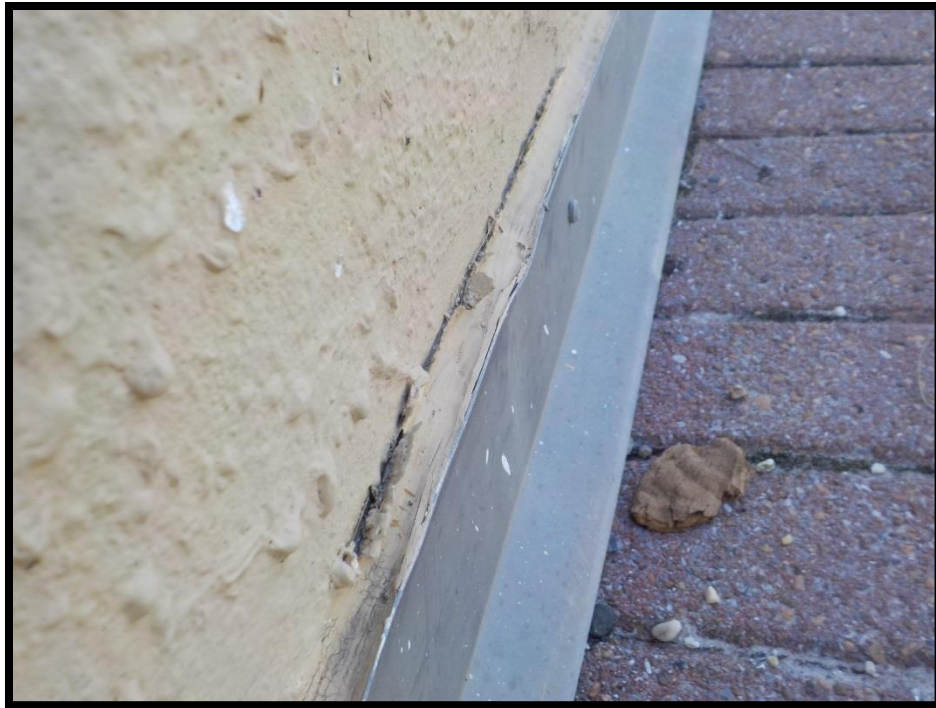
5. The flashing at the main floor lobby curtain wall where the concrete wall met the brick pavers was a surface mount and the sealant was splitting – east side was a sealant joint with failure points documented and the west side was a metal flashing system. Due to settling in the brick pavers there was also an area where water and trash could collect.
Recommendation: This is a sealant dependent flashing (as are most on the building) so a tear in the sealant is a failure. Moisture can migrate to the open wall termination. Remove and replace failing sealants with a commercial grade low modulus sealant compatible to coating(s) and metal flashing.

5 – Failed flashing sealant.

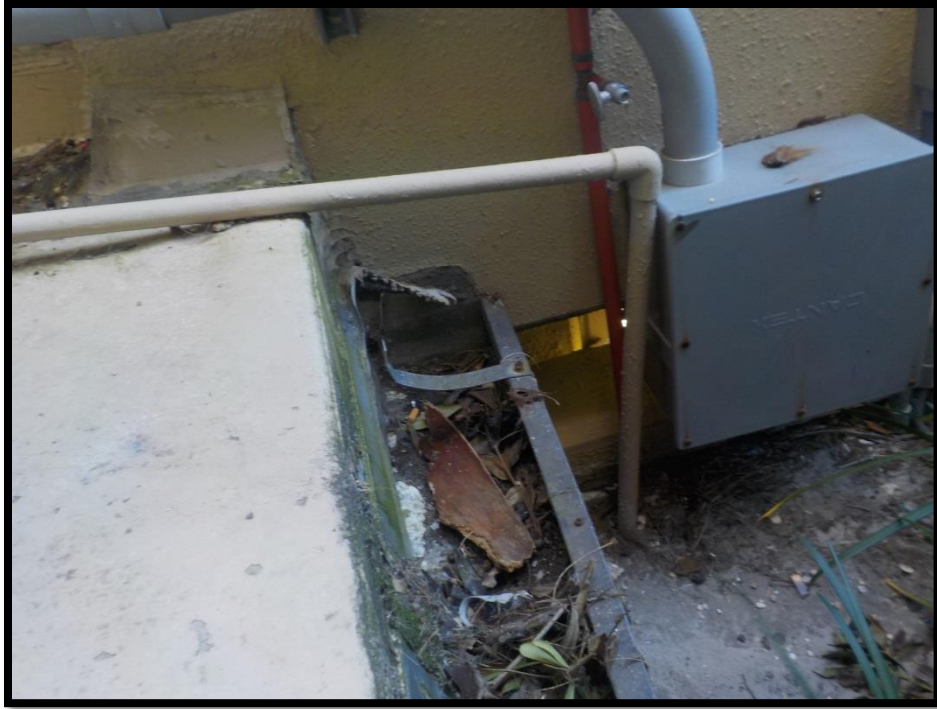
7

7. In the same area above, noted a gutter with no outlet at either end between the parking deck stairwell structure and the main building.
Recommendation: Clean debris from gutter and observe for clogged drainage point. Produce proper drainage and downspout dump point if no drainage exists.

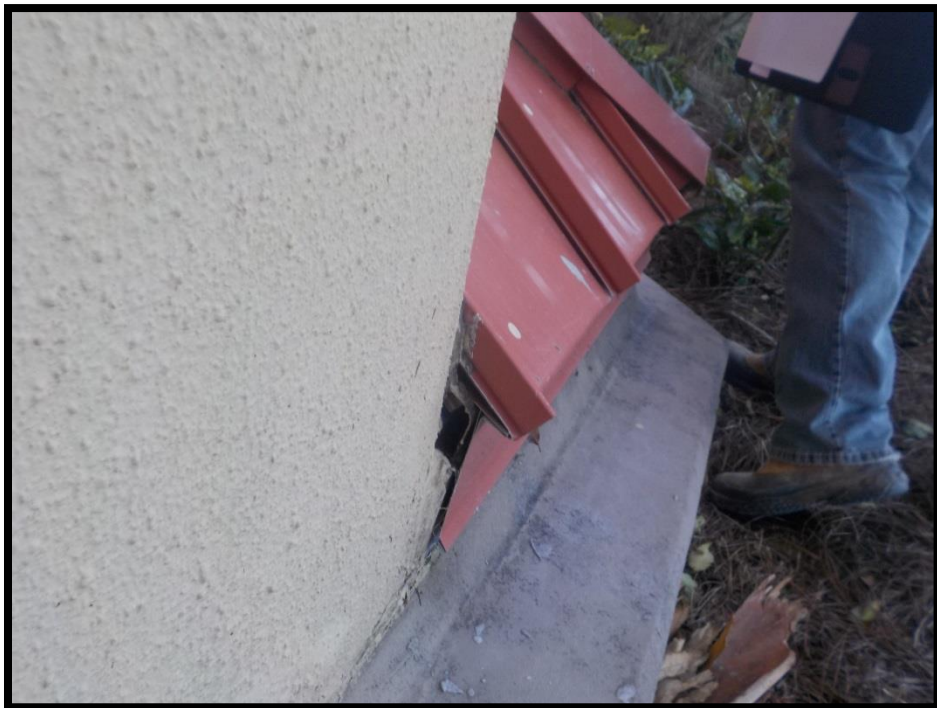
8. Ground through 3rd floor. Red metal roof terminations at wall abutment were open with no flashings. One area had ridge cap impact damage that appeared to be storm damage.
Recommendation: Raw lumber could be observed at these terminations. The wall is assumed to be bare concrete or open to the lobby beneath the roofing. These areas should be properly flashed and sealed at their terminations.

8 – Open roof termination to wall overview.

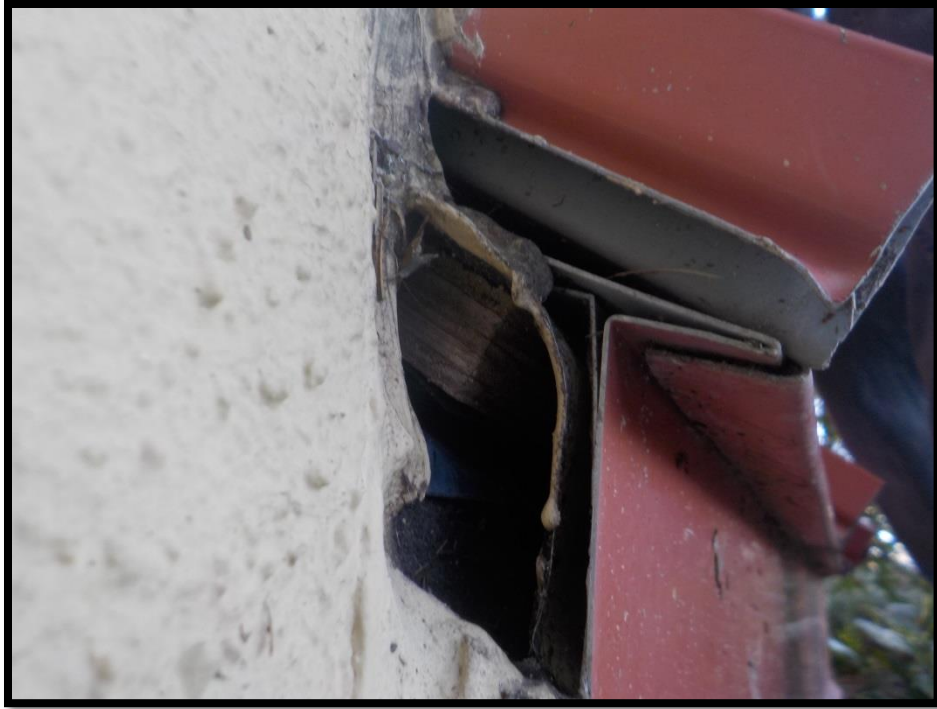
8 – Close up of exposed lumber beneath roof.

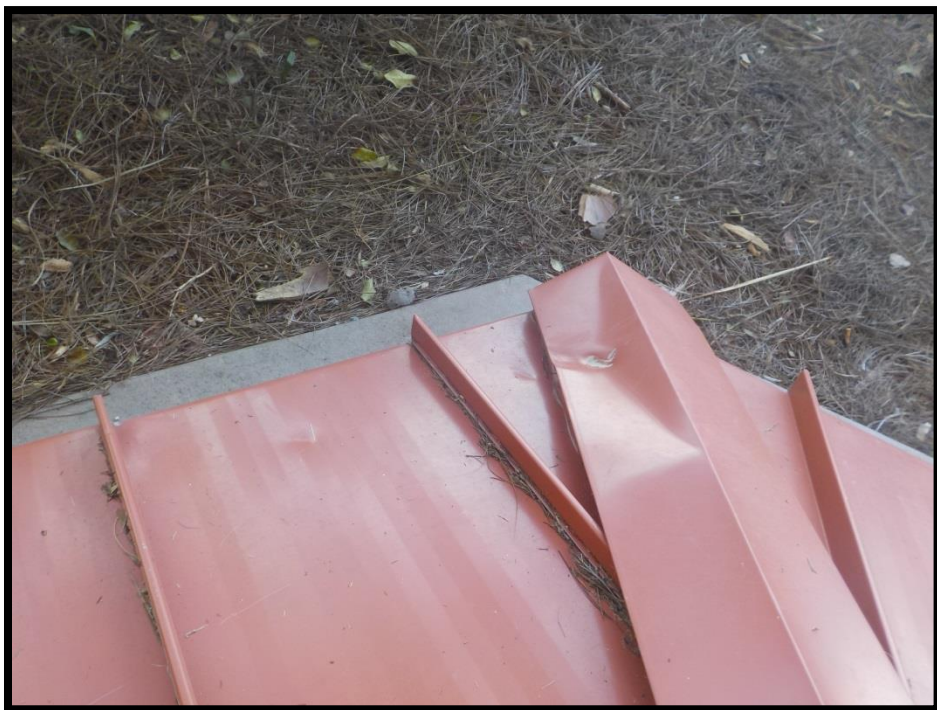
8 – Impact damaged ridge cap.

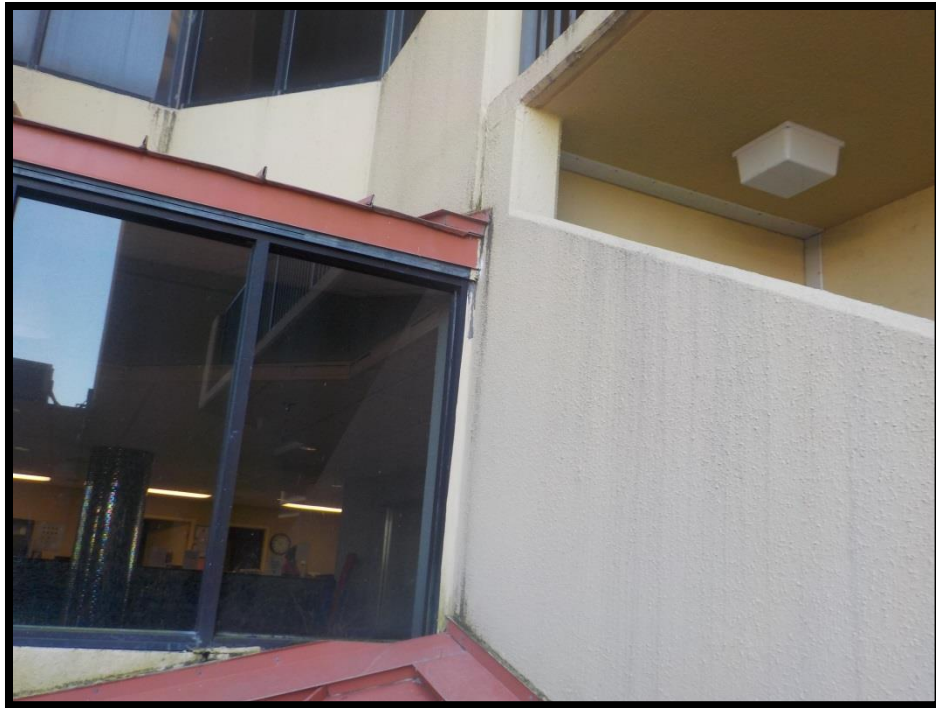
8 – Overview of roof to wall at higher elevation.

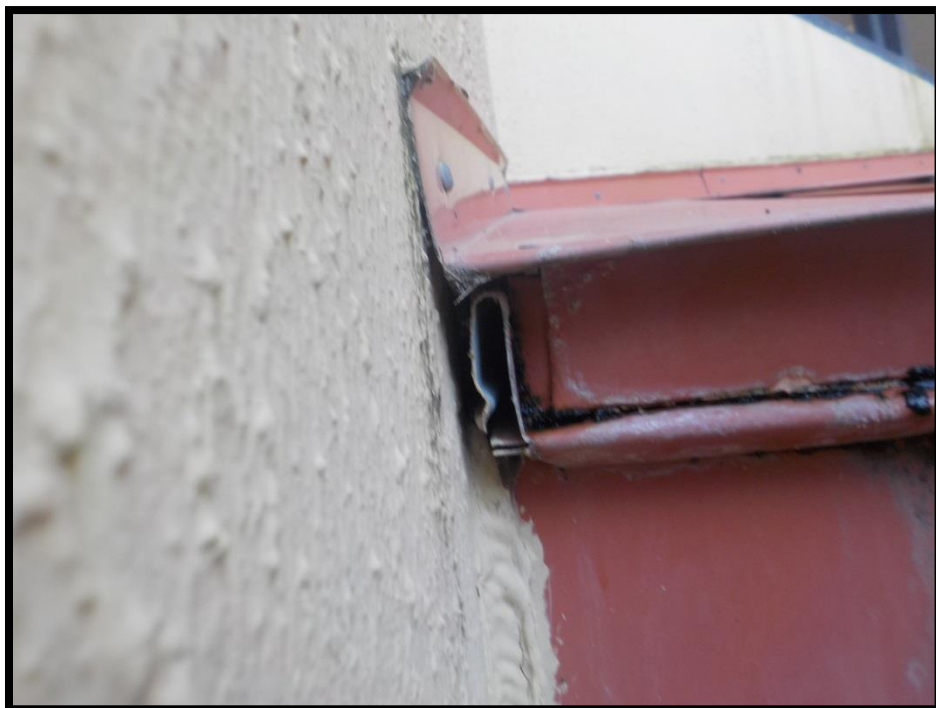
8 – Close up of open roof to wall termination.

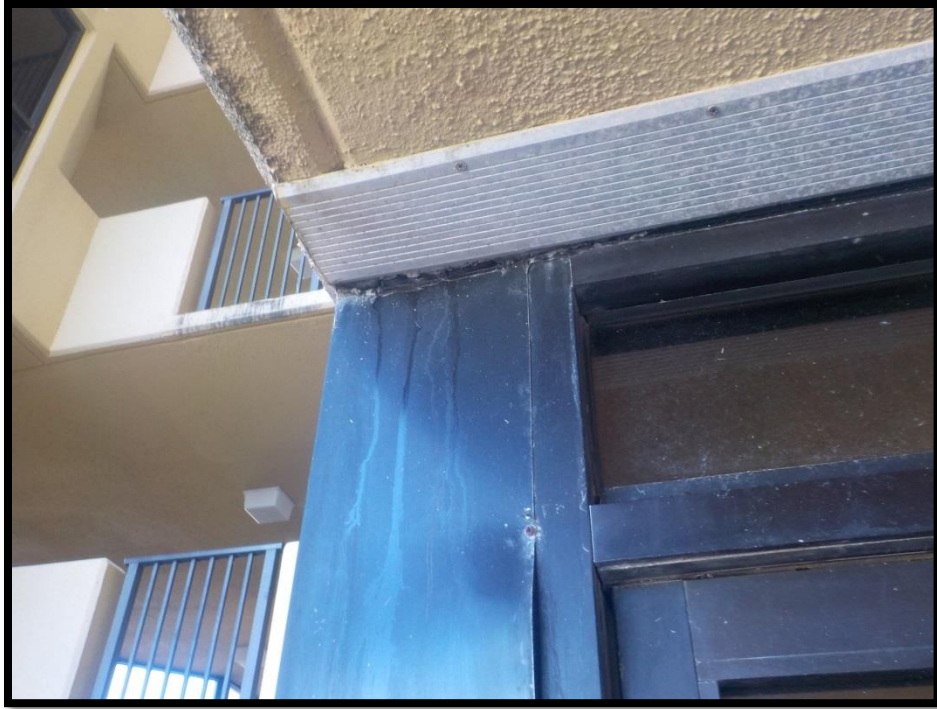
9

9. 306 documented damage to the doors exterior trim (bowing) – noted water streaks where the frame abuts to the metal cap covering the leaking expansion joint – noted that the tie in where the two met is in need of repair.
Recommendation: Refer to typical expansion joint damage section above. Surface mount screws appeared to have bound the metal while building movement took place. Release from pressure and reattach.

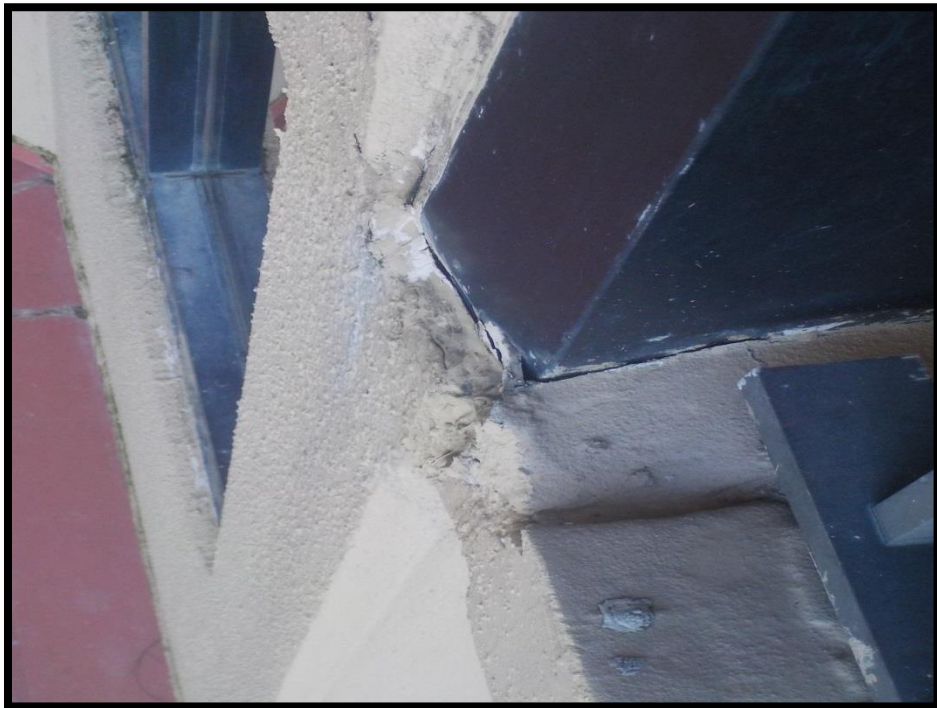
10. 309 (closed area in interior common hall overlooking the lobby) noted dripping on the aluminum frame of the window (lobby roof ties in directly to the main building above this window) – noted discoloration on the walls – also documented that the sprinkler outside the unit was corroded and had been patched around at some point – also noted a penetration by the A/C vent.

10 – Water dripping from a window rumination.

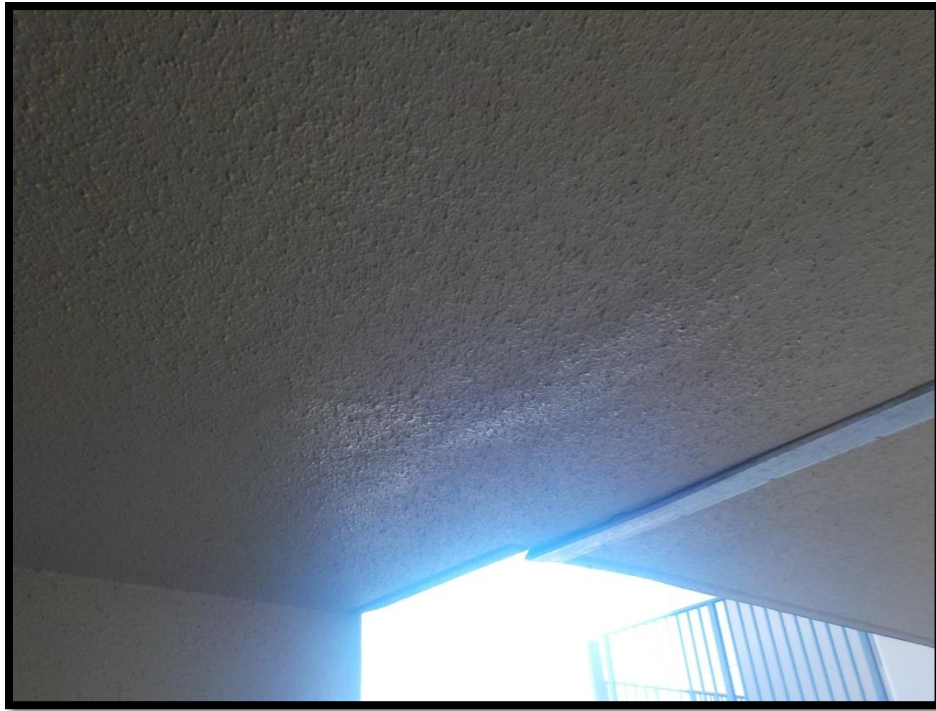
10 – Condensation on ceiling.

- a. Exterior door within close proximity to this area – potential for condensationRecommendation: Investigate to find water source.
11. 312 Door frame separation from wall.
Door and window frame to wall abutments looked to be in fair to good condition overall. This area was significantly separated. It was noted that some frames had a sealant joint at their perimeters and others did not according to how well they fit into the rough ins.
Recommendation: Apply a closed cell backer rod and commercial grade low modulus sealant compatible to the wall coating and frame.

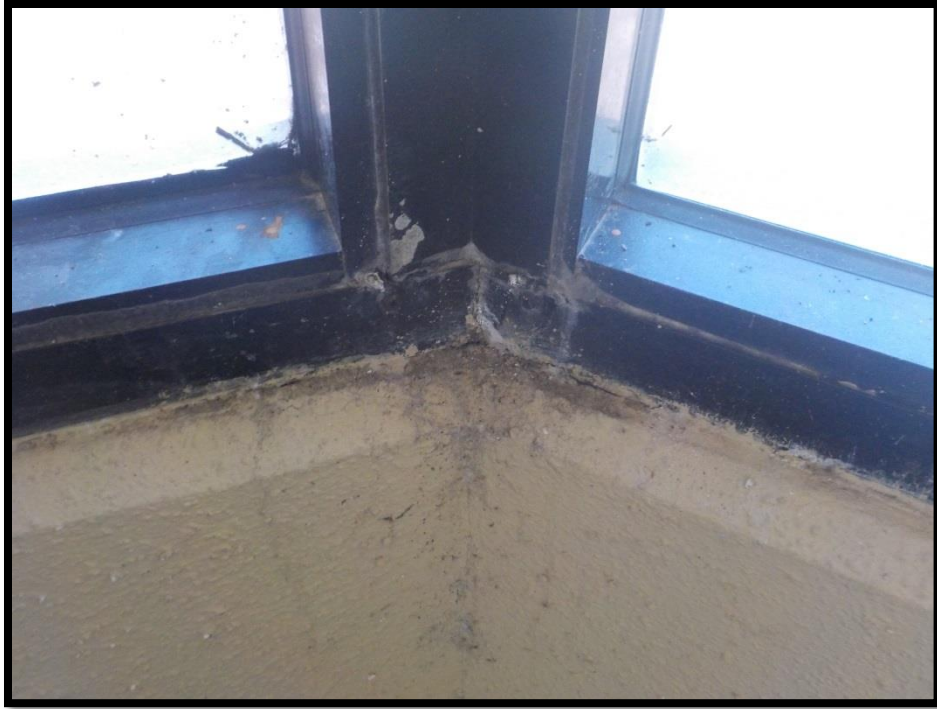
12

12. 501 – 503 noted multiple areas of efflorescence.
Recommendation: Investigate to find water source.
13. 6th floor of the elevator common lobby documented corrosion at a ceiling cutoff cover.
Recommendation: Sand, prime and paint.
