Phoenix V Building Observations

Notes from onsite building observations performed on September 29-30, 2020.

Phoenix V Building Observation Photographs

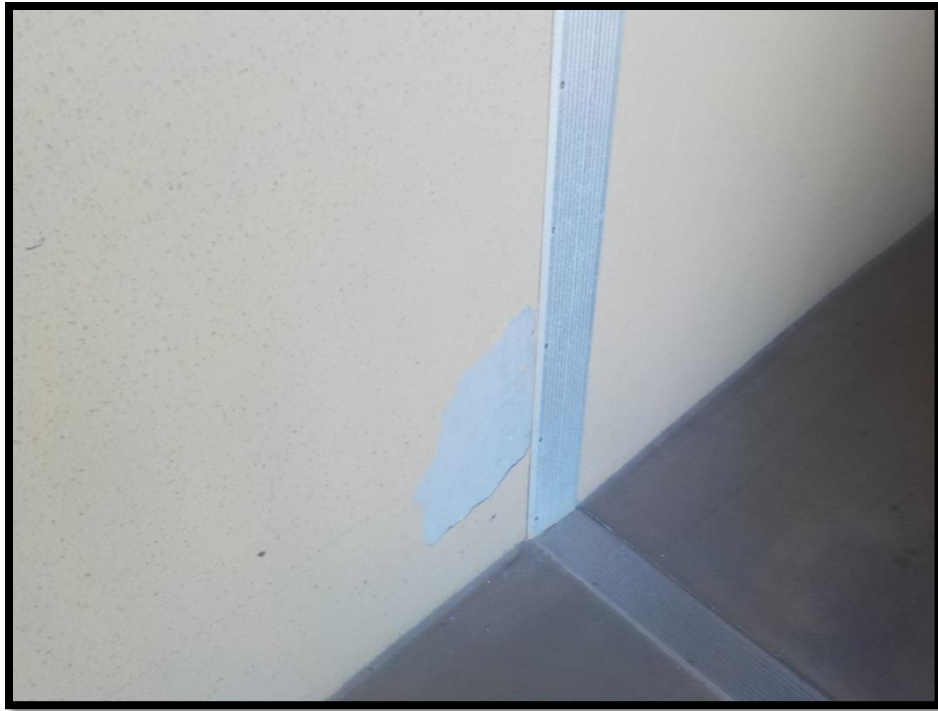
14

14. 603 and 611, large areas of wall coating missing.
Recommendation: Prepare substrate and recoat area.
15. Chipped coating on the horizontal plane of the concrete knee wall outside 611 – visible dripping on the North face of the wall.
Recommendation: Any breach in the waterproofing coat could allow moisture into the concrete substrate and behind the coating. These vertical breeches should be repaired by prepping and coating.

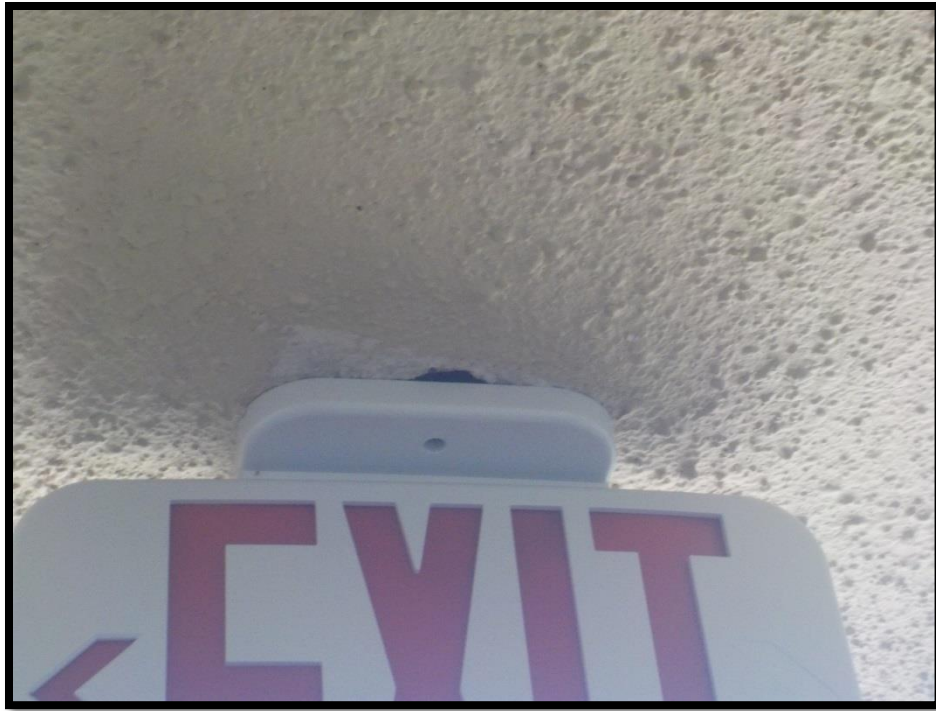
16

16. 709 void at the ceiling wire opening for exit sign.
Recommendation: Rotate sign and seal around base to ceiling.

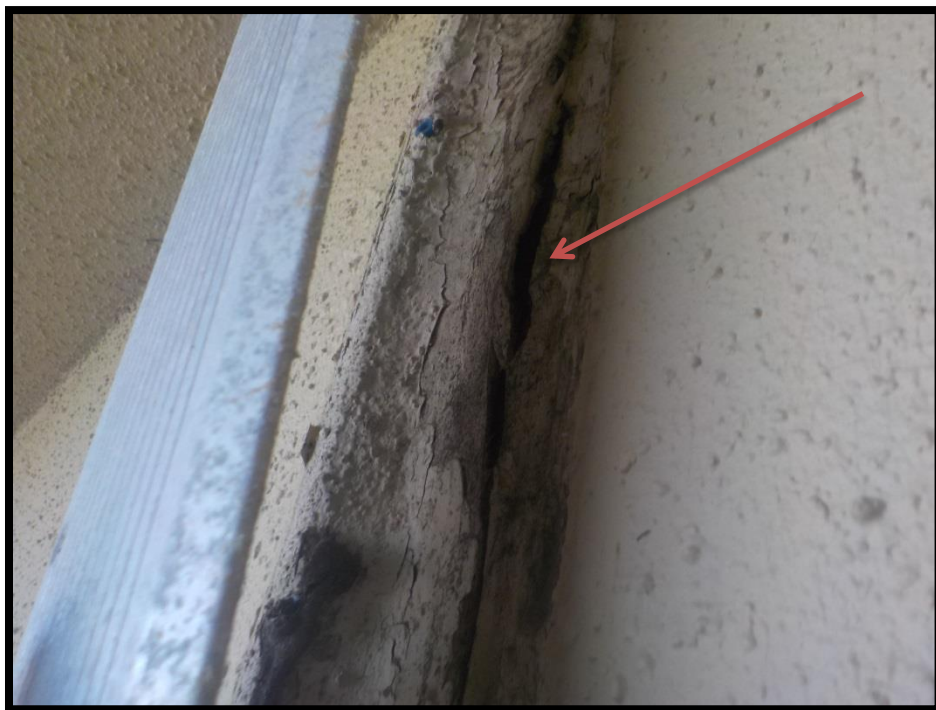
17. Expansion joint cover between units 710 and 711 had visible detachment along the top and on the horizontal wall – horizontal cap cover had lost multiple fasteners and there was clear evidence of a failed seal – the exposed end of the metal cap along the ceiling was not properly sealed creating an area of potential water intrusion (similar issue on the 8th floor)
Recommendation: Refer to typical expansion joint damage section above.

17 – Note sealant split behind cover.

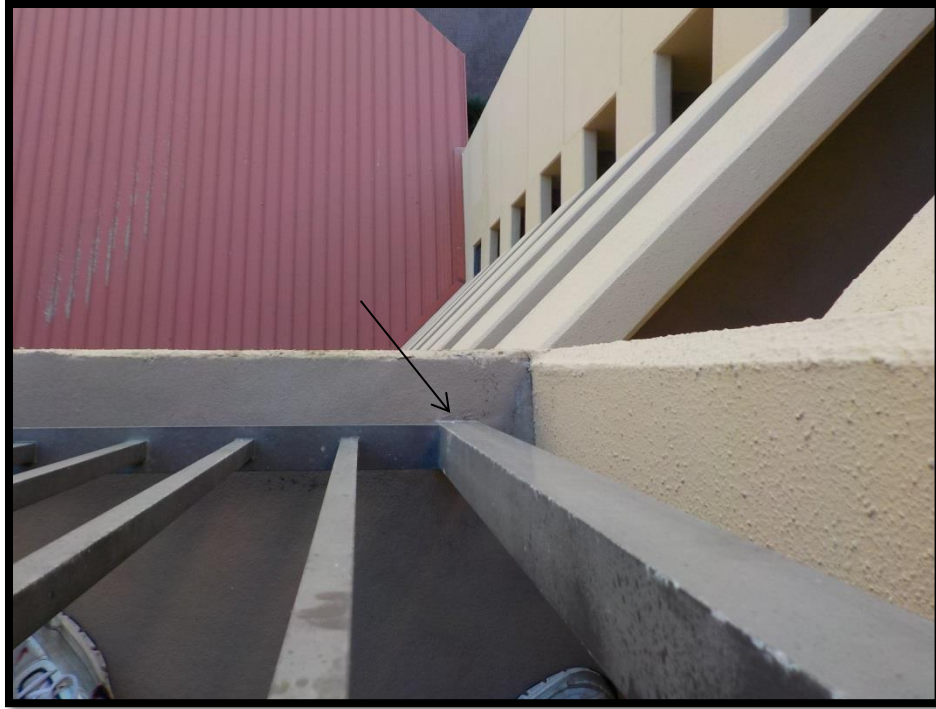
18. 709 improper sealing around the bottom of the handrails where they tie into the concrete deck – potential water intrusion issue due to holes in the metal handrails.
Recommendation: Assumed bare concrete beneath handrail stanchions. Remove and repair sealant.

18 – Deck coating separation at handrail stanchion base.

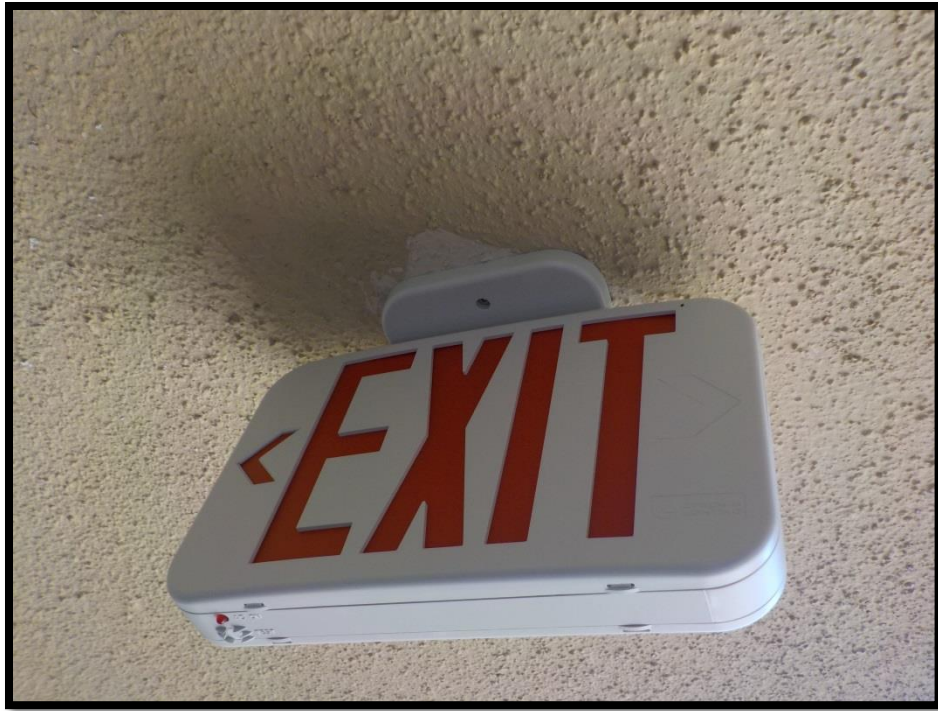
20

19. 811 noted missing coating on the concrete knee wall.
Recommendation: Prepare substrate and recoat area.
20. 904 void in ceiling coating at rotated exit sign.
Recommendation: Prepare substrate and recoat area.

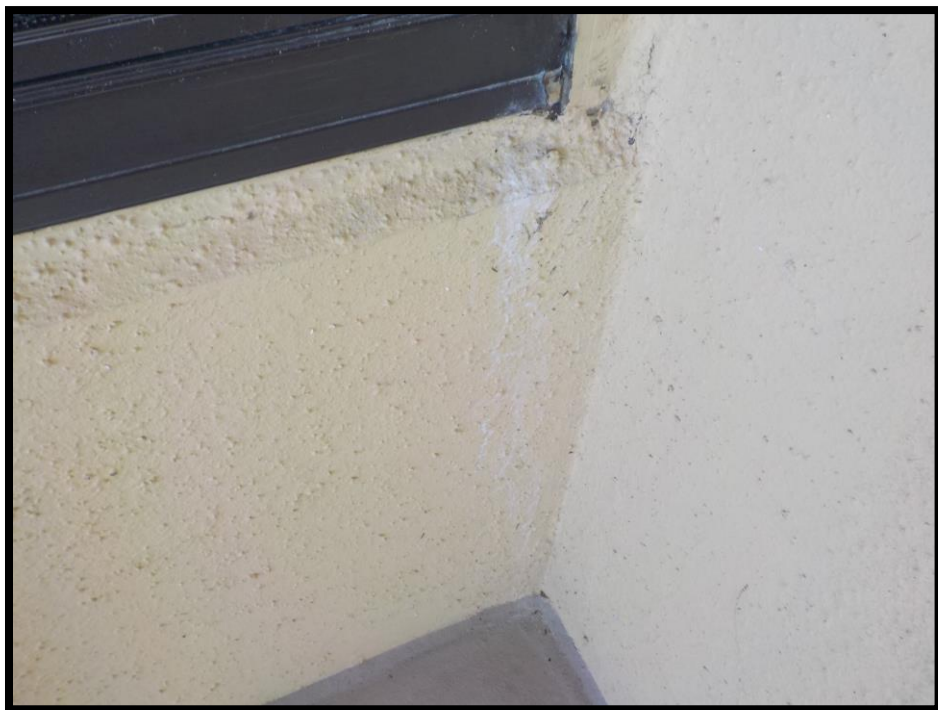
21

21. 1006 and 1009 window efflorescence.
Recommendation: Investigate to find water source.
22. 1010 corrosion at ceiling to exit sign abutment.
Recommendation: Sand, prepare substrate, rust inhibit and recoat area.

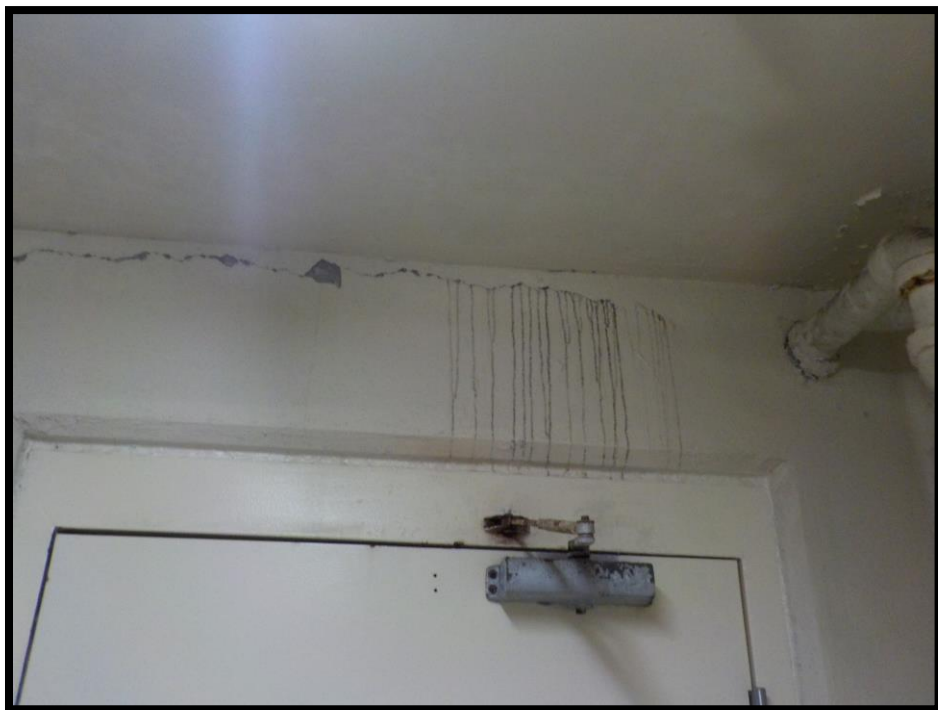
23

23. 10th stairwell, East end. Large horizontal crack in concrete from fire line penetration over door frame.
Recommendation: Have structural/concrete expert observe.

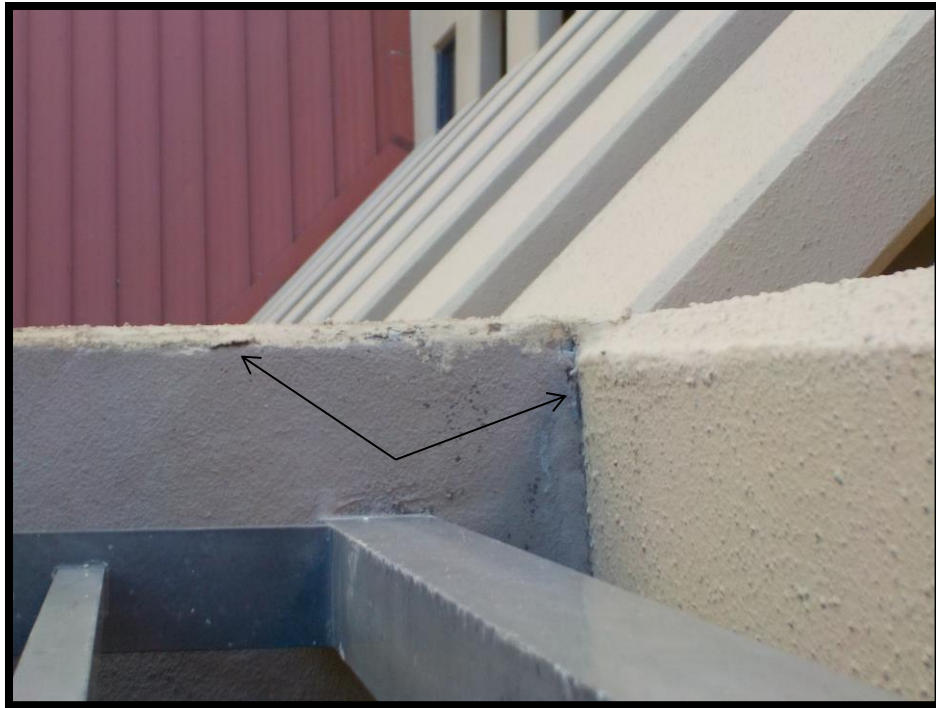
24. 1109 window efflorescence.
Recommendation: Investigate to find water source.
25. 1210 disconnect at floor coating to knee wall coating. Note slab face staining.
Recommendation: All areas where coating can allow water into the concrete and behind coatings can produce wrinkles, blisters and moisture damage. Prepare substrates and recoat area. Assure no gap at coatings. Assure coatings are compatible before repair work.

25 – Openings at coating abutments with wrinkling of slab face coating.

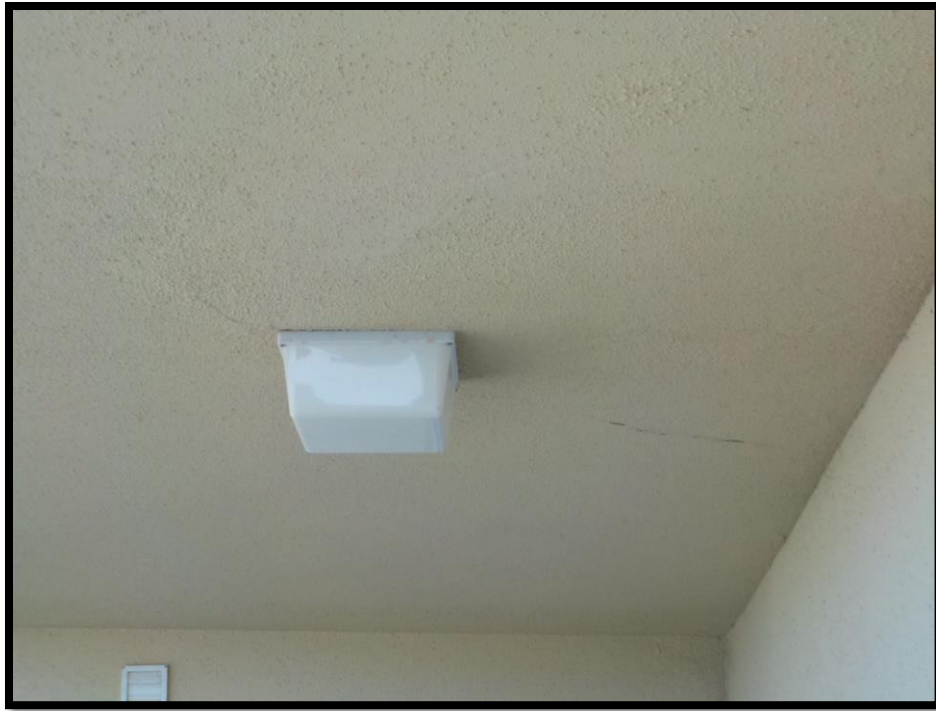
28

28. 1416 ceiling crack appearing to stem from or toward a core hole for light wiring.
Recommendation: Remove light fixture, rout crack, bond break, seal rout and coat ceiling.

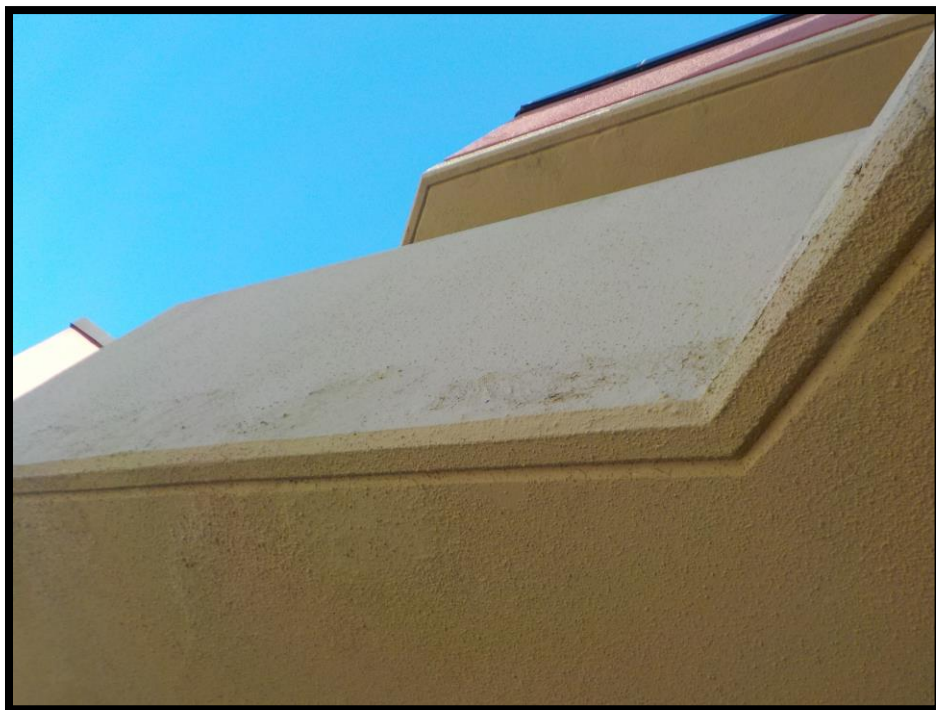
30. 1409 disconnect at floor coating to knee wall coating. Note slab face staining.
Recommendation: All areas where coating can allow water into the concrete and behind coatings can produce wrinkles, blisters and moisture damage. Prepare substrates and recoat area. Assure no gap at coatings. Assure coatings are compatible before repair work.

30 – Good visual of wrinkled coating on slab face.

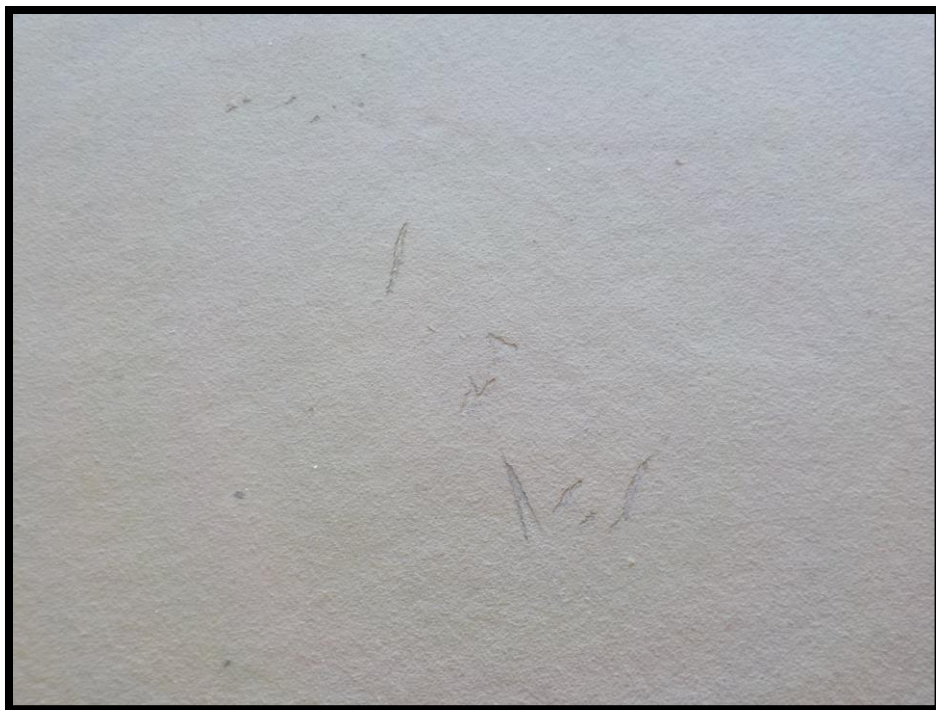
31

31. 1401 deep scarring in floor coating.
Recommendation: Prepare substrate and recoat area.
32. 1509 parapet scupper leaks badly. Ruptured coating blister to the West of scupper.
Disconnect at floor coating to knee wall coating. Note slab face staining.
Recommendation: Parapet scupper should be removed, flashing verified in the parapet throat and scupper reinstalled with proper perimeter sealant. All areas where coating can allow water into the concrete and behind coatings can produce wrinkles, blisters and moisture damage. Prepare substrates and recoat area. Assure no gap at coatings. Assure coatings are compatible before repair work.

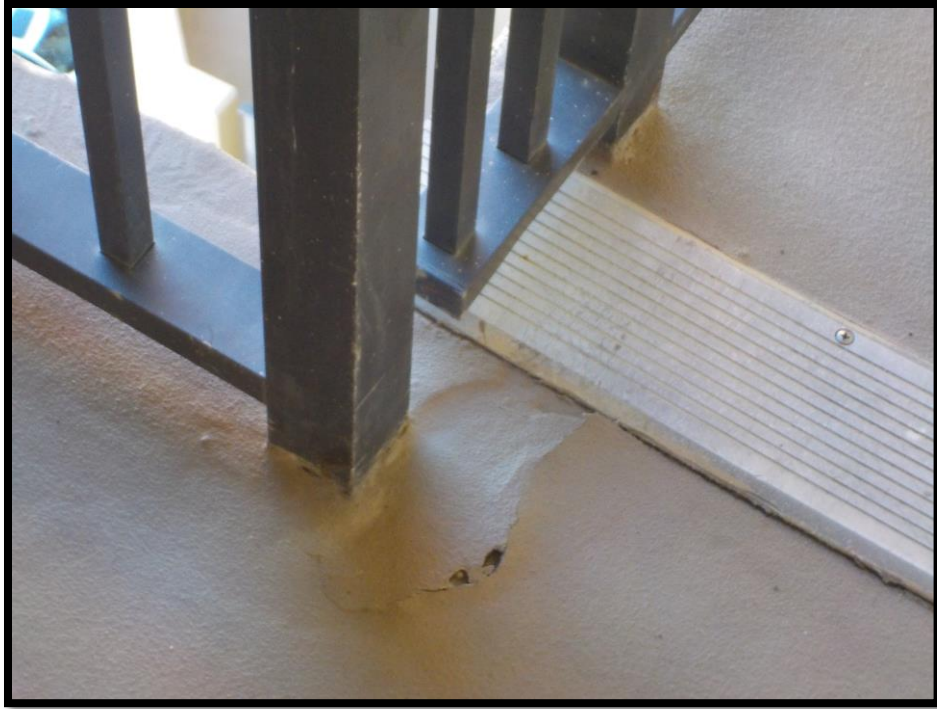
33

33. 1512 deck coating and possibly substrate damage at expansion joint.
Disconnect at floor coating to knee wall coating. Note slab face staining.
Recommendation: Remove expansion cover and chip all loose decking. Repair decking.
All areas where coating can allow water into the concrete and behind coatings can produce wrinkles, blisters and moisture damage. Prepare substrates and recoat area. Assure no gap at coatings. Assure coatings are compatible before repair work.

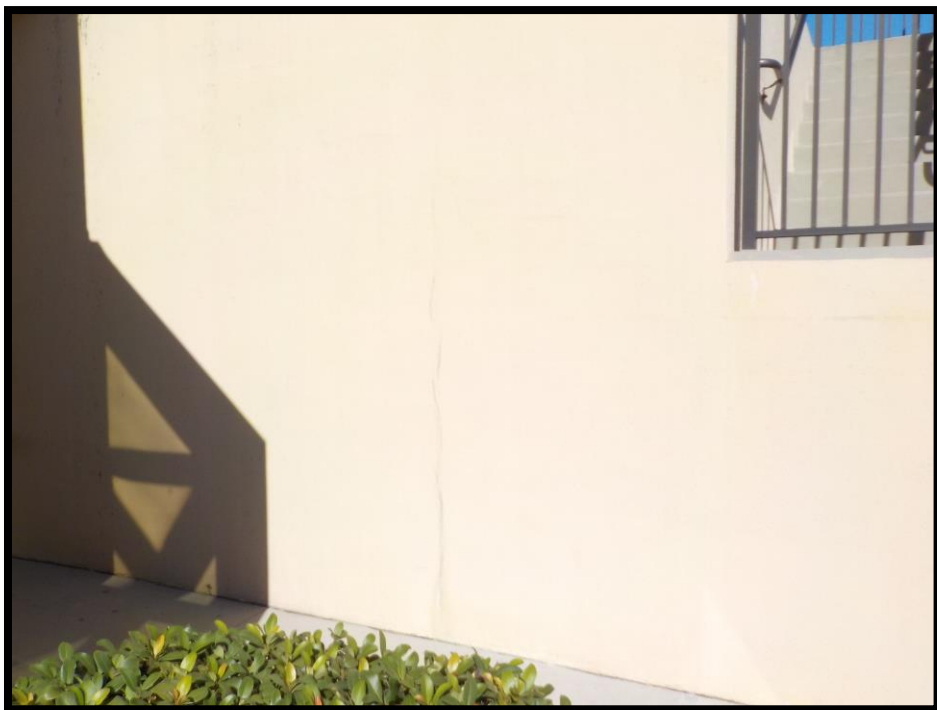
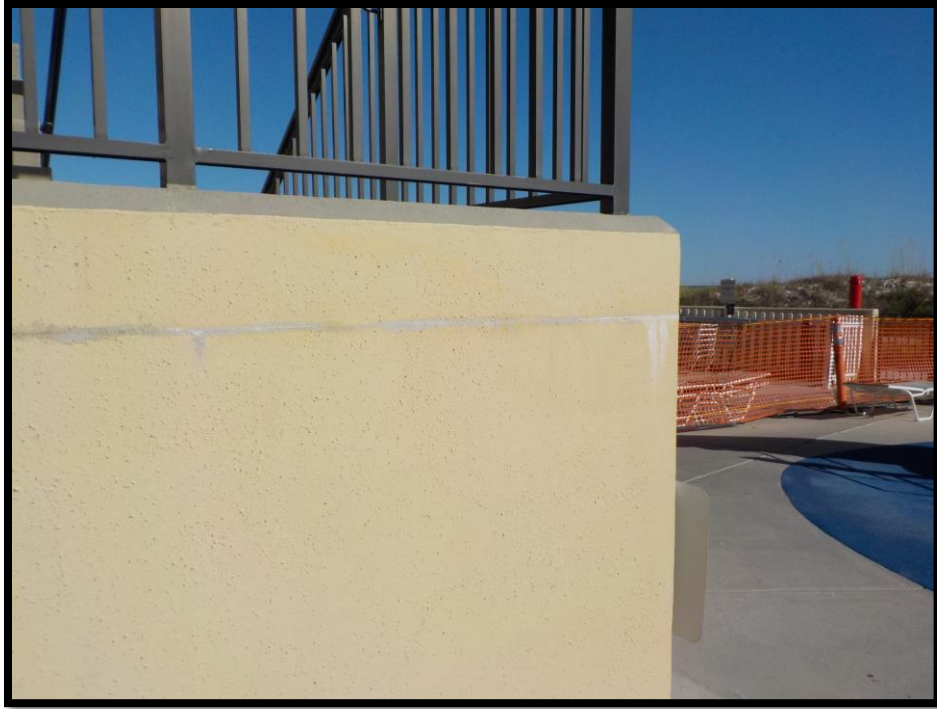
34

34. South pool maintenance room. No control joints in the concrete structure. Structure has formed its own in the way of cracks.
Recommendation: Rout cracks, bond break, seal rout and coat ceiling.

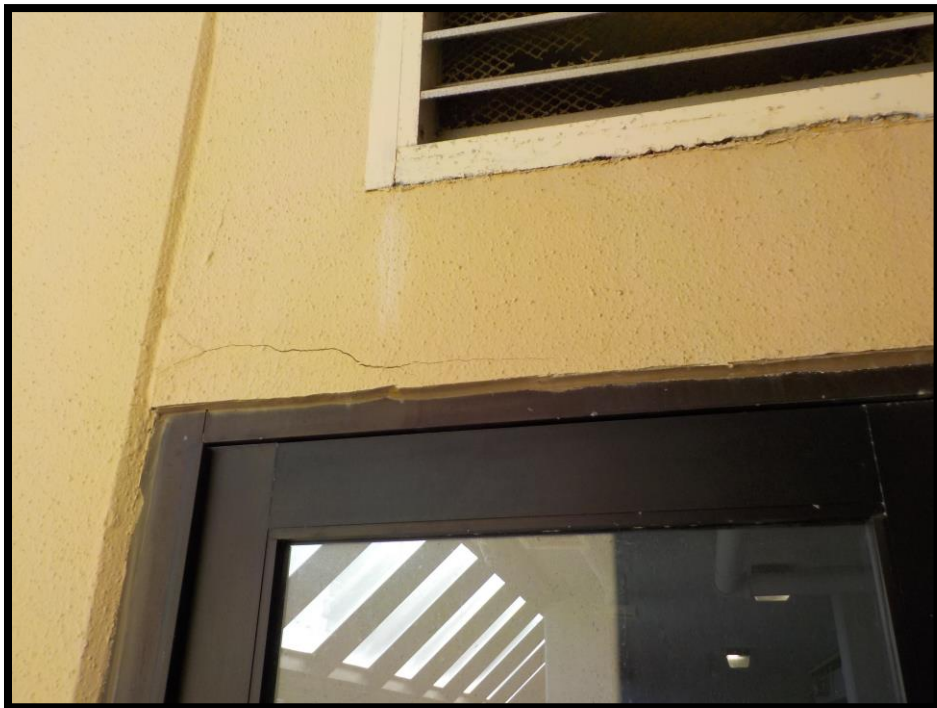
35. Documented damage around the exterior of the indoor pool area. South doorway was improperly cut into the stucco and cracking has occurred. Typical concerns observed on South skylights but not as bad as noted on North.
Recommendation: Remove door frame and have the stucco rough in properly sized and terminated at the head with a drip edge flashing. Install door frame with a perimeter closed cell backer rod and commercial grade low modulus sealant compatible to the wall coating and frame.

35 – Improper door head.

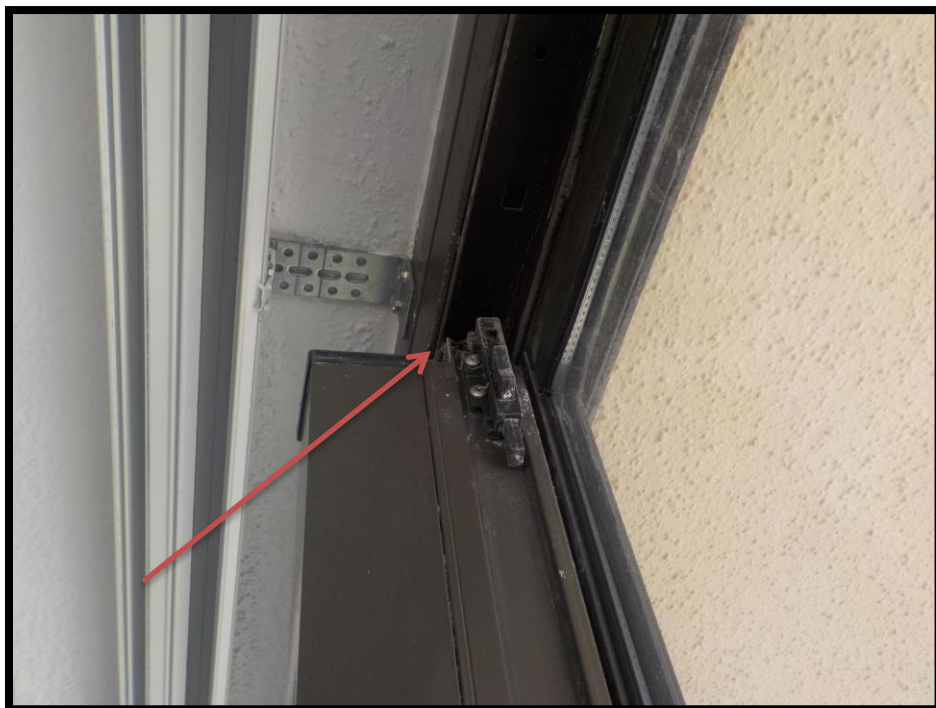
36. 1017 sliding doors were observed for damage by request. The doors (both South and North) moved within their frames such as the door may pulsate inward and outward during a storm. This same movement was found on 2 other South sliding doors from the accessible ground floor. As Mr. Behel reported on 10/7/20, he's documented that the operable track or rail is produced from a low grade metal. I'd like to learn more on the history of the sliding doors movement within the frame before the storm.

36 – Note door position in reference to interior frame.

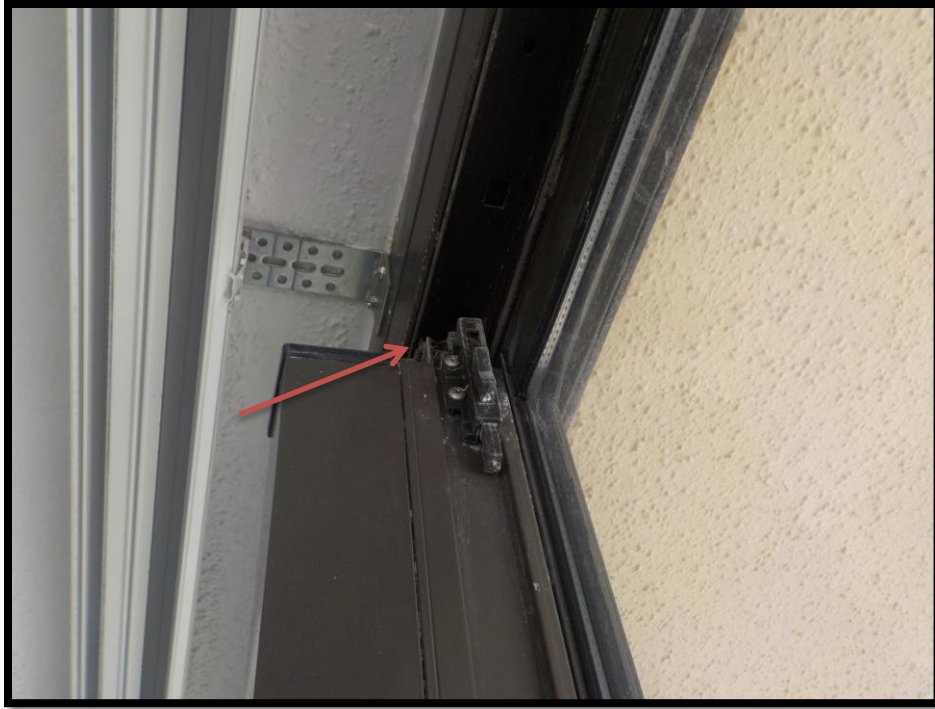
36 - Note door position in reference to interior frame when pushed toward exterior.

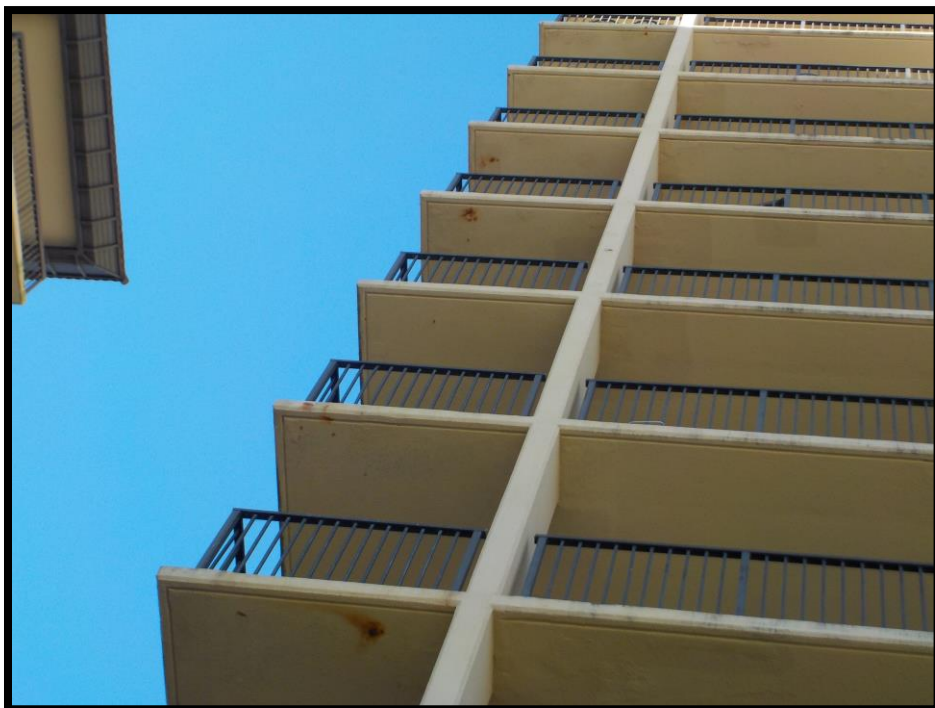
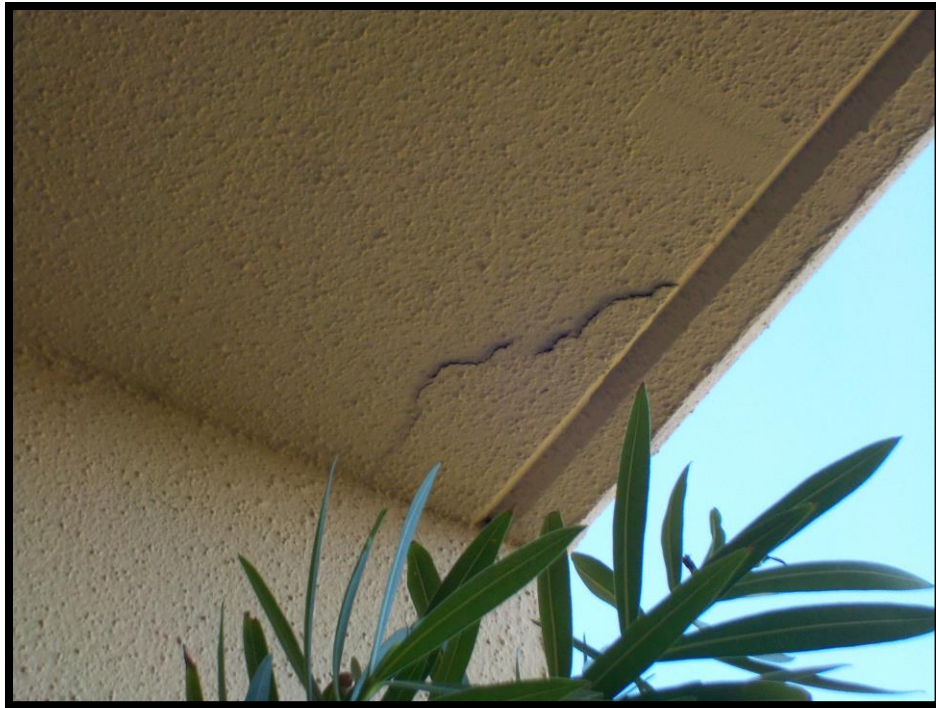
South Balcony Spalling as observed from the ground – documented spalling in the concrete balcony decks working in stacks going from East to West – documented blistering and ruptured blisters throughout many balcony decks at the column to lid tie in.

Spall observation.

Recommendation: Investigate to find water source before making spall repairs. I'd like to learn more of Mr. Brecciaroli's background on the balcony tile.

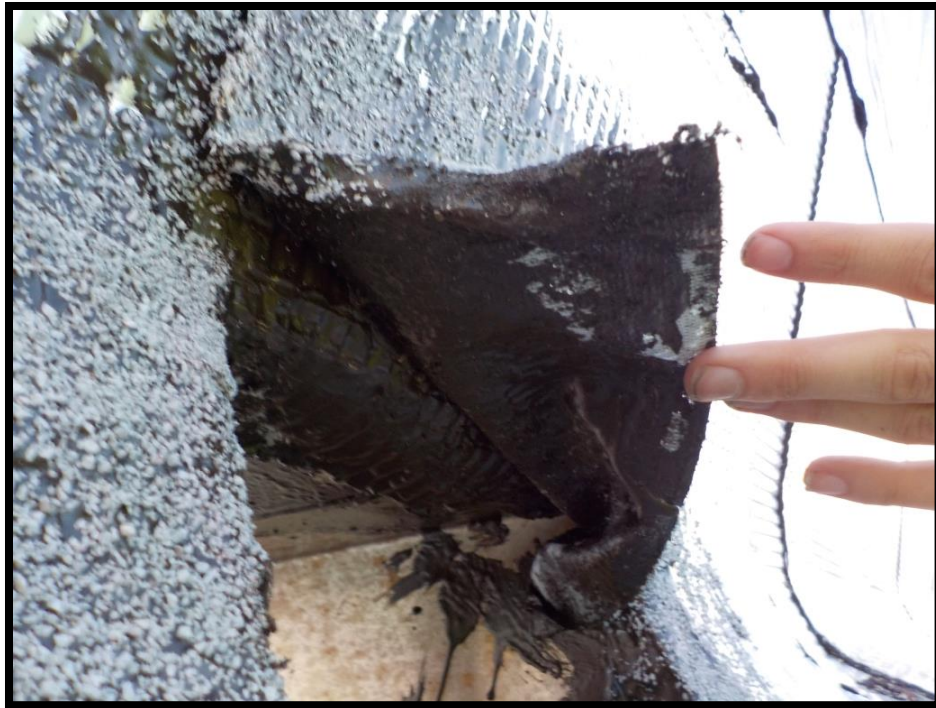
Roof Observation as noted during site visit – flashing loose inside the parapet scupper throats was a typical observation.

Scupper throat flashing condition observed.

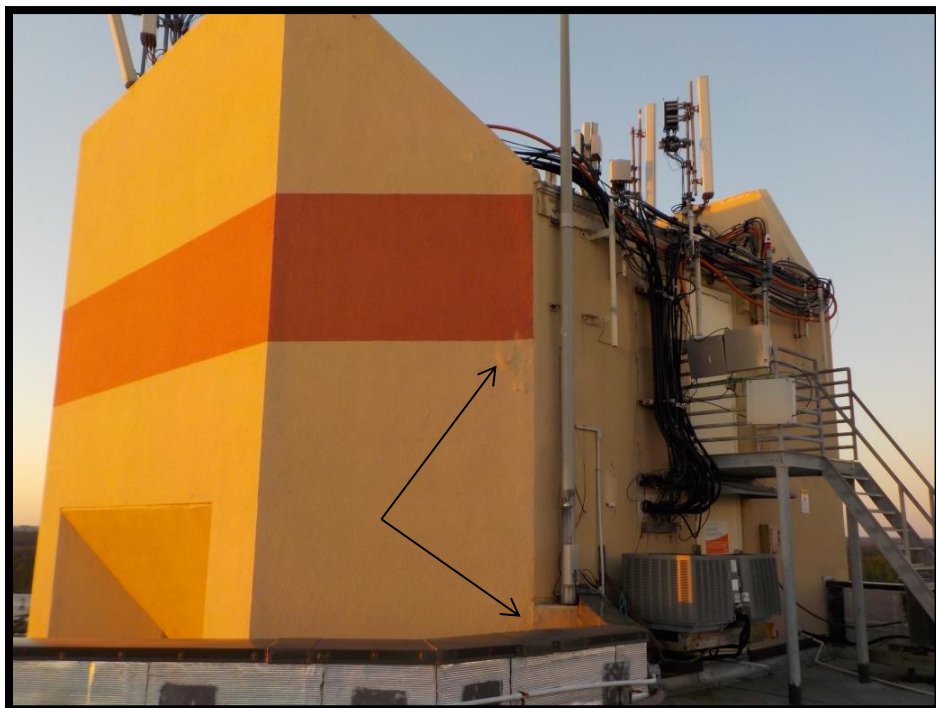
The elevator penthouse wall is allowing water behind the surface mounted flashing and behind/under the roofing.

Elevator penthouse. Note coating blisters.

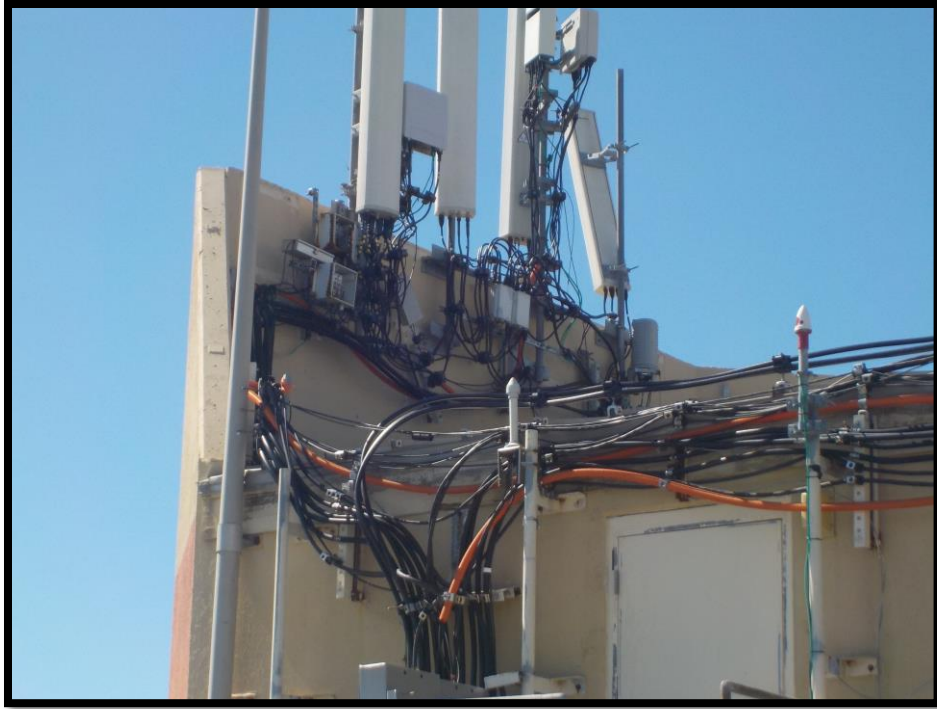
Elevator penthouse wall penetrations.

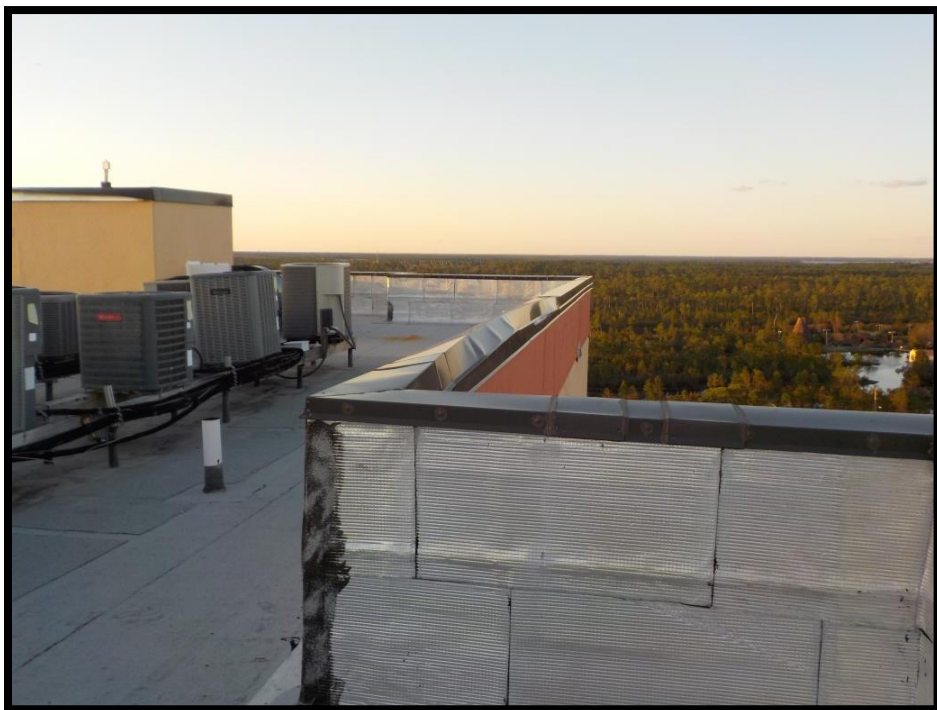
Coping cap damage was observed on the South East building corner and on both corner stairwell penthouses. The roofing membrane was noted to properly saddle the parapet walls beneath the coping cap. The cap metal was folded over a lower cap leg instead of being cleated or clipped as would typically be seen. This was the cause of failure during the storm.

South East flashing damage.

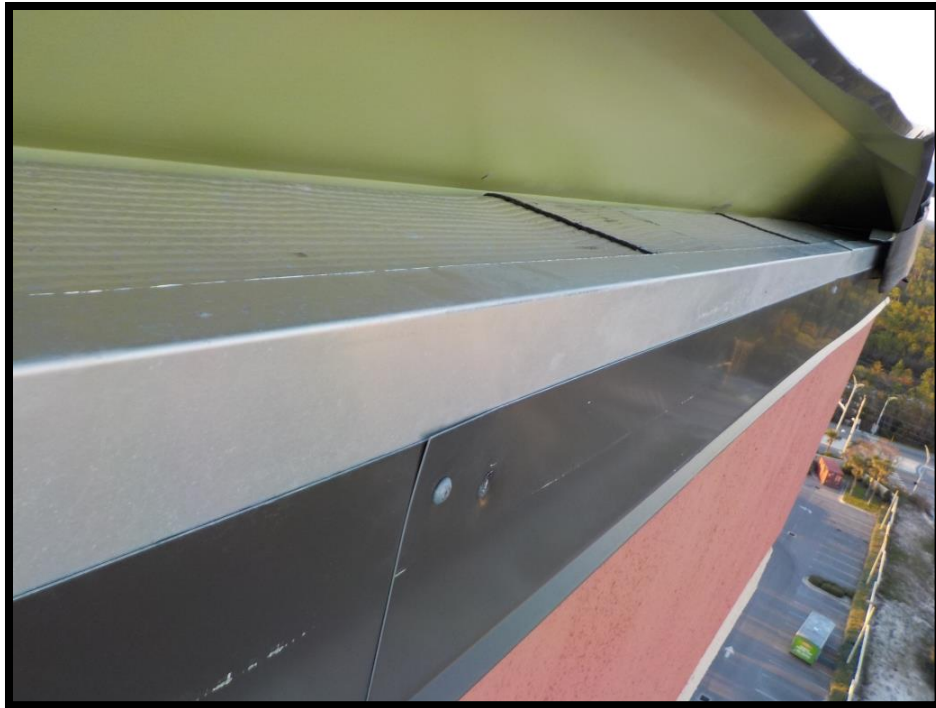
No cleats or clips observed.

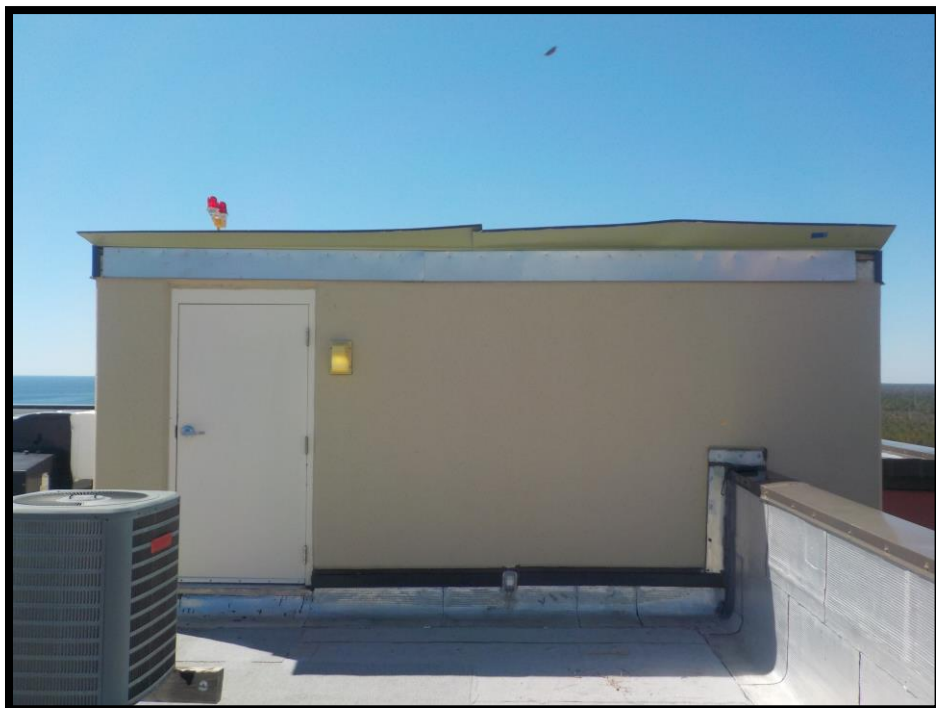
Stairwell penthouse flashing damage.

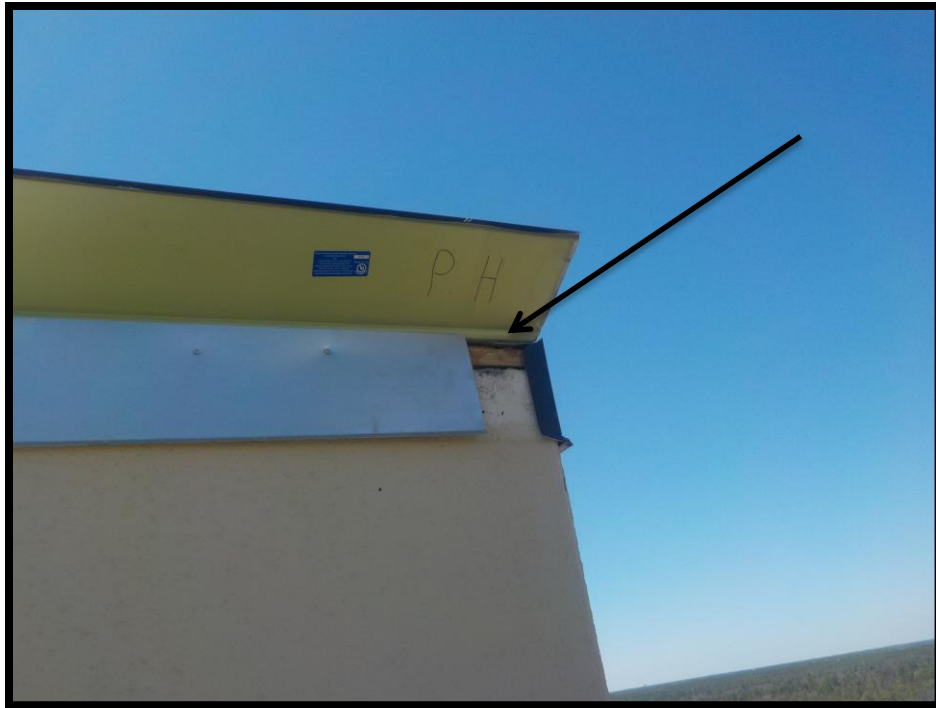
It was also noted that windblown water can enter the top of the stairwell penthouses due to short flashing legs, lack of flashing leg laps and exposed wood nailers.

Note exposed lumber and lack of flashing lap.

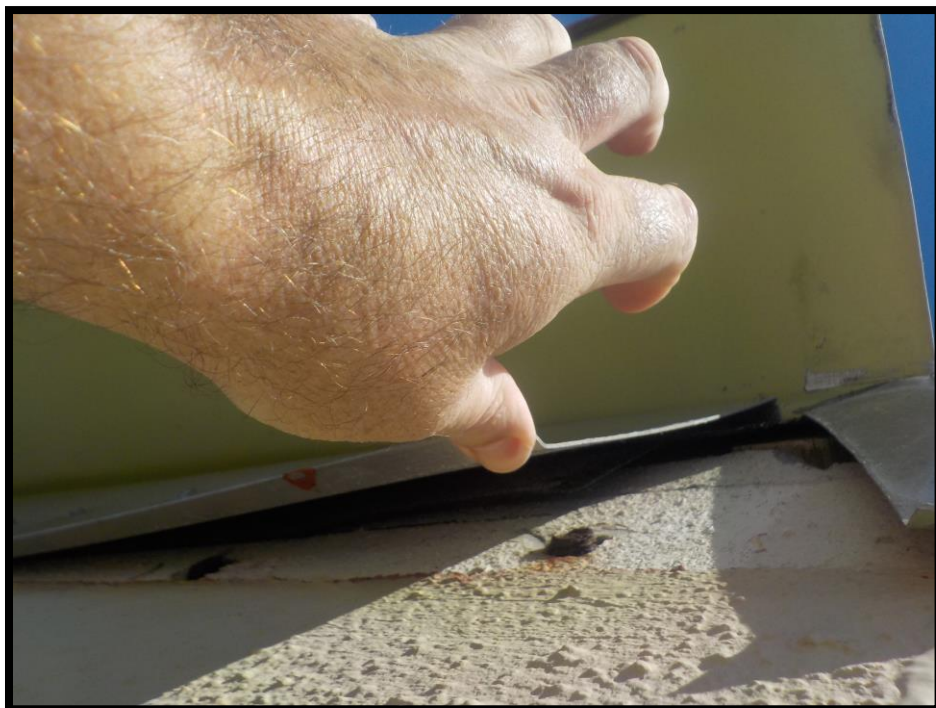
Exposed penetrations just behind stairwell penthouse flashing.
