A RESERVE STUDY UPDATE FOR

**Phoenix V Association, Inc.
Orange Beach, Alabama
File #22920-07488**

FOR PERIOD: January 1, 2020 – December 31, 2020

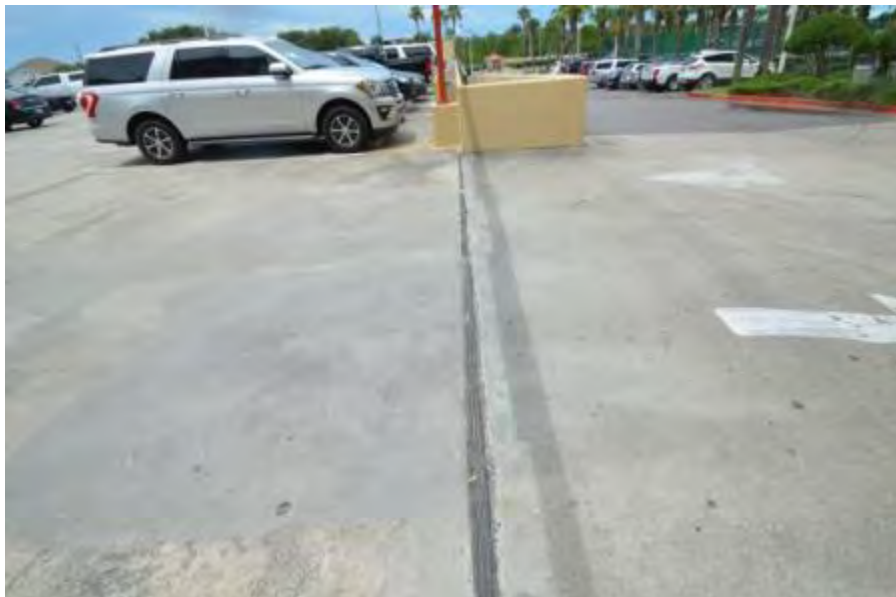
It is our market observation that assuming proper installation with a better quality material, and routine maintenance, expansion joint restoration/replacement should be expected on a life cycle in the 10 to low 10 year range. The current per linear foot unit cost includes removal of existing decking in proximity to the expansion joints, as well as the existing expansion joints, typical minor concrete repairs, and installation of new expansion joints and decking.

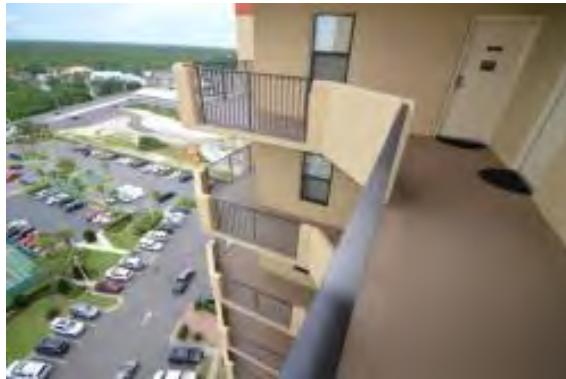
At some point, the association should expect to incur costs for replacement of the railings/handrails. Replacement is sometimes completed in conjunction with major concrete restoration; we have observed life cycles for railings replacement after less than 25 years, while some properties of 40+ years in age have yet to complete replacement. This fund is designed to provide monies for as needed repairs to and eventual replacement of the walkway and balcony railings over a 35 year life cycle. The current per linear foot cost estimate includes removal and disposal of the existing railings, typical minor concrete repairs, and installation of railings of similar height/quality.

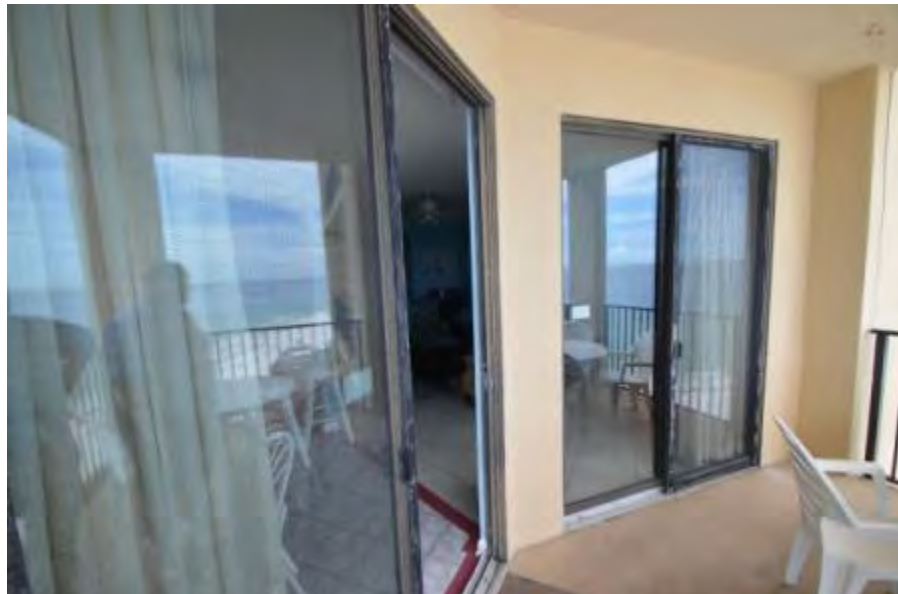
Based on their original 1995 installation date and a 30 year life cycle estimate, replacement of the reported +/- 520 sliding glass doors should be expected in the next +/- 5 years. At the association's request and sole discretion, this project was phased over a 5 year schedule, with a 2025 completion date assumed. Given the scope and cost of this project, we recommend that prior to reserve funding decisions being made, a window/sliding glass door engineer/consultant(s) assess the existing sliding glass doors to determine more specific remaining useful life and current cost estimates.

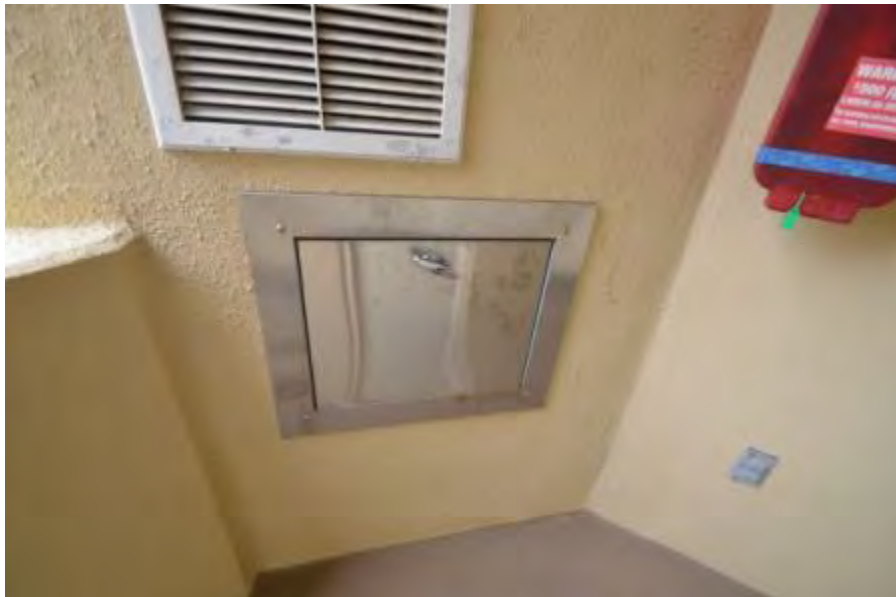
While some doors may require replacement sooner due to improper use, etc., the market reflects a probable life cycle in the high 10 to mid-20 year range for replacement of trash chute door inventories; properties with greater usage, such as rental properties like the subject, tend towards the lower end of that range. Some associations prefer to fund as needed repairs/replacements through their annual operating budgets, while others do establish and fund replacement reserves. The association reportedly does the former, and no reserves for inventory replacement were included. For the association's consideration, we estimate a total inventory replacement cost of \$18,704 for the 28 doors.

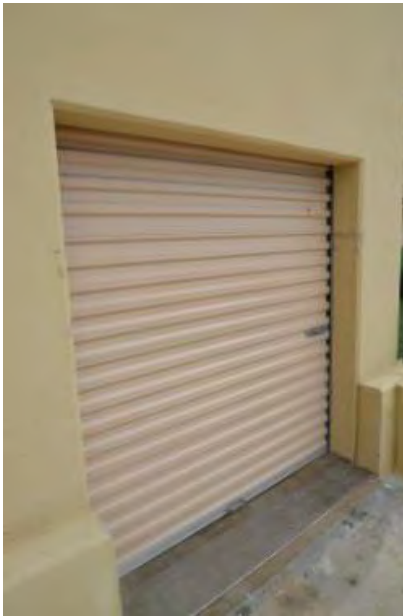
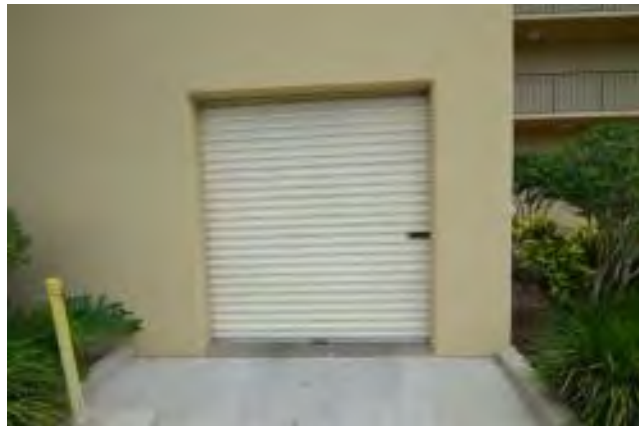
Given the amount and type of usage, life cycles in the mid 10 year range have most typically been observed for replacement of roll up trash room doors. The install dates of the two existing doors were not confirmed; assuming replacement over a typical life cycle and the 1995 initial installation date, actual ages in the +/- 10 year range are indicated. The observed conditions suggest a similar effective/actual age. Each was forecast for replacement in 2024. We reserve the right to modify this report upon confirmation of the factual installation date(s).

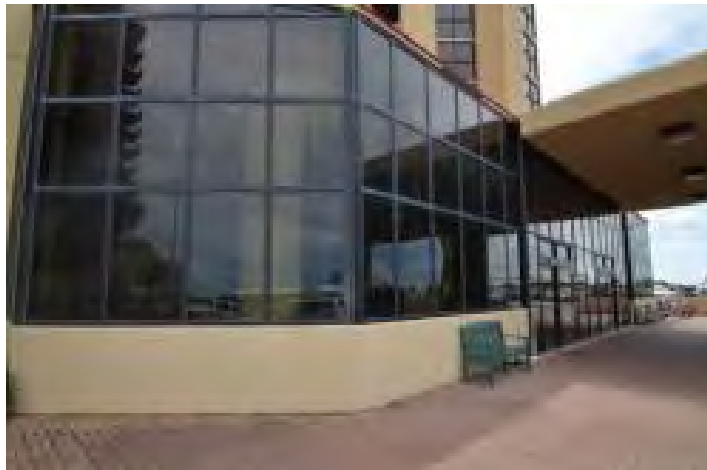
A determination of the design/installation quality and current condition of the exterior windows/storefront glass is beyond the scope of this report. Generally, we do not observed similar properties completing total replacement due to wear out/failure of the glass/framing, but rather due to the desire to upgrade to more efficient/wind resistant glass. Discussions with the association indicate that there is concern of the status and condition, and as such, we recommend that prior to reserve funding decisions are made, a window/exterior consultant(s) assess the existing glass systems to determine budgetary remaining useful life and current replacement costs. This report can then be amended to include exterior glass.

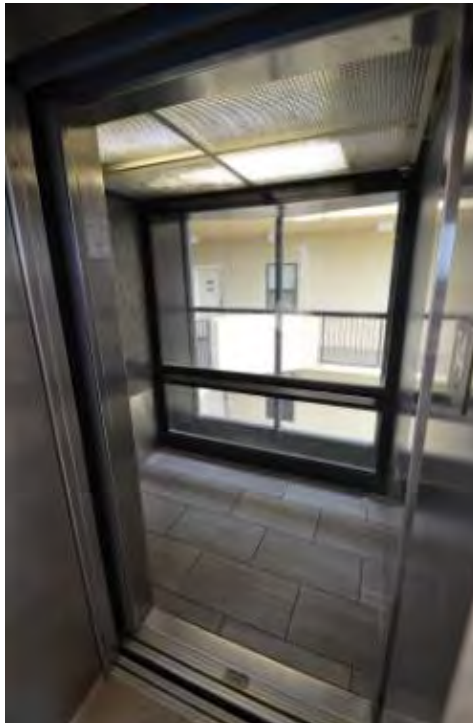
Major cosmetic refurbishment of passenger elevator cabs (flooring, wall finishes, ceilings/lighting, etc.) has been observed on life cycles in the 15-20 year range in properties of similar overall quality. Partial renovation was completed in 2018, and a 2034 expense date scheduled accordingly.

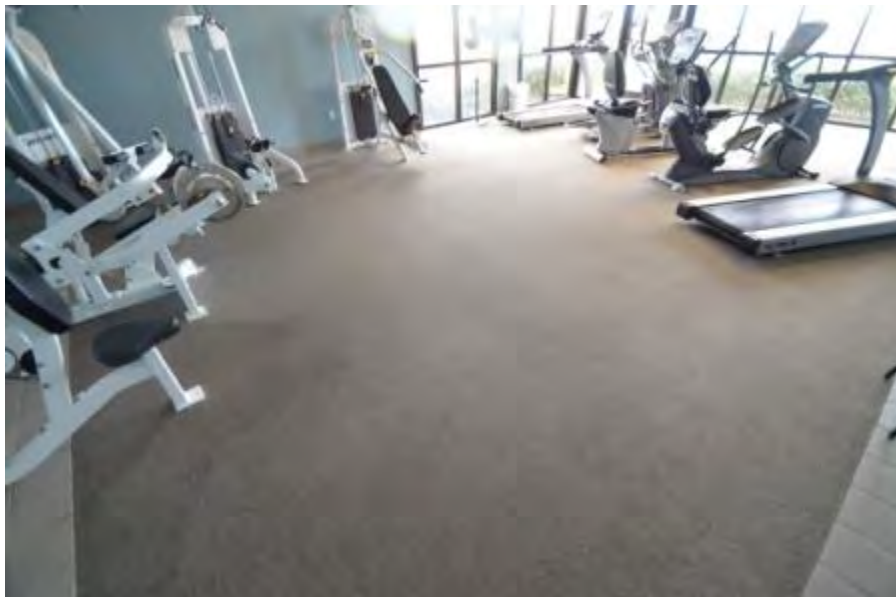
Life cycles of 5-6 years, to 15+ years, have been observed for replacement of carpeting in primary common area interiors (hallways, social rooms, exercise rooms, administrative offices, etc.); the useful life depends on the quality of carpeting, level of ongoing maintenance, and association cosmetic tastes. A 10 year life cycle estimate reflects a 2023 replacement date for the carpeting in the exercise room. The current cost estimate includes removal and disposal of the existing carpeting and installation of like quality. The floor area estimate includes a typical market waste allowance.

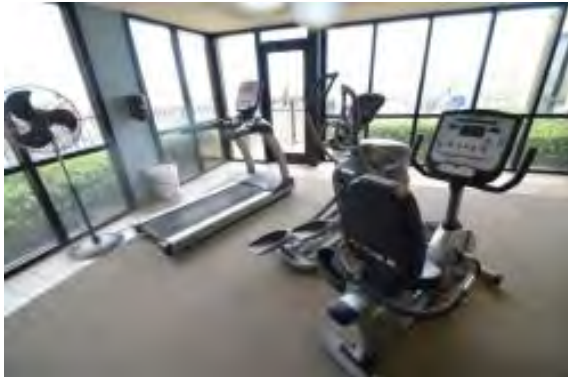
It is our market observation that while minor additions and/or replacements can be expected from time to time, better quality properties complete exercise equipment inventory replacements (treadmills, elliptical trainers, upright and recumbent exercise bikes, arc trainers, etc.) on a life cycle in the 10 year range, to insure the modern, appealing equipment is in use. This fund is designed to provide monies for as needed replacements over a recurring 10 year life cycle. The current lump sum cost estimate is an order of magnitude figure based on the size and quality of the existing inventory.

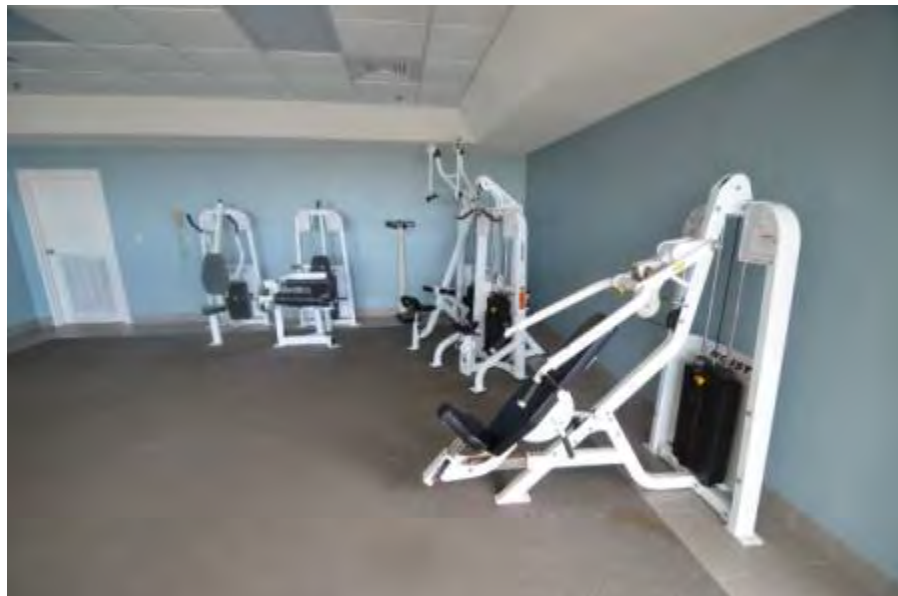
Life cycles in the mid-10 year range have most typically been observed for replacement of strength training stations/equipment. This fund is designed to provide monies for replacement of the existing strength training stations over a 14 year life cycle, accordingly. The current lump sum cost estimate is based on the size and quality of the existing inventory.

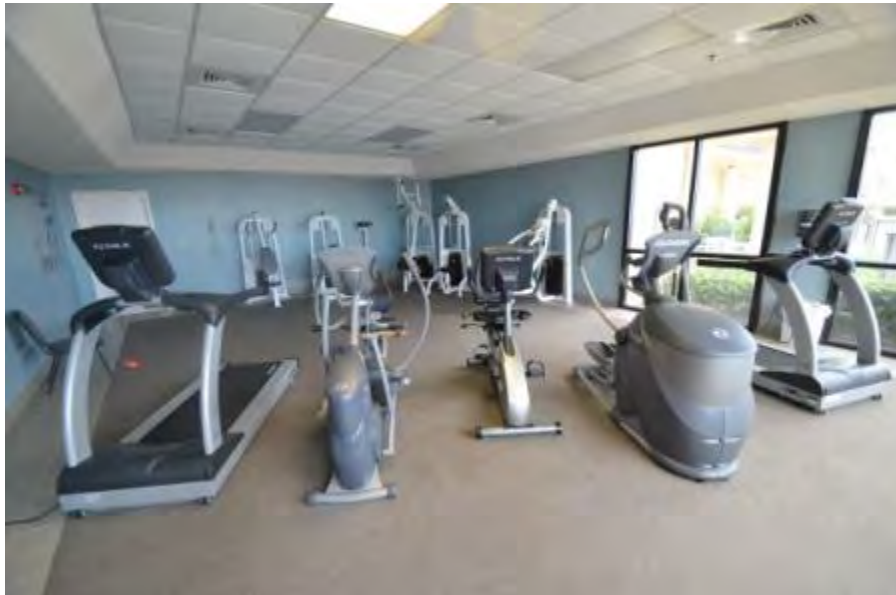
Assuming routine in house touch ups/repairs, interior painting of primary common areas (hallways, social rooms, exercise rooms, administrative offices, etc.) should be expected on a life cycle in the low to mid 10 year range. A 14 year life cycle estimate reflects a 2027 expense date for repainting of the exercise room interiors. The current cost estimate is based on the approximate painted areas, and includes typical minor repairs/surface preparation.

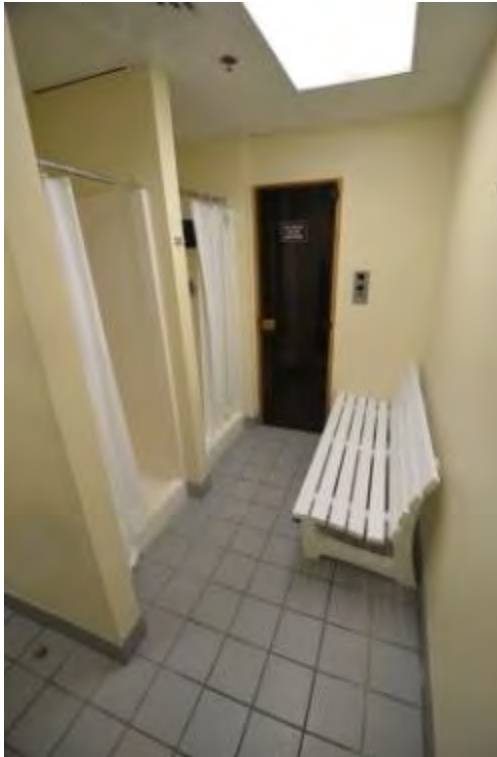
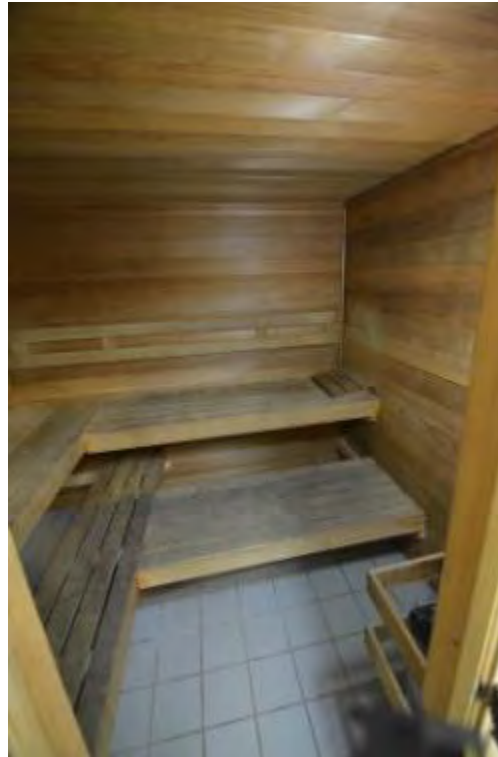
At some point, the association should expect to incur costs for major restoration of the exercise room restroom interiors (including, but not necessarily limited to, flooring, wall finishes, vanities, mirrors, dividers, sauna interiors, plumbing and electrical fixtures, etc.). Life cycles of less than 15 years, to 30+ years, have been observed in properties of similar quality. A 20 year life cycle estimate reflects a 2033 expense date. The current cost estimate does not include any unforeseen floor area reconfiguration(s) and/or expansion(s).

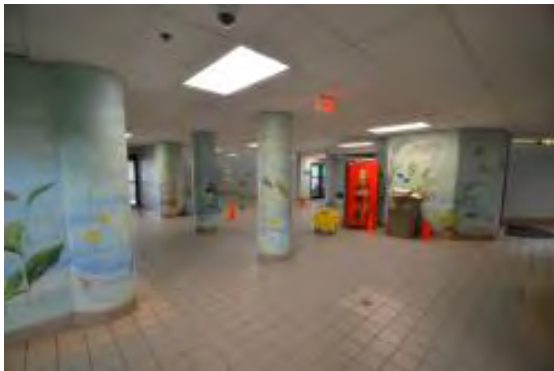
Assuming routine in house touch ups/repairs, interior painting of primary common areas (hallways, social rooms, exercise rooms, administrative offices, etc.) should be expected on a life cycle in the low to mid 10 year range. A 14 year life cycle estimate reflects a 2031 expense date for repainting of the interiors of the basement level hallways. The current cost estimate is based on the approximate painted areas, and includes typical minor repairs/surface preparation. This cost does not include the custom mural painting.

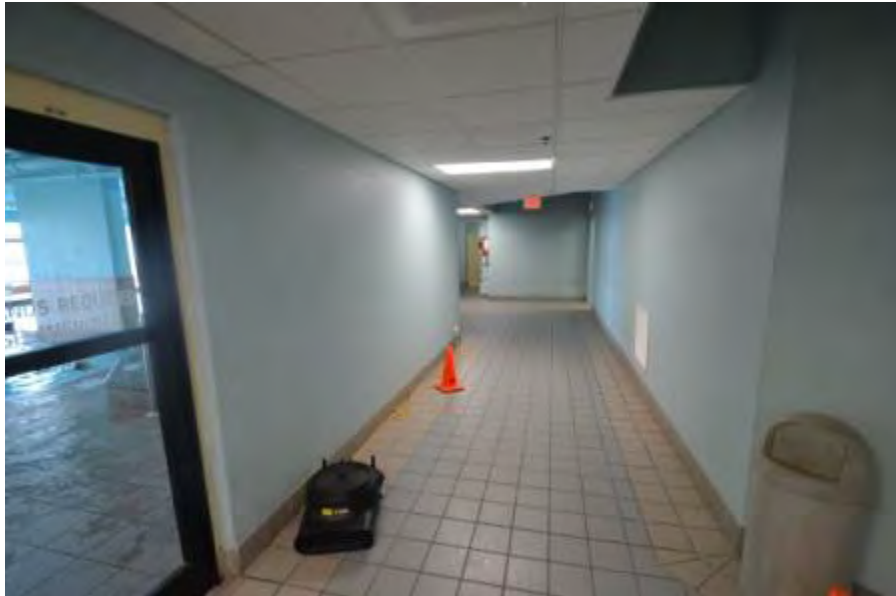
At some point, the association should expect to incur costs for replacement of the quarry tile flooring in the basement level hallways/elevator lobby. Because replacement is typically completed due to cosmetic dissatisfaction rather than physical wear out/failure of the flooring itself, life cycles can vary from property to property; we have observed life cycles of less than 10 years, to over 30 years, for replacement of tile flooring. As there were no reported plans to replace the tile flooring in the social/meeting room in the near future, this expense was forecast in 2021. The current cost estimate includes removal and disposal of the existing tile flooring and installation with like quality. The floor area is a rounded estimate.

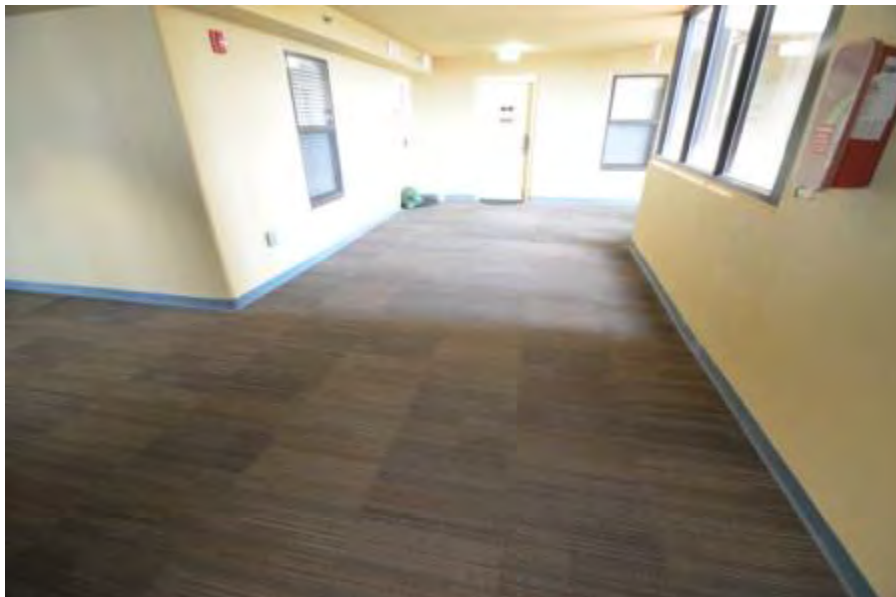
Assuming routine in house touch ups/repairs, interior painting of primary common areas (hallways, social rooms, exercise rooms, administrative offices, etc.) should be expected on a life cycle in the low to mid 10 year range. A 14 year life cycle estimate reflects a 2027 expense date for repainting of the interiors of the residential hallways at floors 2, 3 and 4. The current cost estimate is based on the approximate painted areas, and includes typical minor repairs/surface preparation.

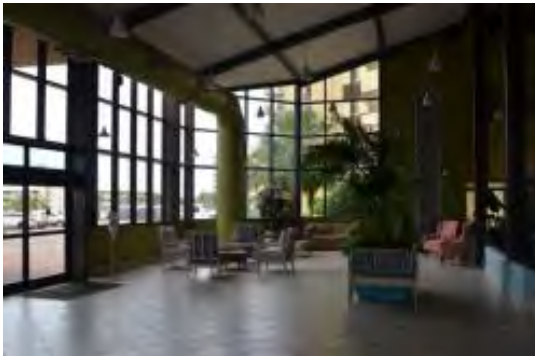
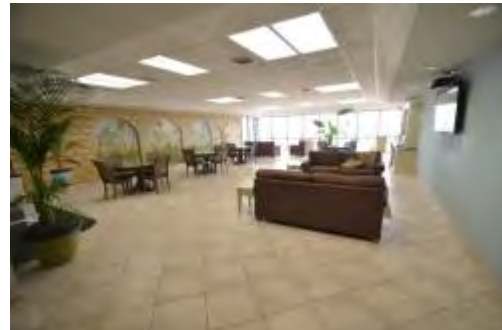
Lobby, Interior Painting

Assuming routine in house touch ups/repairs, interior painting of primary common areas (hallways, social rooms, exercise rooms, administrative offices, etc.) should be expected on a life cycle in the low to mid 10 year range. A 14 year life cycle estimate reflects a 2027 expense date for repainting of the main lobby level interiors. The current cost estimate is based on the approximate painted areas, and includes typical minor repairs/surface preparation.

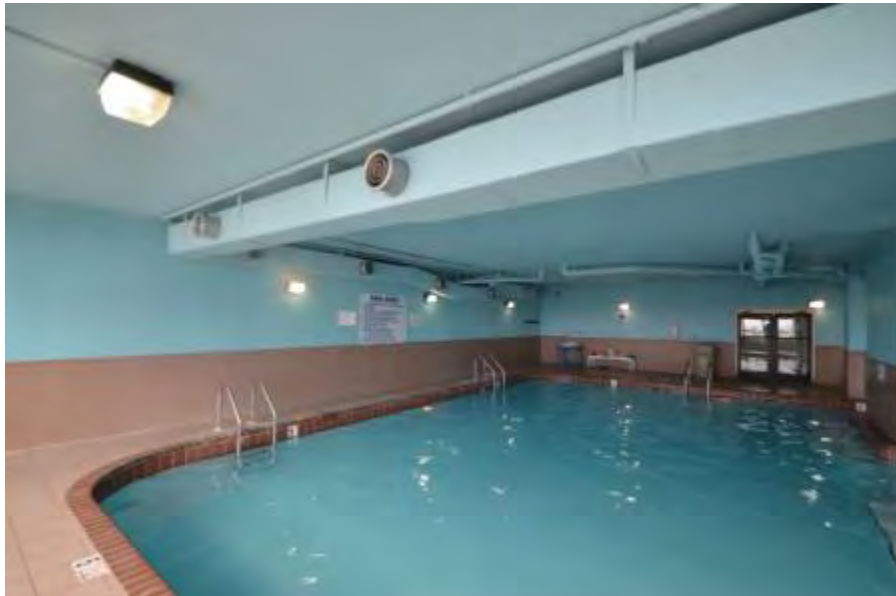
Natatorium, Tile Flooring/Wall Finishes

At some point, the association should expect to incur costs for replacement of the natatorium tile flooring. Because replacement is typically completed due to cosmetic dissatisfaction rather than physical wear out/failure of the flooring itself, life cycles can vary from property to property; we have observed life cycles of less than 10 years, to over 30 years, for replacement of tile flooring. As there were no reported plans to replace the tile flooring in the social/meeting room in the near future, this expense was forecast in 2021. The current cost estimate includes removal and disposal of the existing tile flooring and installation with like quality. The floor area is a rounded estimate.

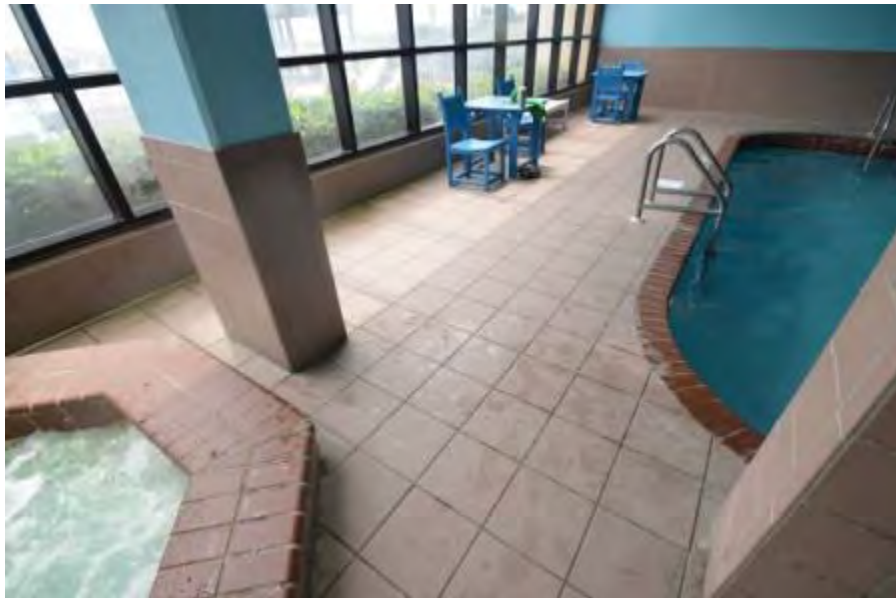
Restroom Renovation

At some point, the association should expect to incur costs for major restoration of the restrooms supporting the lobbies and pools (including, but not necessarily limited to, flooring, wall finishes, vanities, mirrors, dividers, plumbing and electrical fixtures, etc.). Life cycles of less than 15 years, to 30+ years, have been observed in properties of similar quality. A 20 year life cycle estimate reflects a 2037 expense date. The current cost estimate does not include any unforeseen floor area reconfiguration(s)and/or expansion(s).

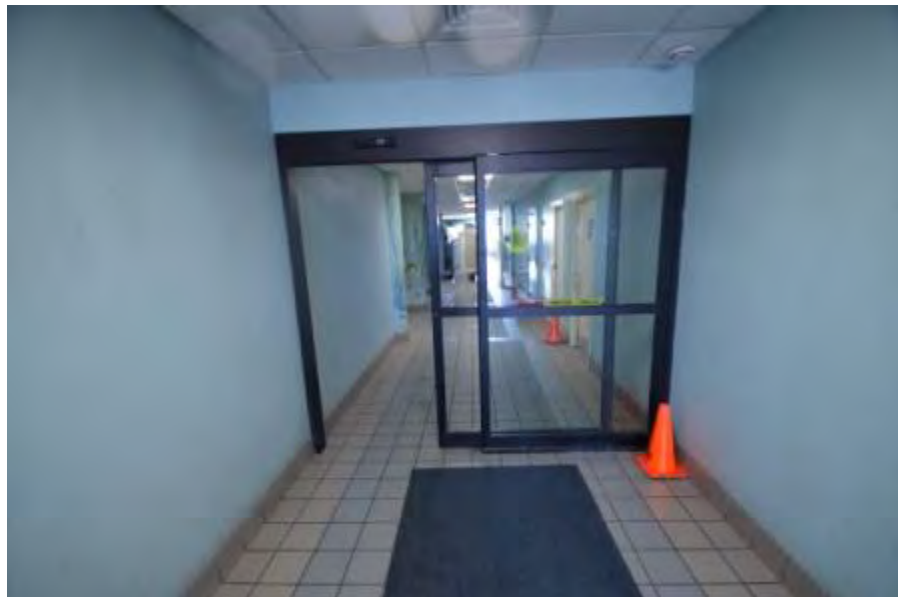
Automatic Doors, Garage Access

Life cycles in the mid to high 10 year range have been observed for replacement of properly maintained automatic doors/equipment. This fund is designed to provide monies for as needed repairs to and eventual replacement of the automatic doors accessing the garage/main lobby level over a recurring 16 year life cycle.

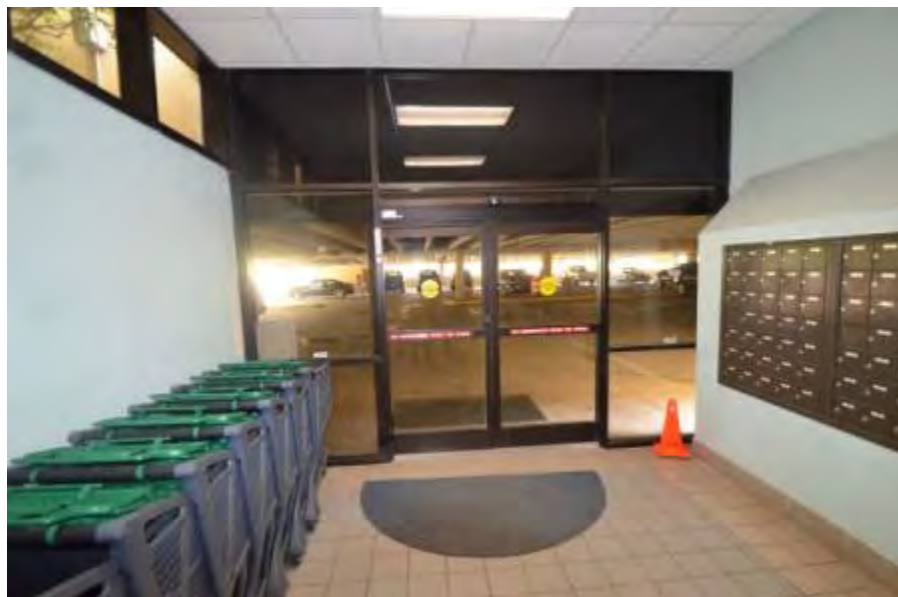
Automatic Doors, Lobby Access

Life cycles in the mid to high 10 year range have been observed for replacement of properly maintained automatic doors/equipment. These funds are designed to provide monies for as needed repairs to and eventual replacement of the automatic doors accessing the lobby over recurring 16 year life cycles.

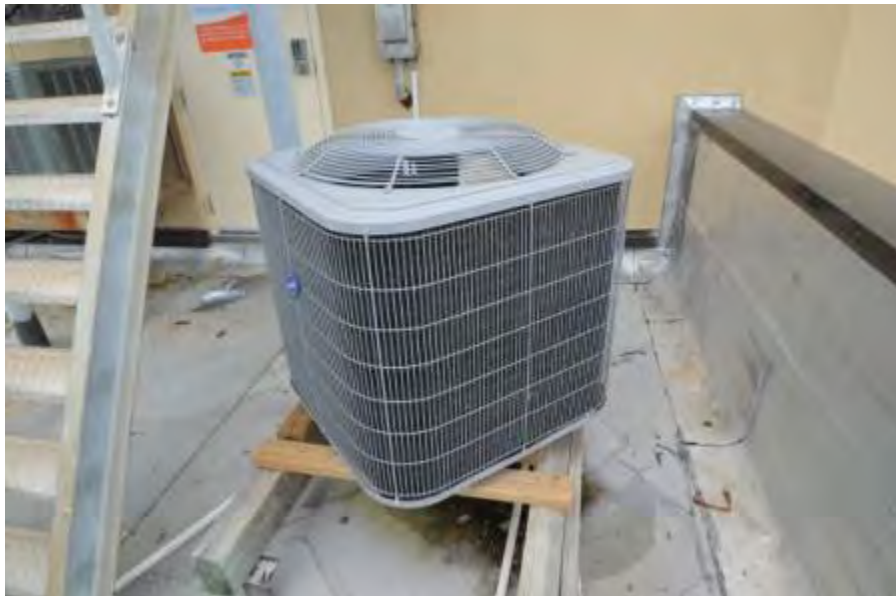
Life cycles in the 7-12 year range have most typically been observed for replacement of residential/commercial grade split system condenser units designed for use in the corrosive ocean environment. The installation date of the unit supporting the elevator equipment room was not confirmed; **based on its observed condition, we estimate an effective age of 2-3 years (2016) and scheduled replacement in 2025. We reserve the right to modify this report upon confirmation of the factual installation date.**

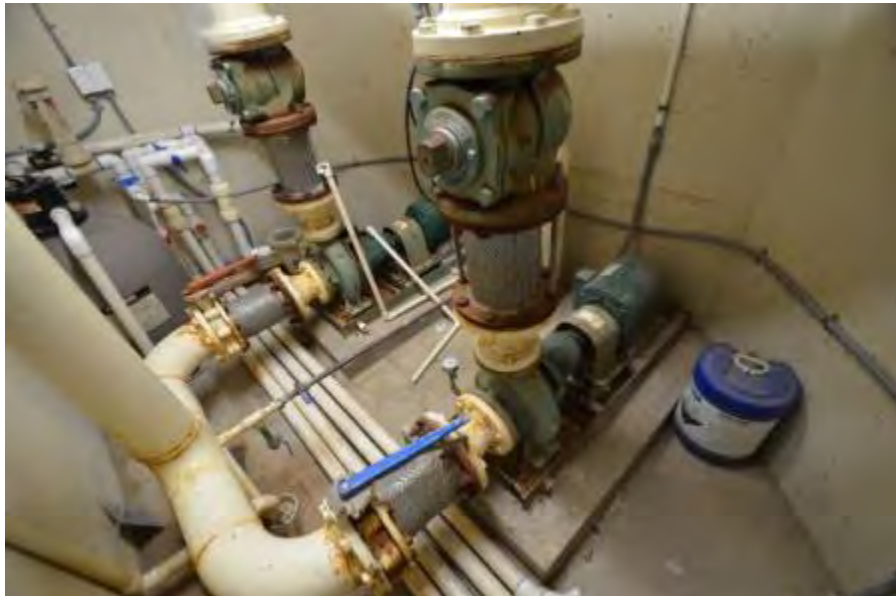
Cooling Tower Pump/Motor/Drive

Life cycles in the low to high 10 year range have been observed for replacement of smaller HVAC/circulating pumps under normal conditions; this life cycle range assumes proper and routine maintenance, including (but not necessarily limited to) pump rebuilds, motor replacements, etc. **The date of install of the two 7.5 HP circulating pumps was not confirmed; assuming replacement in the early 2010's, which would be commensurate with a 1995 installation date and a 16 year life cycle, replacements were scheduled in 2027. We reserve the right to modify this report upon confirmation of the factual installation date(s).**

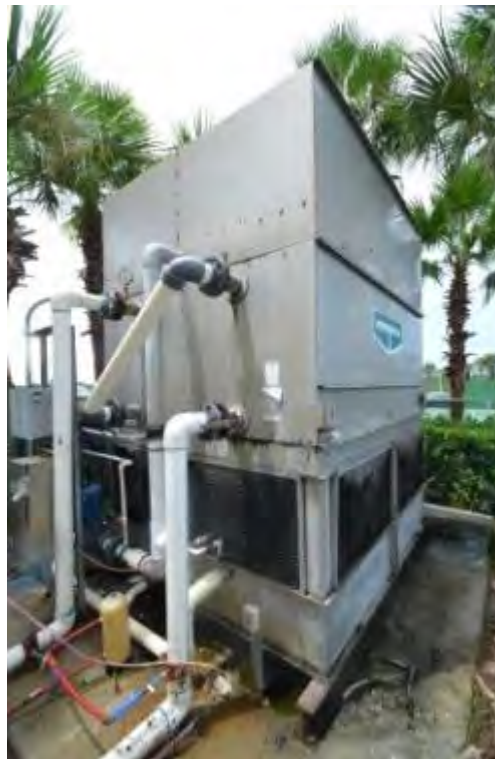
Cooling Tower/Equipment

The market reflects a probable life cycle in the mid-20 year range for the ground mounted cooling tower, which appears to be of stainless steel construction. This fund is designed to provide monies for as needed repairs to and eventual replacement over a 26 year life cycle, accordingly. The current per ton cost estimate includes consulting/engineering fees, removal and disposal of the existing tower, and installation of a similar size/quality tower. The size in tons is a rounded estimate.

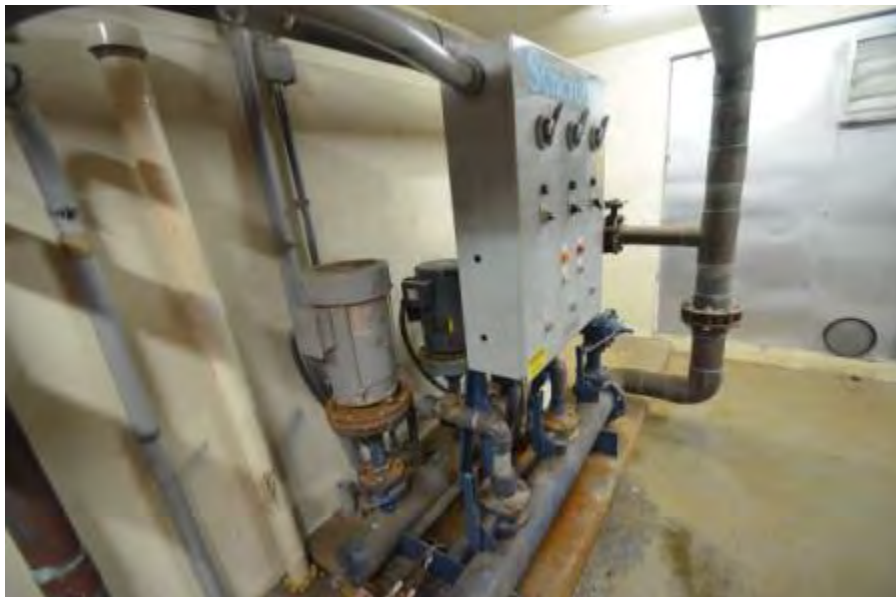
Domestic Water Pumps/Equipment

The common area mechanical equipment inventory includes a domestic water booster pump station/system, with three 15 hp pumps, controller panel, drives and associated equipment. Assuming periodic pump rebuilds, motor replacements, controller upgrades, etc. as a function of routine maintenance, modernization/replacement of standard domestic water pumps and equipment has a market indicated life cycle in the low to mid 20 year range. This fund is designed to provide monies for as needed repairs to and eventual system modernization/replacement over a 24 year life cycle, based on its reported 2011 installation date.

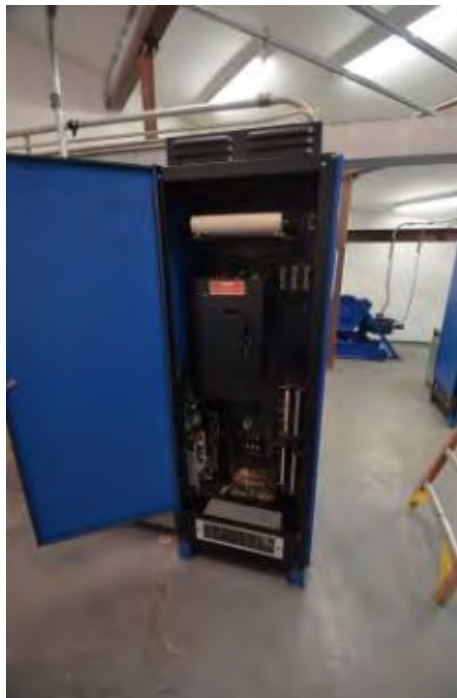
Elevator Mechanical Modernization

Modernization of traction/electric elevator mechanical and electrical components, including (but not necessarily limited to), controllers, door hardware, etc. has been observed on life cycles in the 25-30 year range in properties of similar quality, assuming a typical maintenance program; the useful life is often determined by an association's dissatisfaction with the elevators' speed, smoothness of ride, and noise. A 30 year life cycle estimate reflects a 2025 expense date. Given the actual age of the existing equipment, we recommend that prior to reserve funding decisions being made (and on a periodic and regular basis thereafter), an elevator consultant(s) assess the existing systems/equipment to determine more specific remaining useful life and current cost estimates. We reserve the right to modify this report upon receipt of such an assessment(s).

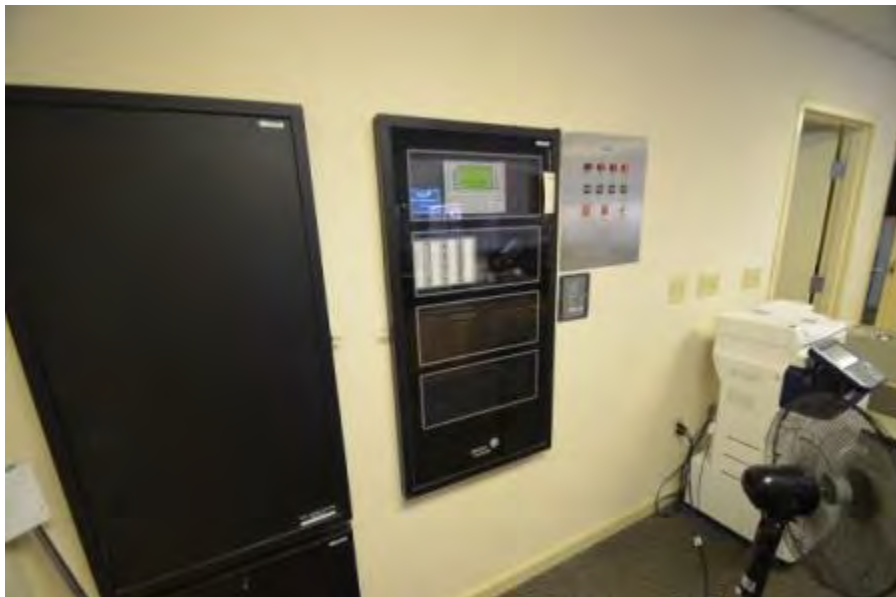
Fire Alarm System Modernization

Due to improvements in technology and/or parts obsolescence, major modernization of fire alarm system components (panels, pull stations, horns/strobes, detectors, hoses) is typically necessary on a 20-30 year schedule. A mid-range 25 year life cycle estimate reflects a 2043 expense date.

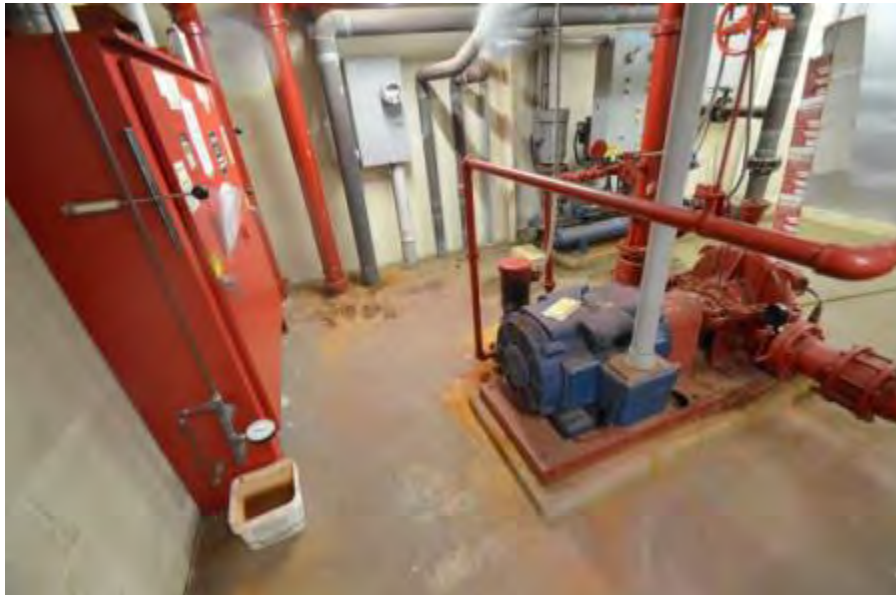
Fire Pump/Equipment

The 100 hp electric driven fire pump should enjoy a useful life of 40+ years, assuming a routine maintenance program. This fund is designed to provide monies for as needed repairs to and eventual replacement over a 40 year life cycle. The current cost estimate includes the controller panel, pump, valves, fittings, etc.

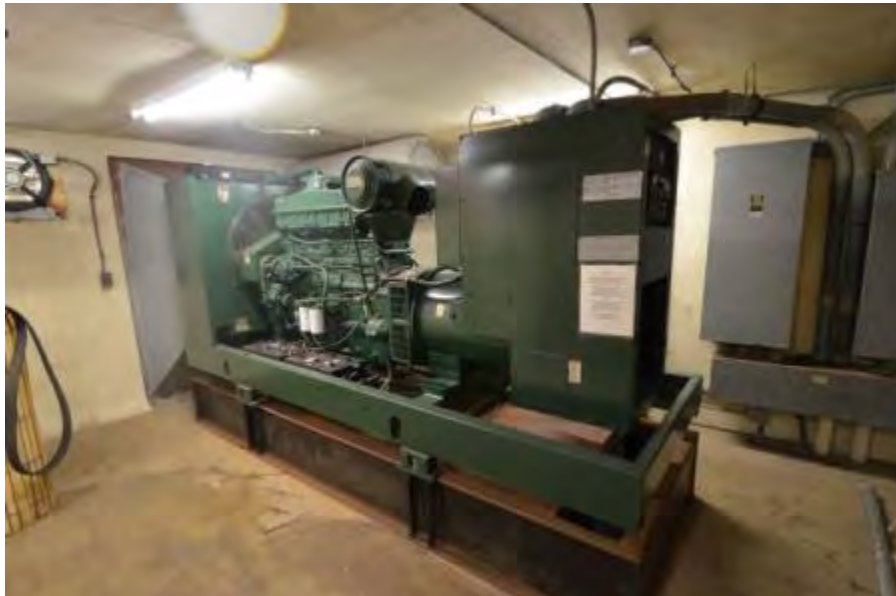
The 300 kilowatt emergency generator has a market indicated life cycle of 35-40+ years, given its location within an enclosed building area, and assuming proper and routine maintenance. This fund is designed to provide monies for as needed repairs to and eventual replacement over a 40 year life cycle. The current cost estimate includes the transfer switch, fuel tank, and other associated equipment.

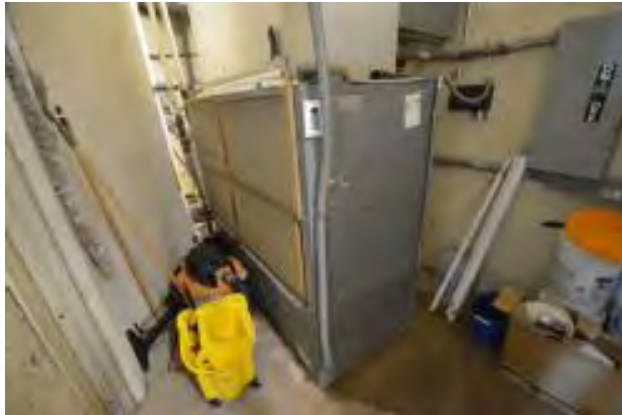
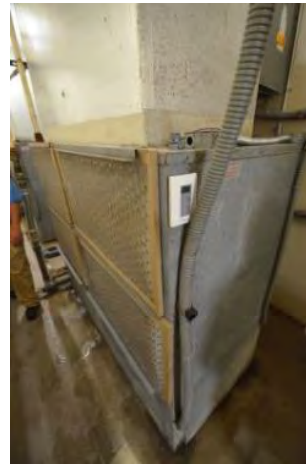
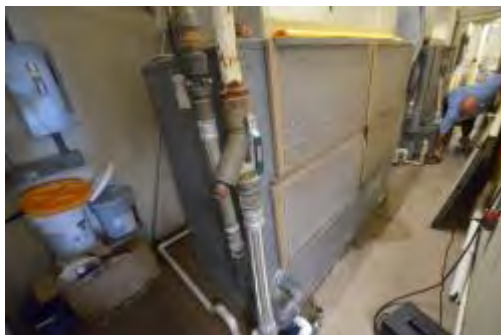
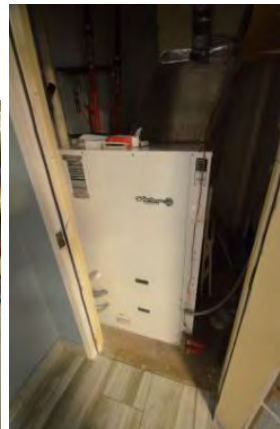
Heat Pump # 1, Basement West

Properly maintained heat pump units have market observed life cycles in the mid-10 to low 20 year range under normal conditions; the installation dates of the individual common area units were not confirmed. **It was assumed that all were replaced after a +/- 20 year life cycle, based on the original 1995 construction date, and future replacements scheduled accordingly. We reserve the right to modify this report upon confirmation of the factual installation dates.** The photographs are of representative common area units.

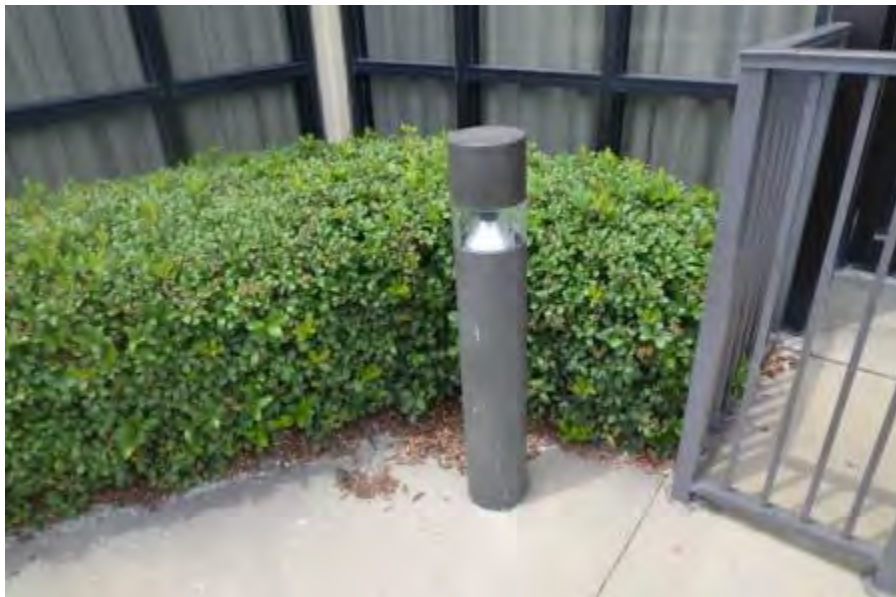
In the corrosive ocean environment, life cycles in the mid 10 to 20 year range have most typically been observed for replacement of aluminum bollard light posts/fixtures. A 2021 inventory replacement date was scheduled, accordingly.

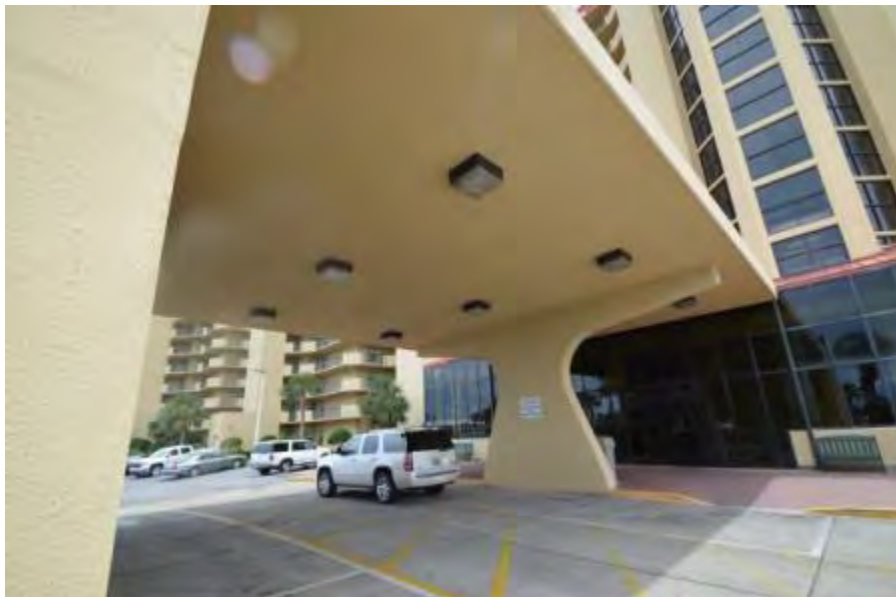
Lighting, Porte Cochere

In the corrosive ocean environment, life cycles in the mid 10 to 20 year range have most typically been observed for replacement of ceiling mounted lights like those supporting the entry porte cochere. A 2021 inventory replacement date was scheduled, accordingly.

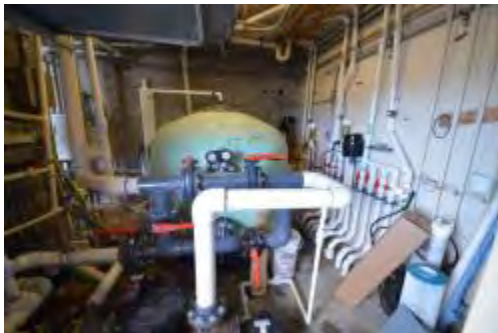
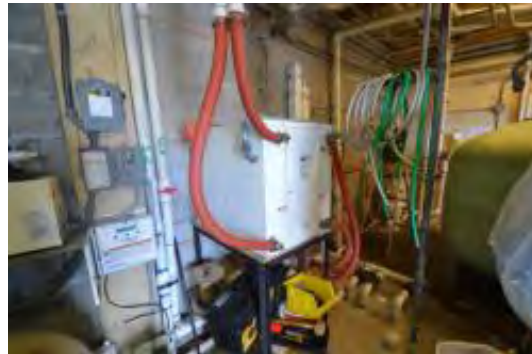
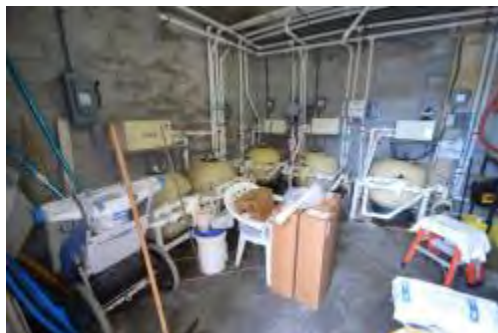
Pool & Spa Equipment Fund

Under normal conditions, total replacement of pool and spa equipment inventories (pumps, motors, chlorination systems, filters, heaters, etc.) should not be necessary at any one given time. As such, reserving for total replacement is not considered prudent or practical. This is supported by our review of reserve budgets at similar properties; while some associations establish and fund contingency reserves for as needed repair/replacement costs, others prefer to fund incidental expenses through their annual operating budgets, as a function of routine maintenance. For the association's consideration, we have included a line item to provide monies for as needed pool/spa equipment upgrades/replacements over a recurring 10 year life cycle. This fund is a projection only, and is not designed to provide monies for total inventory replacement. Costs and time frames may vary from these estimates.

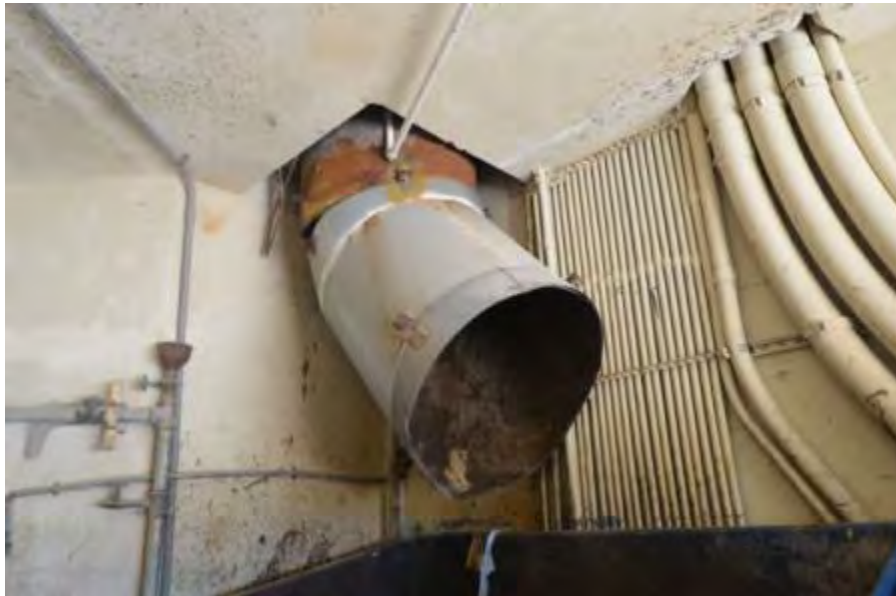
Trash Chutes

Data taken from older properties suggests that major trash chute restoration/replacement should be expected on a 35-40+ year basis, which assumes typical and routine maintenance. This fund is designed to provide monies for as needed repairs to and eventual major restoration/replacement over a 40 year life cycle.

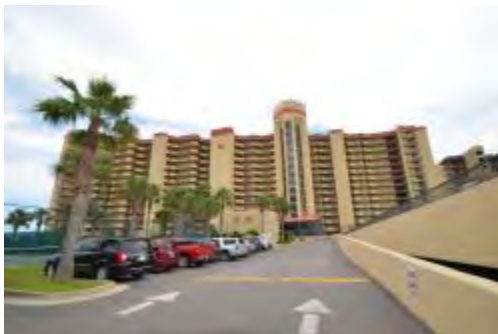
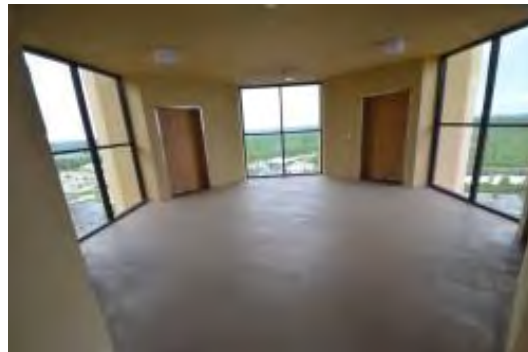
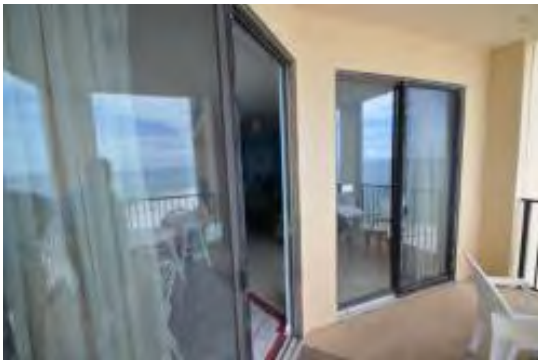
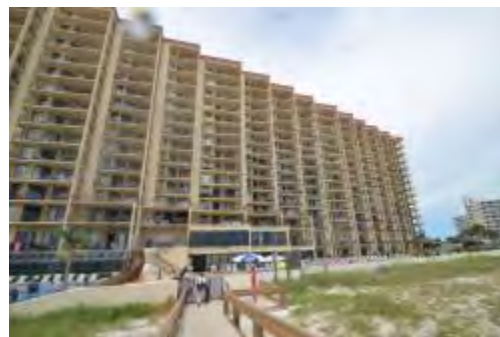
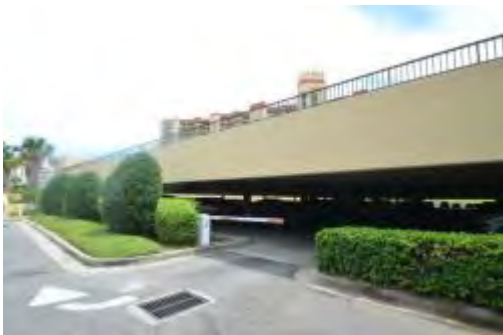
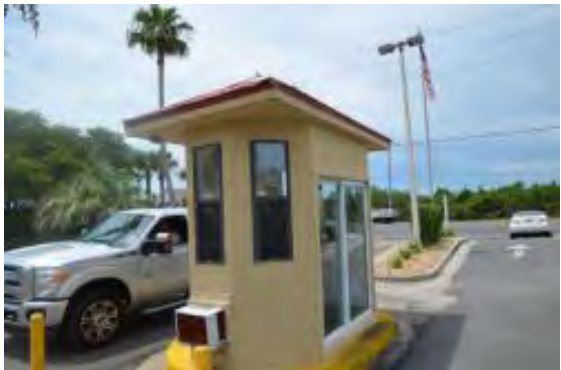
Paint/Waterproof Building Exteriors

To insure proper protection of the underlying concrete, stucco, wood and metal surfaces, the market reflects a maximum 7 year useful life for exterior painting & waterproofing (in lieu of an association purchased longer warranty). **It was assumed that the 2017 project included a 10 year warranty, and a 2027 expense date scheduled accordingly. We reserve the right to modify this report if this assumption is in error.** The current average per dwelling unit cost estimate includes typical minor concrete/stucco repairs, surface preparation, as needed window/sliding glass door caulking and painting/refinishing of all exterior concrete, stucco, wood and metal surfaces (including railings and window/slider frames).

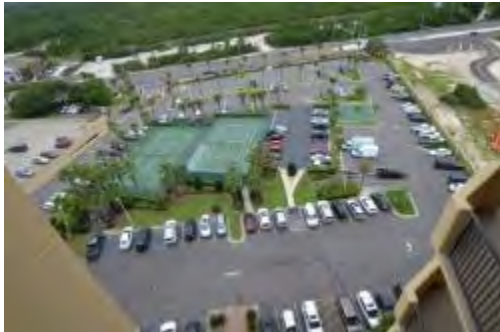
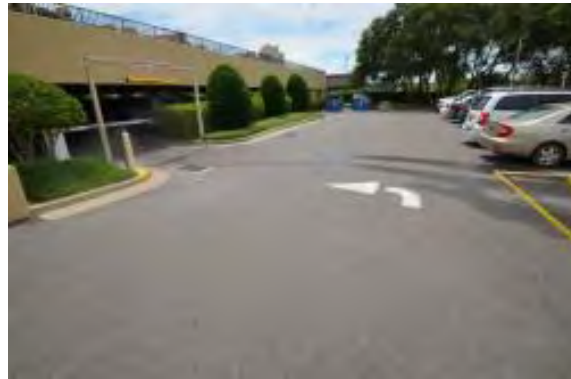
Asphalt Paving

We have observed life cycles of less than 15 years, to 25+ years, for asphalt overlay projects, assuming proper design, installation and routine maintenance. A 20 year life cycle estimate reflects a 2037 repaving date. The current unit cost estimate includes milling/removal of the existing asphalt paving, typical minor repairs to the underlying pavement subbase and drainage systems, installation of new asphalt paving, and re-striping. The paved area is a rounded estimate.
