A RESERVE STUDY UPDATE FOR

**Phoenix V Association, Inc.
Orange Beach, Alabama
File #22920-07488**

FOR PERIOD: January 1, 2020 – December 31, 2020

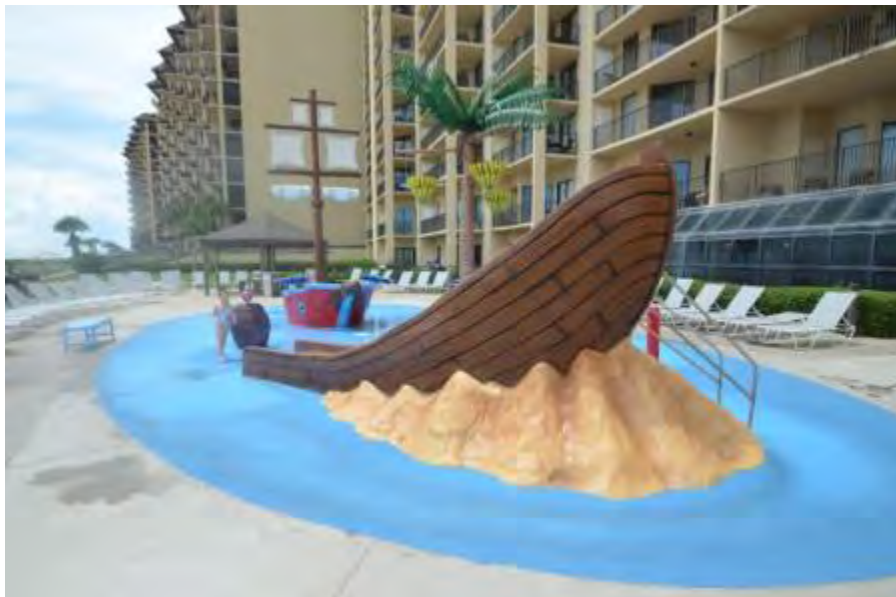
This fund is designed to provide monies for periodic restoration/replacement of the kid's water feature improvements, including decking, etc. over a recurring 12 year life cycle. The current cost estimate is an order of magnitude figure based on the size and quality of existing improvements.

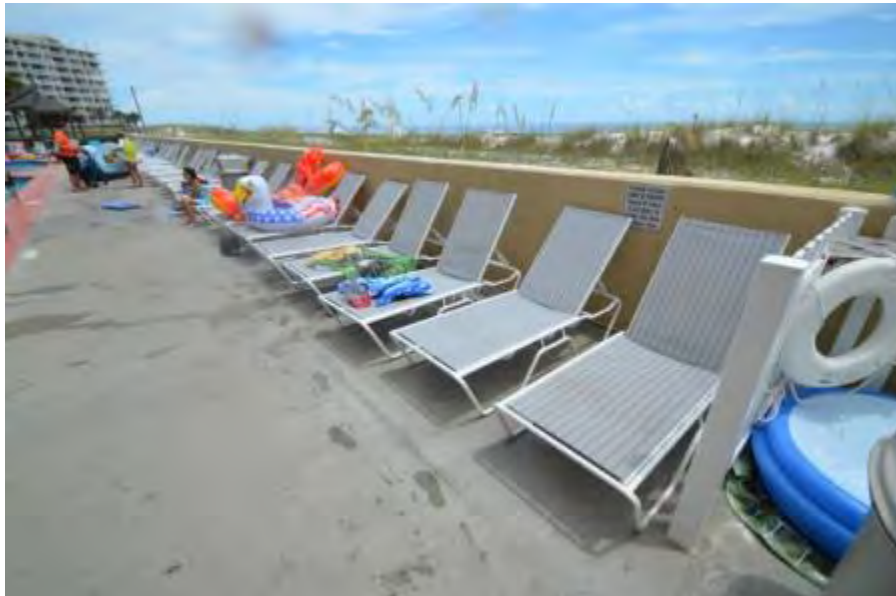
Pool Deck Furniture

While minor additions/replacements can be expected from time to time, and assuming periodic as needed re-slinging and/or refinishing as a function of routine maintenance, most associations complete similar pool deck furniture inventory replacements on a +/- 10 year life cycle. The cost estimate is based on the approximate size and observed quality of the existing inventory.

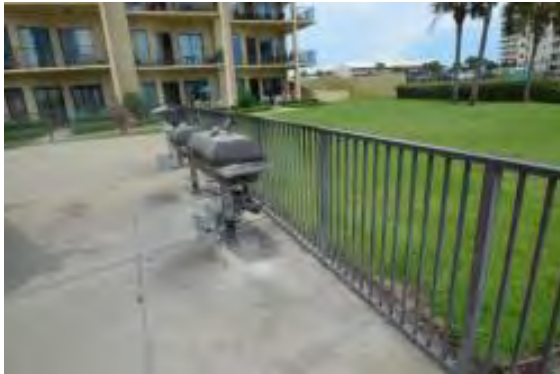
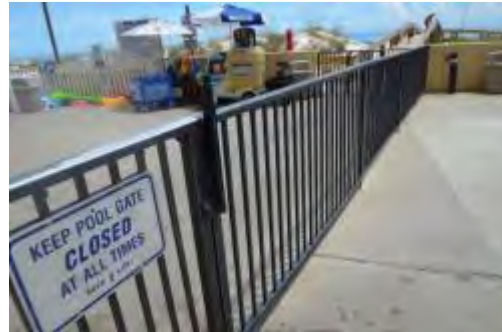
Pool Fencing & Gates

A life cycle in the low to mid 20 year range is the most typical useful life we have observed for replacement of standard aluminum pool/spa deck fencing and gates. The existing fencing/gates appear to be (largely) original to the property, reflecting an actual age of +/- 24 years. Based on its observed condition, we have scheduled replacement in 2020. The current cost estimate includes removal and disposal of the existing fencing and gates and installation of like height/quality fencing and gates, and is based on the approximate linear footage of 600 feet (including the sun deck/stairs). We reserve the right to modify this report upon confirmation of the factual linear footage.

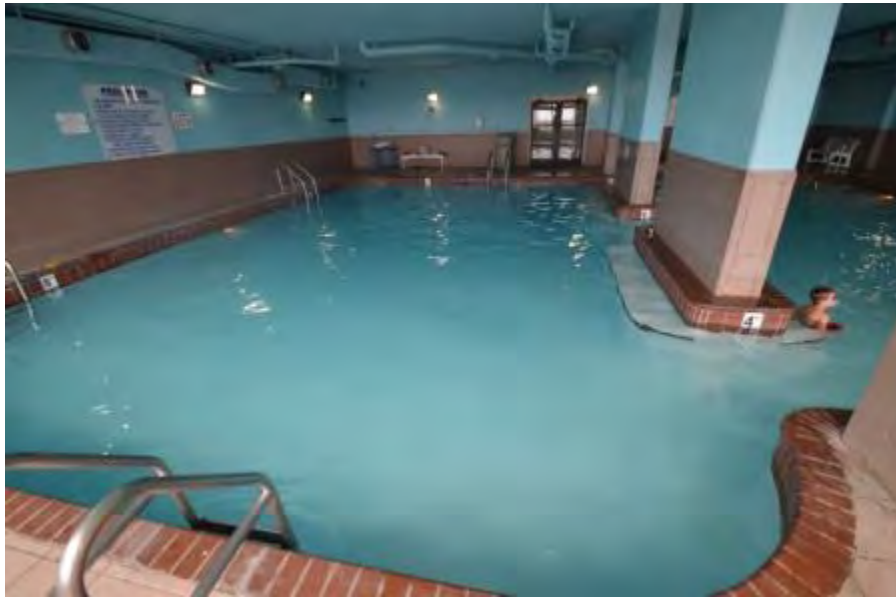
Pool Interiors (Natatorium)

Assuming proper installation, chemical balancing, and routine maintenance, interior resurfacing of indoor natatorium pools with marcite or aggregate interior finishes should be expected on a life cycle in the mid-10 year range. The association expects to complete this project in 2019, and a 2033 expense date scheduled accordingly. The current per square foot of surface area cost estimate includes typical minor tank/structural repairs, tile upgrades and/or replacements, and installation of new aggregate surface materials (i.e. "diamond brite", "pebble crete", etc.). The surface area is a rounded estimate.

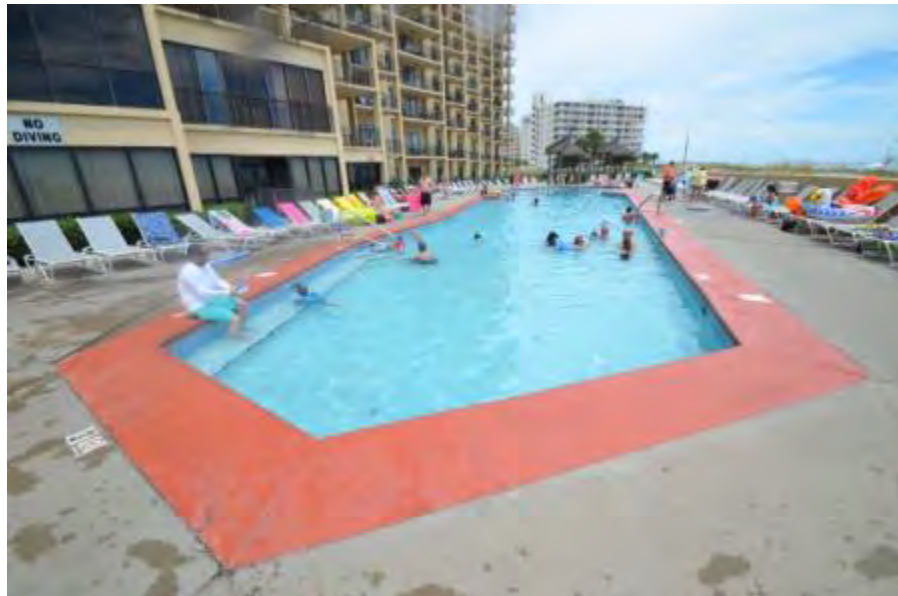
Pool Interiors (Outdoor)

Assuming proper installation, chemical balancing, and routine maintenance, interior resurfacing of standard concrete pools with marcite or aggregate interior finishes should be expected on a life cycle in the 10 to mid-10 year range. This project was most recently completed in 2005, reflecting an actual age of +/- 14 years. As there were no reported plans to restore/resurface in 2019, a fall 2020 expense date was forecast. The current per square foot of surface area cost estimate includes typical minor tank/structural repairs, tile upgrades and/or replacements, and installation of new aggregate surface materials (i.e. "diamond brite", "pebble crete", etc.). This cost excludes the custom phoenix tile at the deep end.

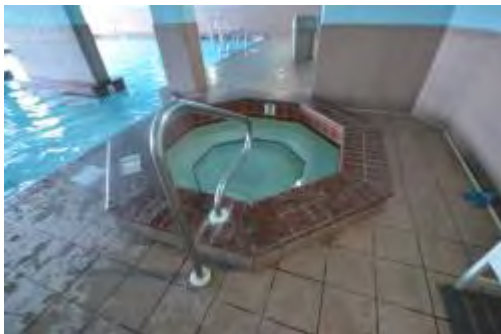
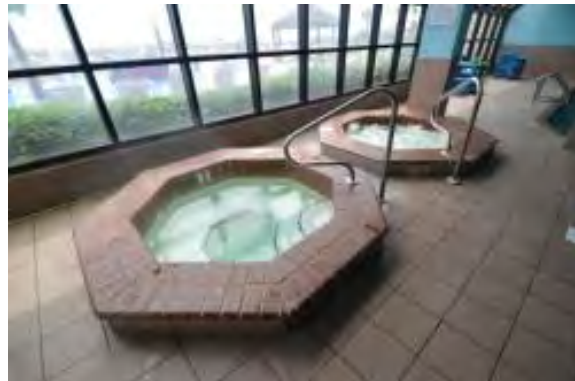
Spa Interiors

Given the higher temperatures and chemical concentrations, interior resurfacing of standard concrete spas with marcite or aggregate interiors is typically necessary on a shorter life cycle than similar pool interiors. Life cycles in the 7-10 year range have most typically been observed, assuming proper installation, chemical balancing and routine maintenance. The association expects to complete this project in 2019, and 2028 expense dates scheduled accordingly.

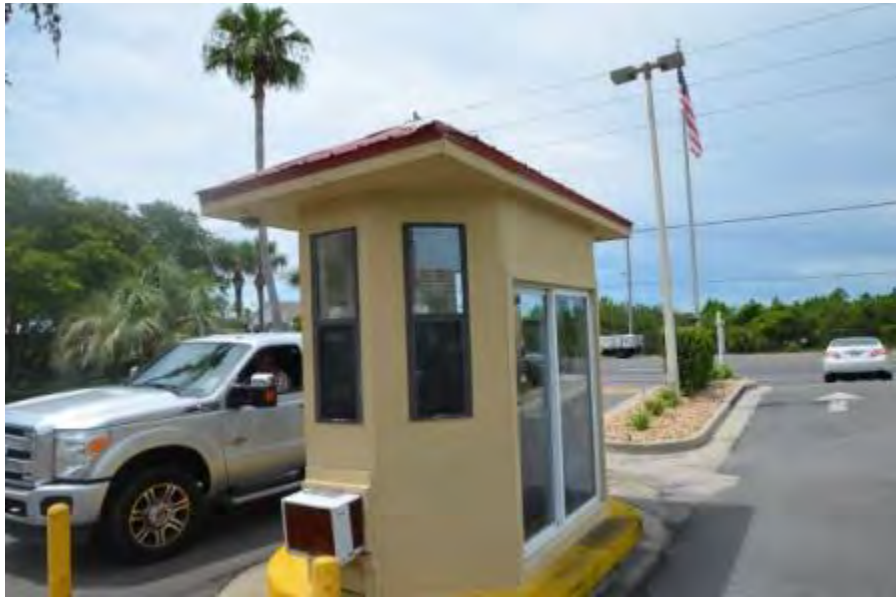
Roofing, Gate House

Pitched standing seam metal has a probably life cycle in the mid 20 year range, assuming proper design (including non-corrosive panels/hardware, etc.), installation and routine maintenance. This fund is designed to provide monies for as needed repairs to and eventual replacement of the pitched metal roofing on the tower building over a 26 year life cycle, which suggests replacement in 2021. The current cost estimate includes removal and disposal of the existing roofing, typical minor repairs to the underlying roof structures, flashing, fascia/soffits, etc. and installation of like roofing.

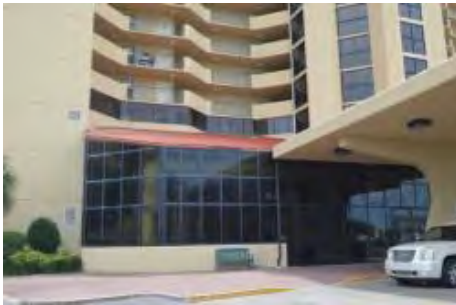
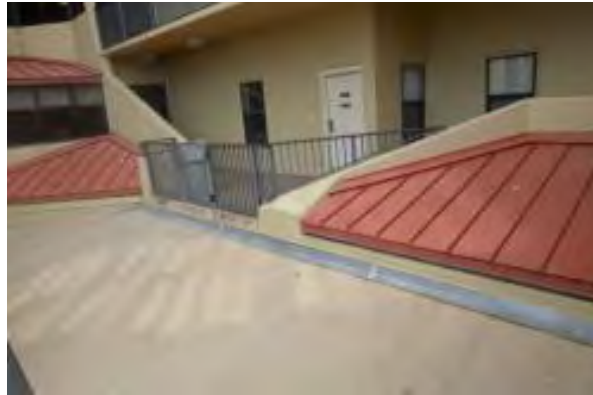
Pitched standing seam metal has a probably life cycle in the mid 20 year range, assuming proper design (including non-corrosive panels/hardware, etc.), installation and routine maintenance. This fund is designed to provide monies for as needed repairs to and eventual replacement of the pitched metal roofing on the tower building over a 26 year life cycle, based on its reported 2010 installation date. The current cost estimate includes removal and disposal of the existing roofing, typical minor repairs to the underlying roof structures, flashing, and installation of like roofing.

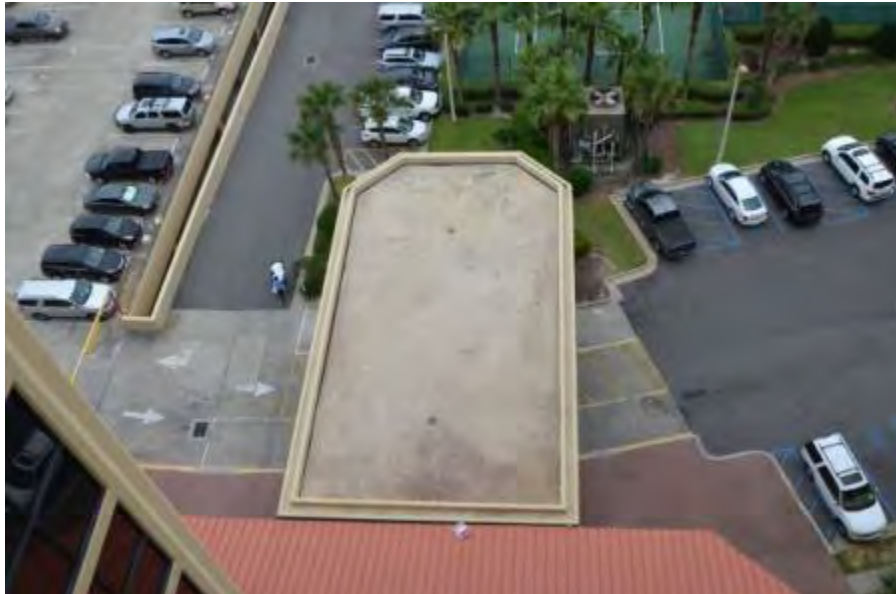
Roofing, Porte Cochere

Life cycles in the mid 20 to 30 year range have been observed for replacement of properly designed, installed and maintained tar and gravel roofs. Replacement of the porte cochere roofing was scheduled in 2025. accordingly. The current cost estimate includes removal and disposal of the existing roofing, typical minor repairs to the underlying roof structures, flashing, etc. and installation of like roofing.

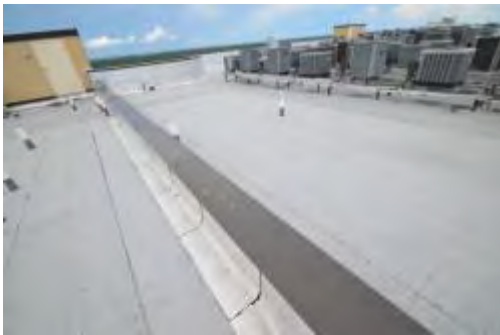
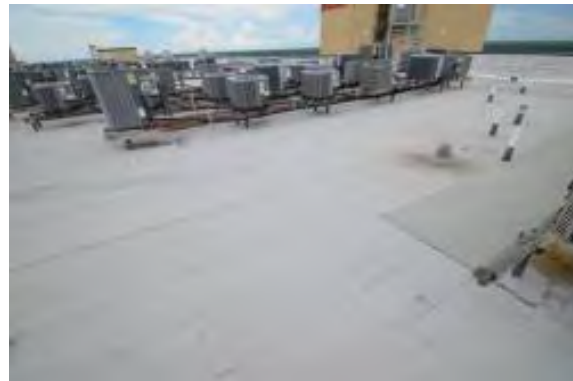
Roofing, Tower

Data gleaned from both within and outside the local market area reflects a probable life cycle in the +/- 20 year range for a properly designed, installed and maintained flat/membrane roof. Replacement of the tower flat roofing was forecast again in 2036, based on its reported 2016 installation date. The current cost estimate includes removal and disposal of the existing roofing, typical minor repairs to the underlying roof structures, flashing, etc. and installation of like roofing. The total roof area is a rounded estimate, and includes the small flat roof areas at the first floor.

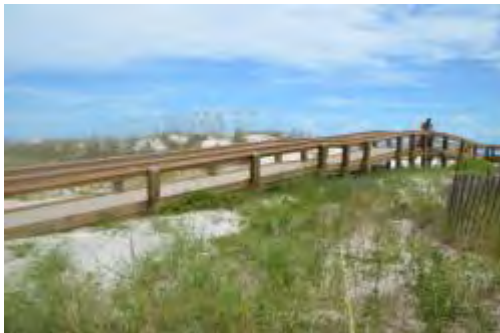
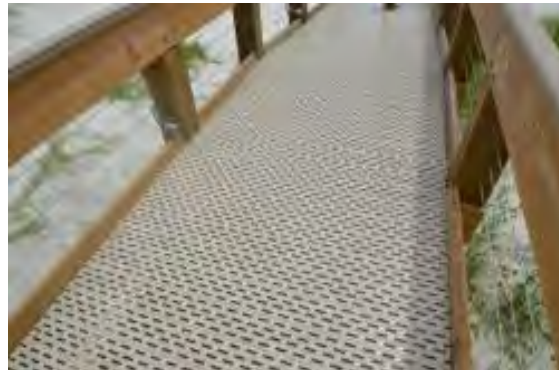
Dune Crossover/Boardwalk

This fund is designed to provide monies for as needed repairs to and eventual major restoration/replacement of the dune crossover/boardwalk over a 20 year life cycle, based on its 2018 installation date. The current cost estimate is an order of magnitude figure based on actual costs incurred during the 2018 project, as reported by the property manager.

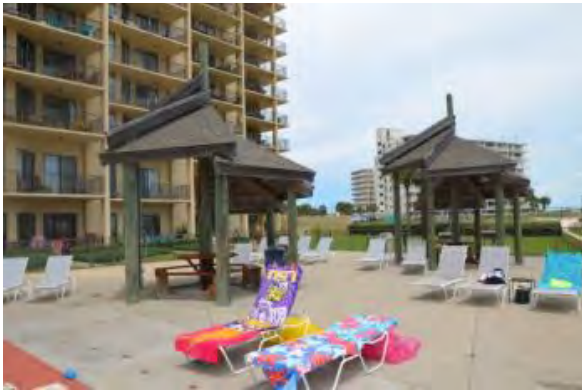
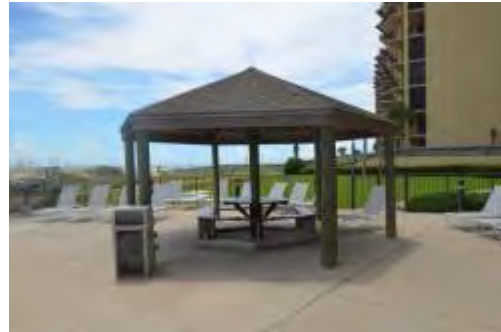
Gazebos Restoration

Under normal conditions, we do not anticipate the need for total replacement of the poolside/oceanfront wood piling/frame gazebos. This reserve is designed to provide monies for periodic major restoration, including (but not necessarily limited to) framing repairs, shingle roof replacements, etc. over a 20 year life cycle. **The date of the most recent major restoration/roofing project was not confirmed; we reserve the right to modify this report upon confirmation of the factual completion date(s) of the most recent major restoration.** The current cost estimate is not reflective of total replacement.

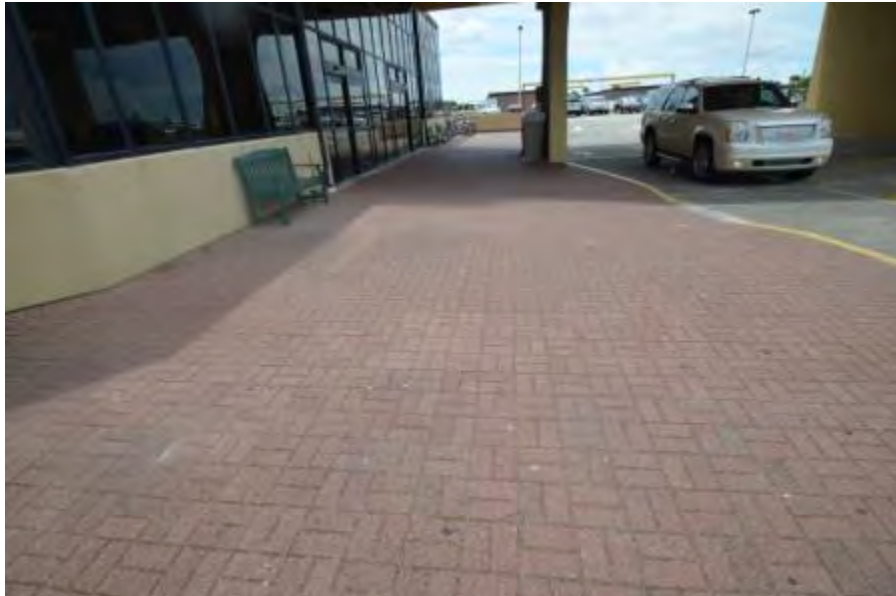
Pavers, Lobby Entry/Walkways

Some associations consider paver parking and drives, sidewalks, pool and spa decks, etc. to be effectively permanent, and opt to exclude replacement from their annual reserve budgets. Others do establish and fund reserves, on observed budgetary life cycles of 20-40 years. It is our opinion that reserving for eventual replacement is prudent, if only for cosmetic purposes; we have observed older pavers that appear worn and dated, even with periodic pressure washing and/or sealing. This fund is designed to provide monies for as needed repairs to and eventual replacement over a 30 year life cycle. The current cost estimate is an order of magnitude figure based on the approximate size and paver quality in place.

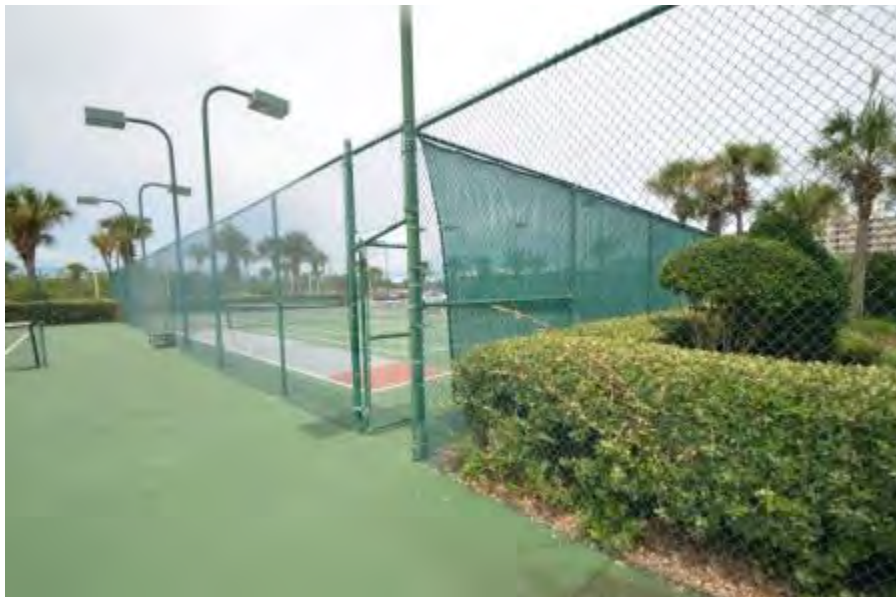
Tennis Court Fencing & Gates

Data gleaned from properties with similar exposure to the corrosive ocean environment indicates that under normal conditions, replacement of typical coated chain link tennis court fencing and gates should be expected on a life cycle in the high 10 to mid-20 year range. This fund is designed to provide monies for as needed repairs to and eventual replacement of the tennis court fencing/gates over a 20 year life cycle, based on the reported 2004 installation date. The current per court unit cost estimate includes removal and disposal of the existing fencing and gates and installation of like height/quality fencing and gates.

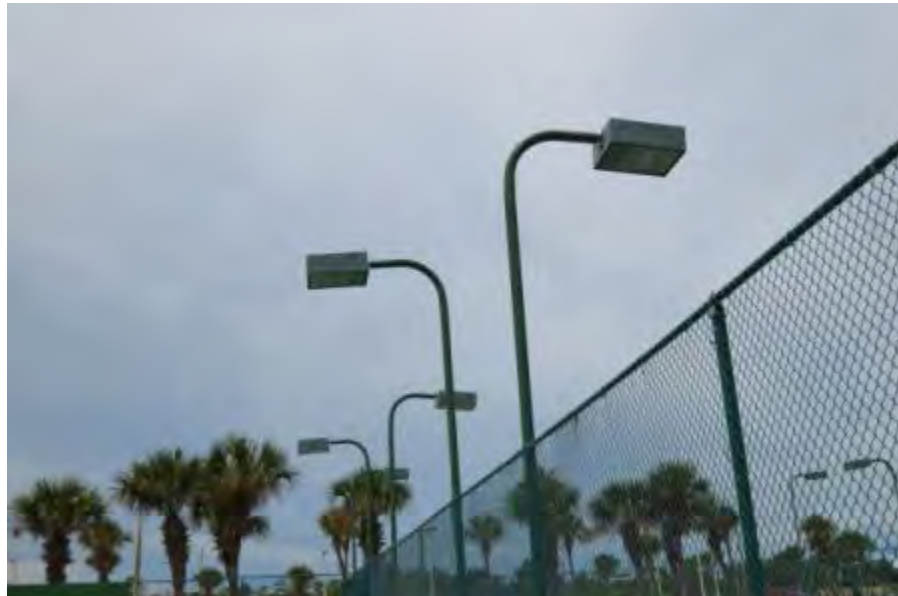
In the corrosive ocean environment, replacement of typical metal tennis court light posts should be expected on a life cycle in the 20 year range. This fund is designed to provide monies for as needed repairs to (including replacement of shoebox light fixtures) over a 20 year life cycle. The per post cost estimate includes removal and disposal of the existing posts and replacement with like quality.

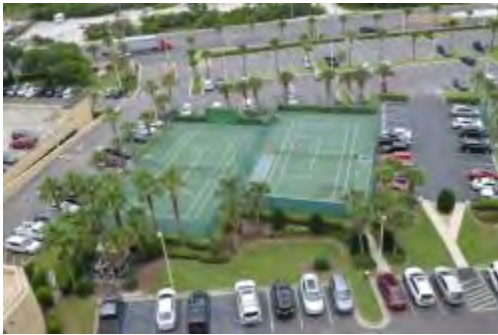
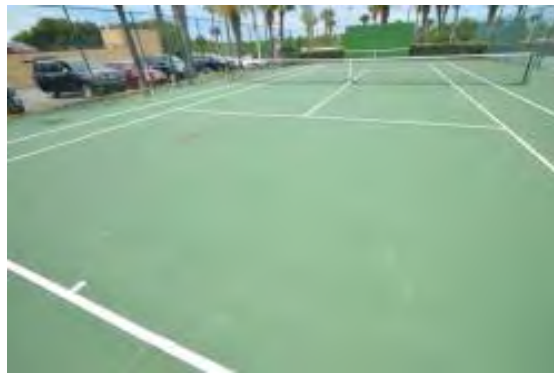
Tennis/Basketball Courts Resurfacing

To insure proper protection of the underlying court structures and a high cosmetic appeal, the market reflects a range in useful life of 6-9 years for resurfacing of standard asphalt tennis courts. As there were no reported plans to resurface in 2019, a 2020 expense date was scheduled; a recurring 8 year life cycle was forecast thereafter. The current per court cost estimate includes typical minor repairs to the underlying court structures and re-stripping.
