GEOTECHNICAL REPORT

Phoenix V Condominium
c/o Coastline Management LLC.
Front Lobby Foundation Evaluation Project
Orange Beach, Alabama

Thompson Engineering Project No.: 21-1102-0146

December 1, 2021

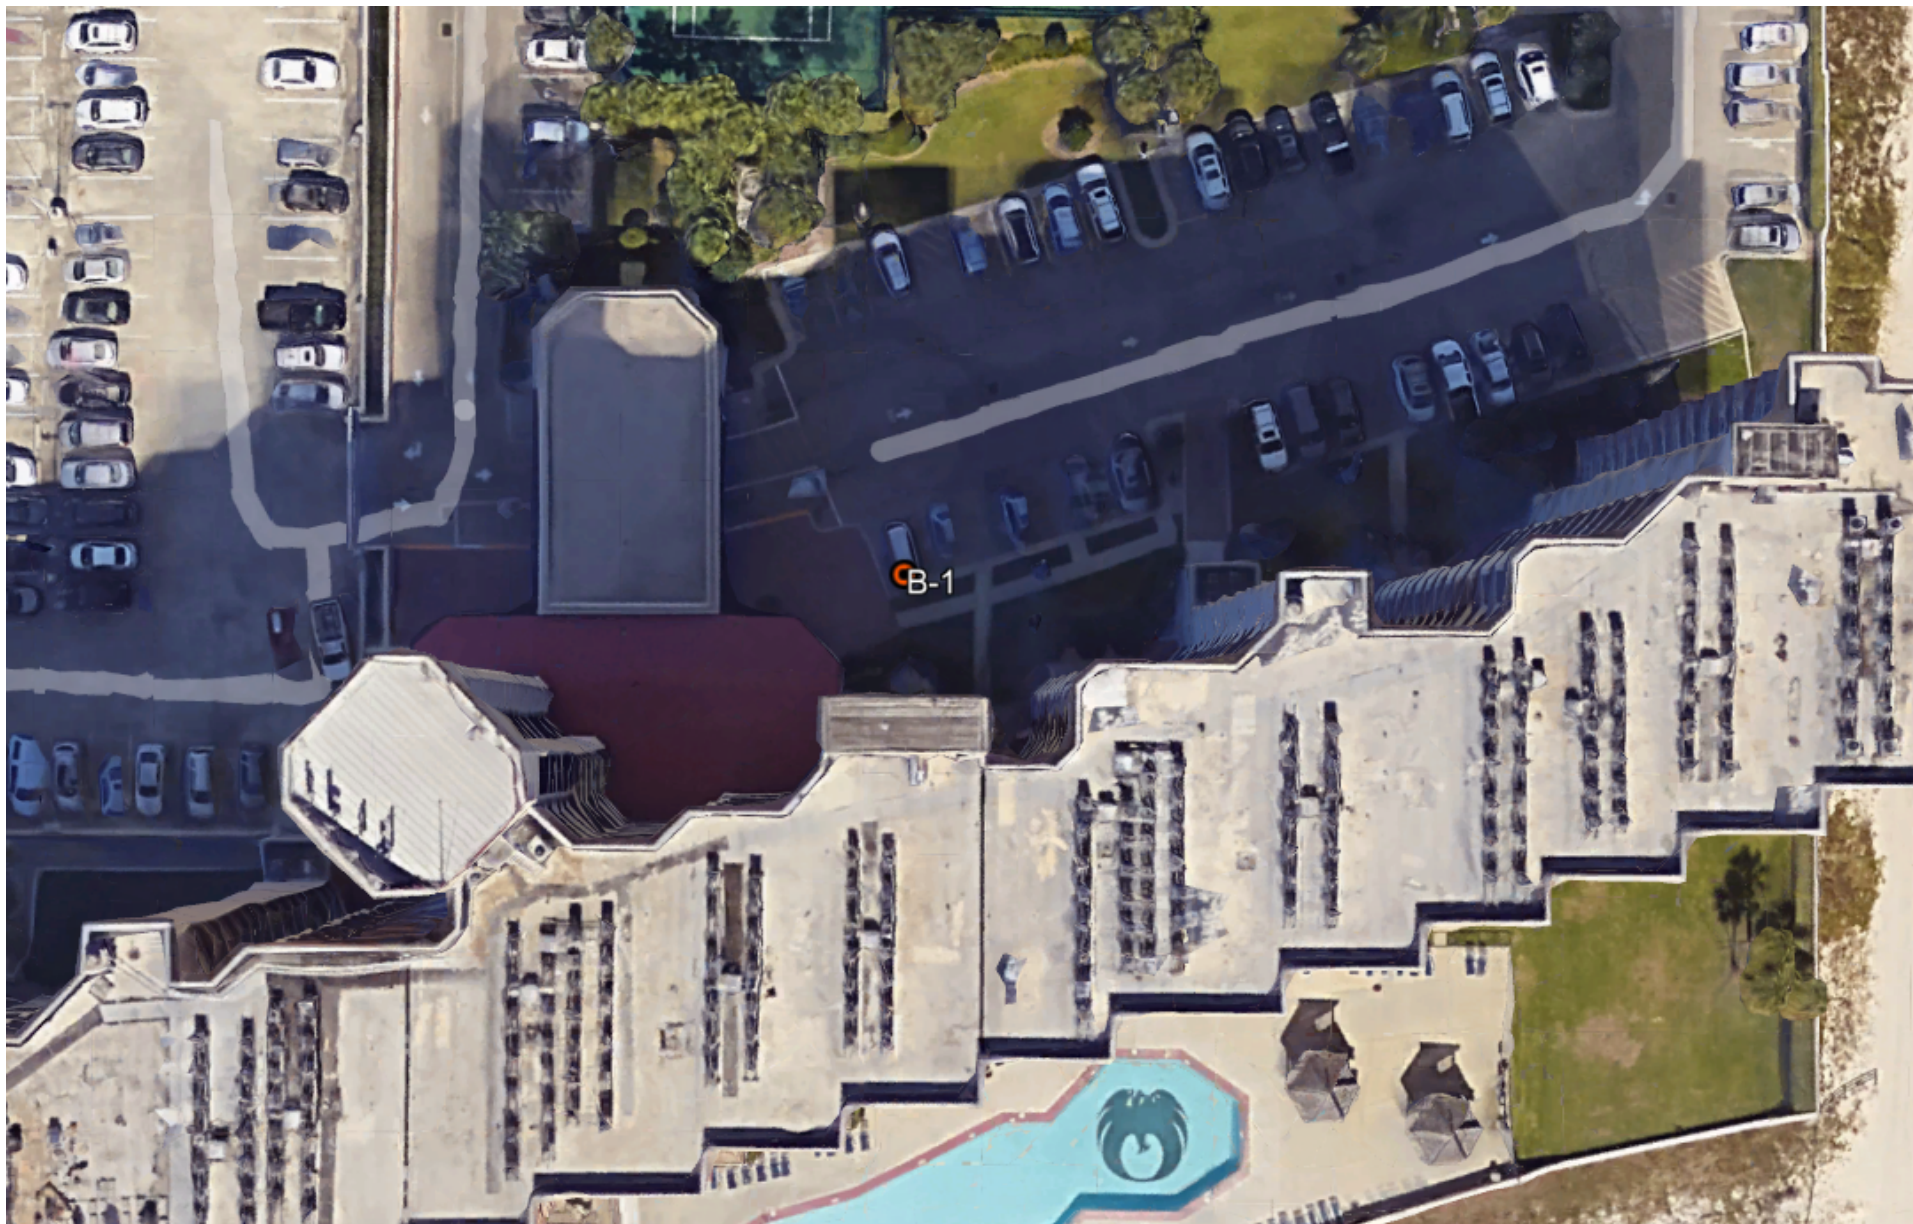
**Boring Location Plan
and Record of Test Boring**

The overall intent of the field exploration program was to evaluate the density of the subgrade soils beneath the existing concrete slab and to establish a site-specific subsurface conditions database for the project area. One (1) soil boring was performed within the vicinity of the existing front lobby. The Boring Location Plan and Record of Test Boring are included in **Appendix A**.
